Occurrence of Poly and Per Fluoro Alkyl Substances (PFAS) in Groundwater on Cape Cod

COASTAL CONFERENCE | DECEMBER 5, 2018

Thomas C Cambareri, LSP, CGWP Director of Technical Services for Water Cape Cod Commission

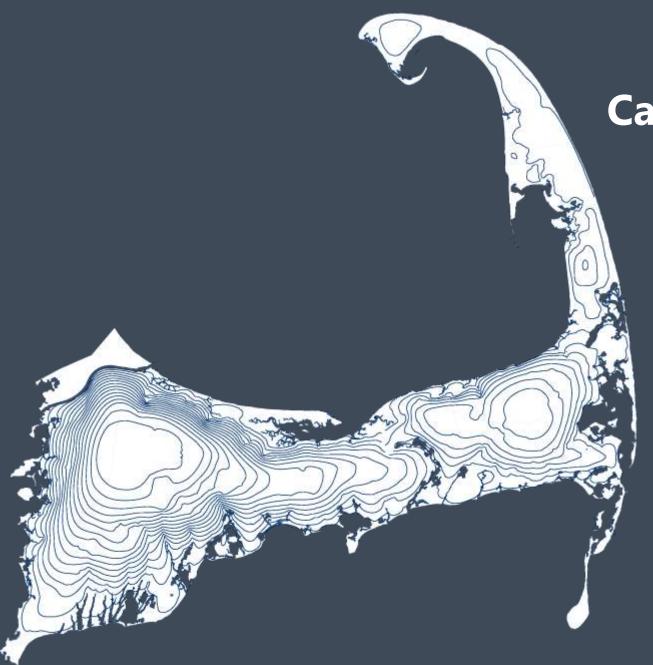
Cape Cod Sole Source Aquifer

Replenished by Precipitation

Six Separate Lenses

Sole Source of Drinking Water

Feeds Kettlehole Ponds

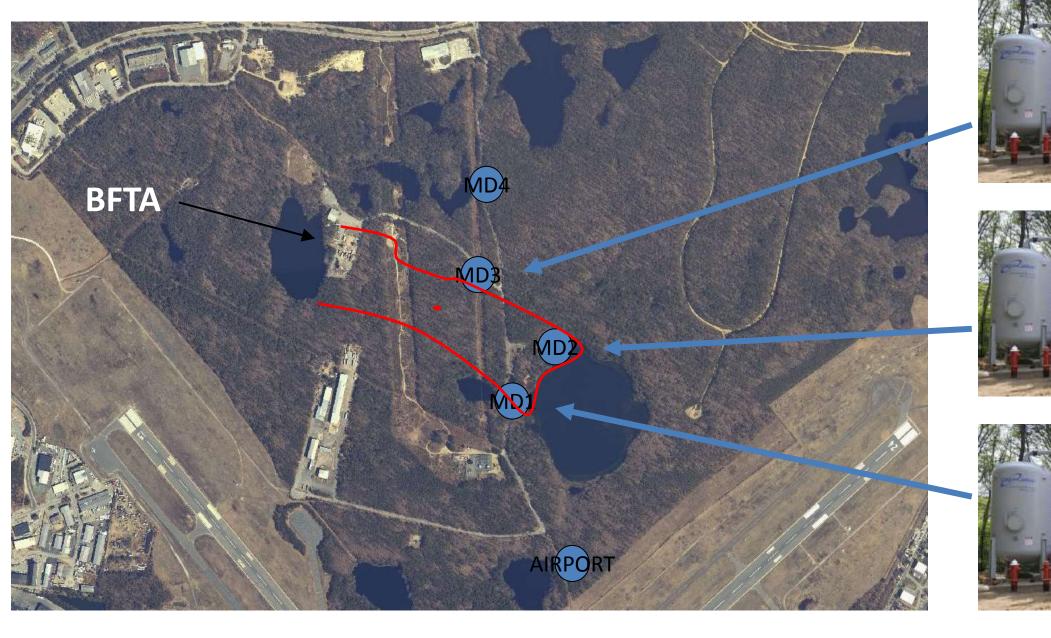
BCFRTA and Mary Dunn Wells and Hyannis Ponds

Low concentrations of PFAS in Soil and Groundwater

Off-site Background Soil PFOS is ND to 0.53 ug/kg

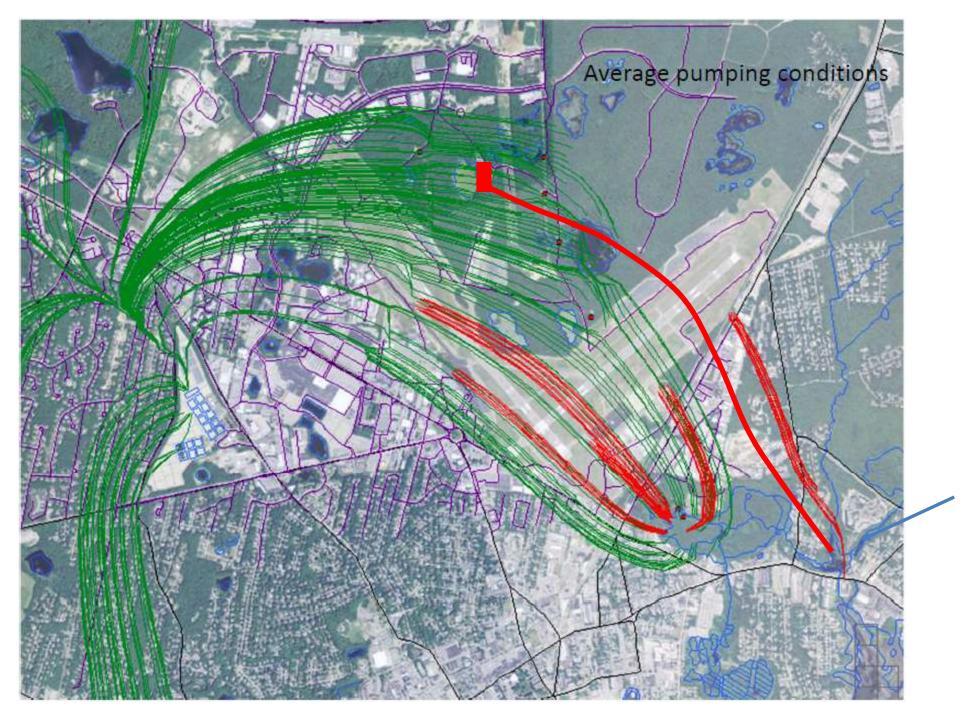
Two Sites and Particle Tracks

Reverse Forward

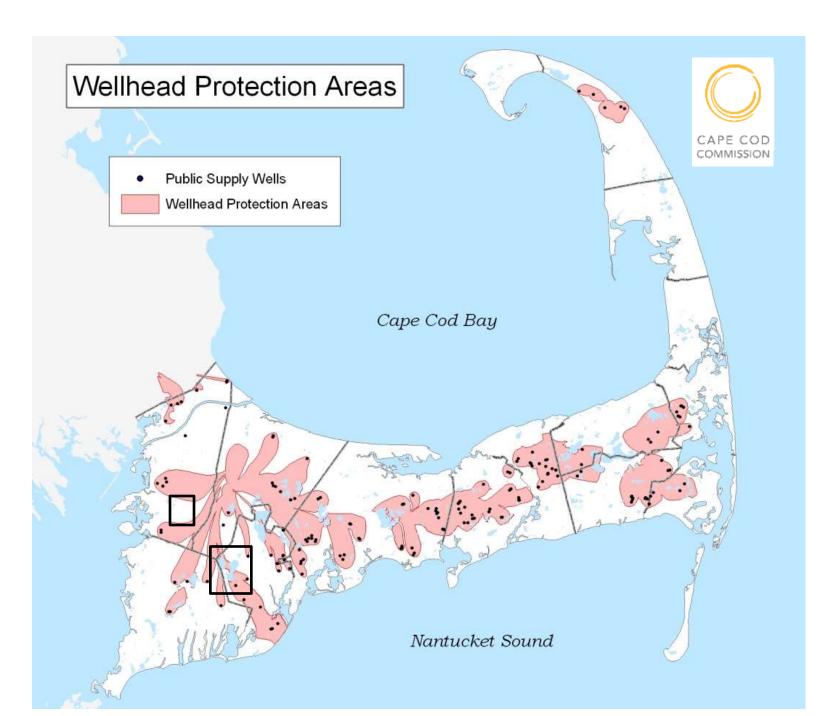
MILL CREEK Recent report on detection of PFAS and 6:2 TF

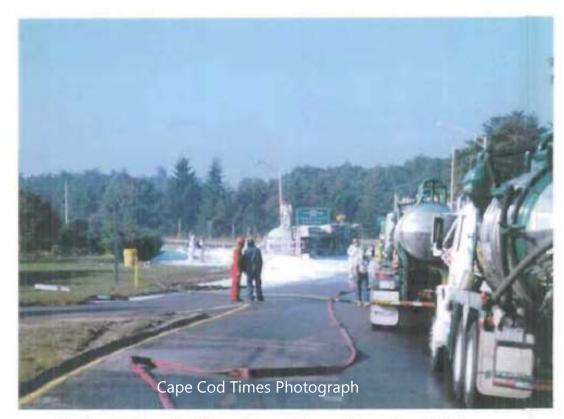
Tanker rollover incident, Route 28 southbound at Otis Rotary facing south, morning of September 19, 1997.

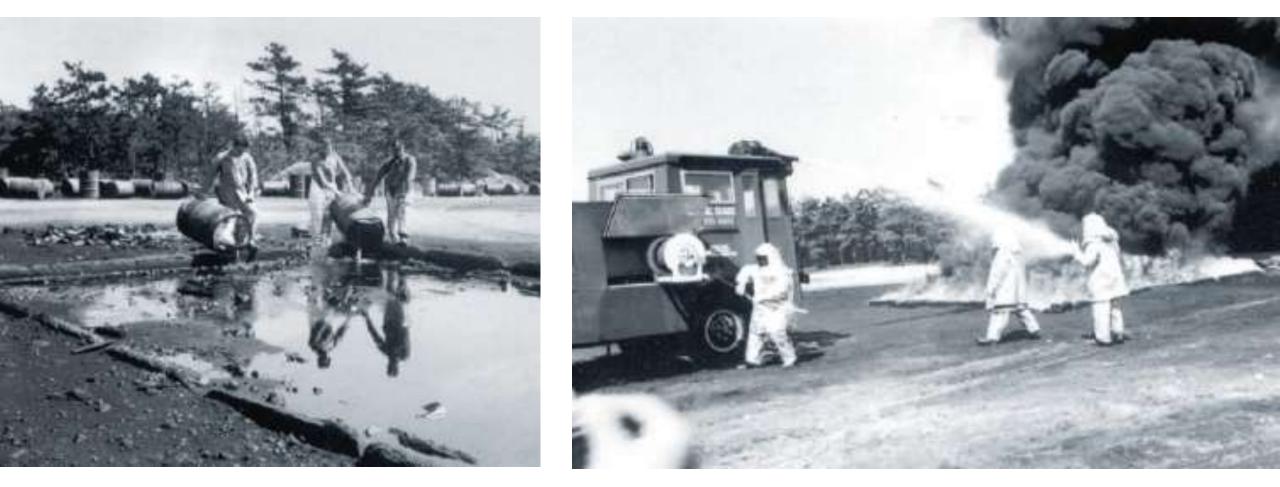
Fire Training Area

Used for fire training from 1958 to 1985

Primary source of contaminants in Ashumet Valley Plume

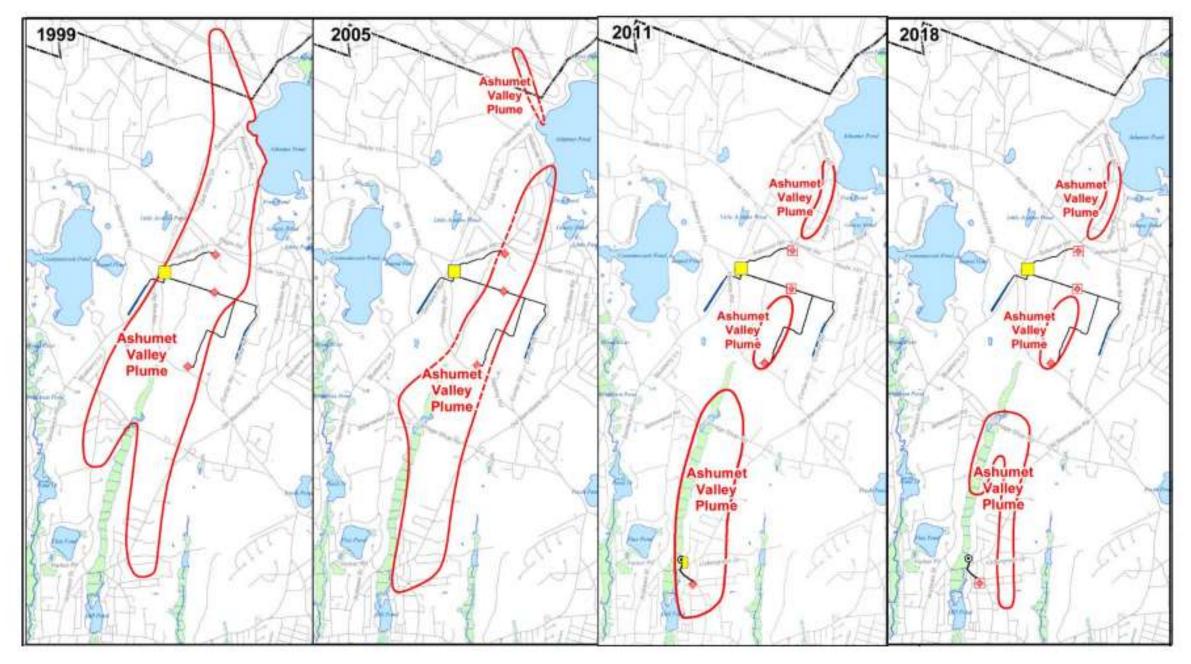
Volatile Organic Compounds Cleanup Status from 1999 to 2015
