River Herring Habitat Assessment and Passage Restoration at Bourne Pond, Falmouth

Brad Chase, Mass. Div. of Marine Fisheries
WBNERR Pond Oxygenation Workshop
Falmouth - Nov. 8, 2023

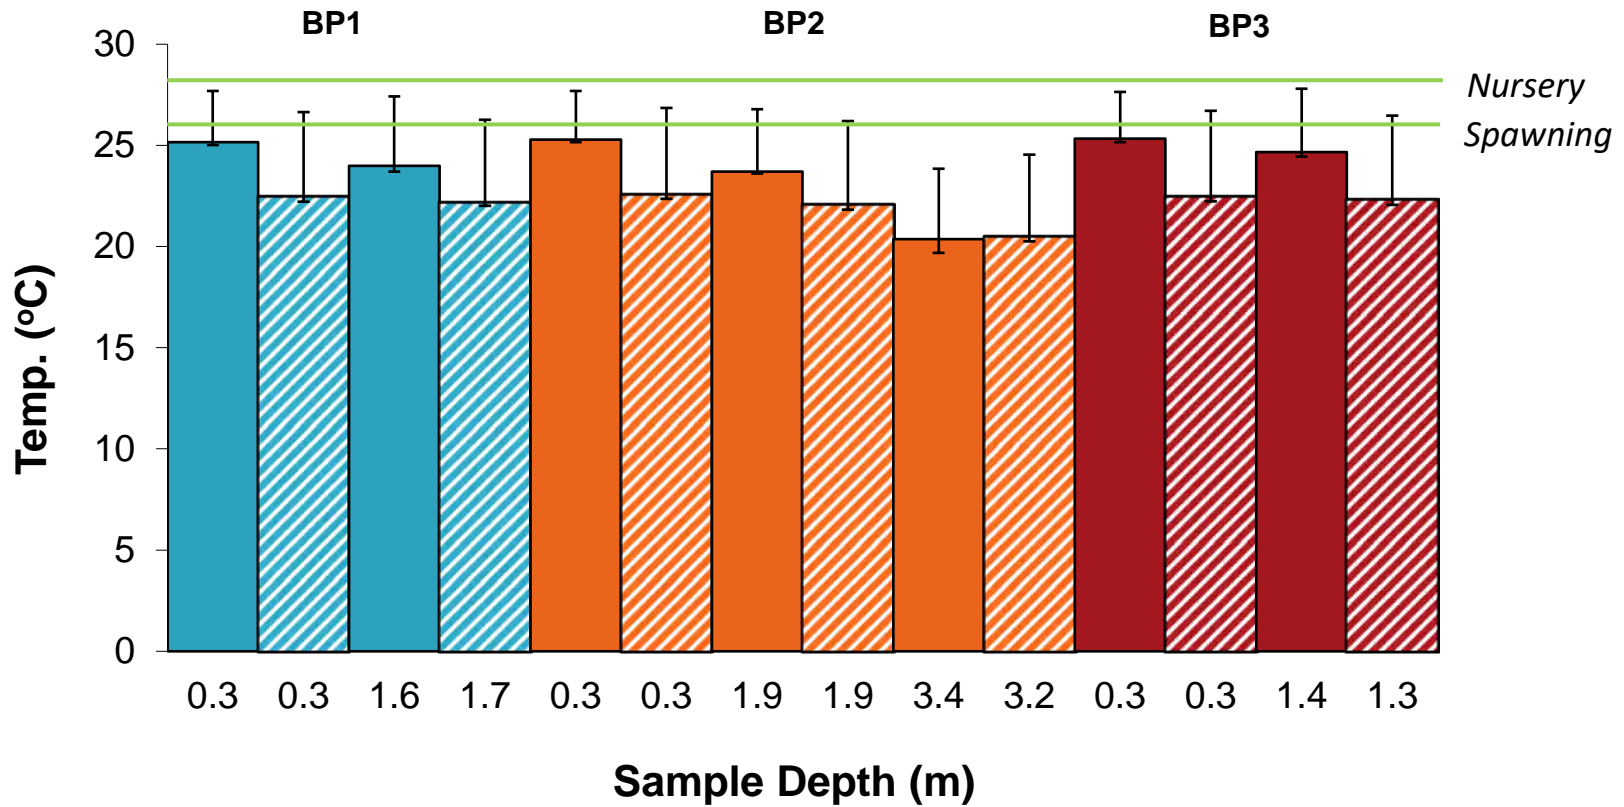
Water Temperature

Figure 9. Water temperature measurements taken at Bourne Pond, 2010 and 2011. Station averages (± 2 SE) are presented for 2010 (blank bars) and 2011 (striped bars). Five samples were recorded at each depth per season. The green horizontal lines mark the

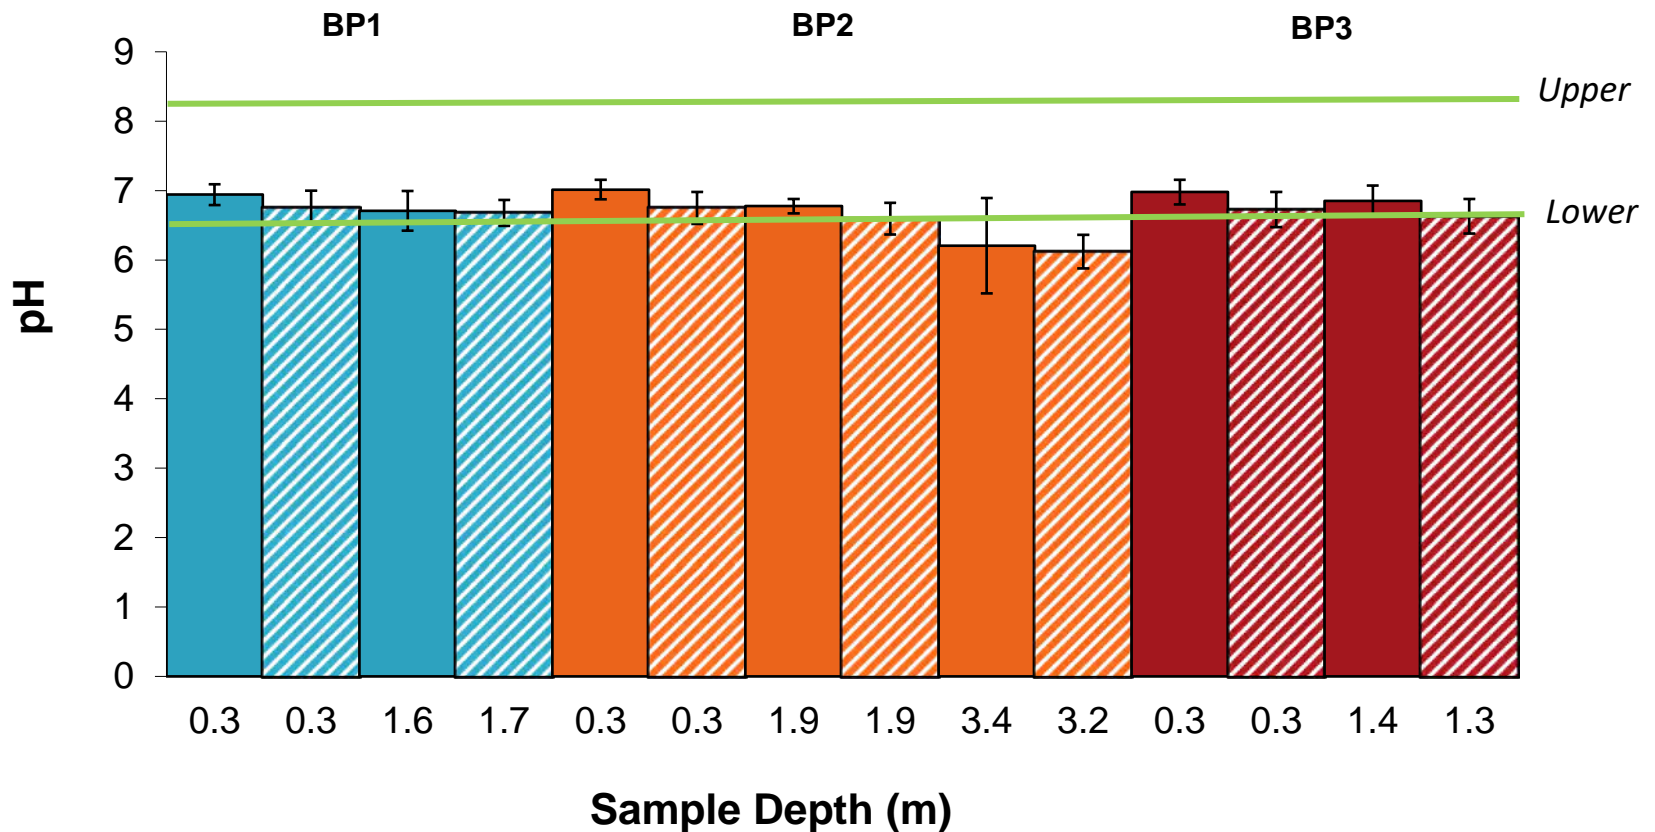
Figure x. Water pH measurements taken at Bourne Pond, 2010 and 2011. Station averages (± 2 SE) are presented for 2010 (blank bars) and 2011 (striped bars). Five samples were recorded at each depth per season. The green horizontal lines mark the QAPP adopt

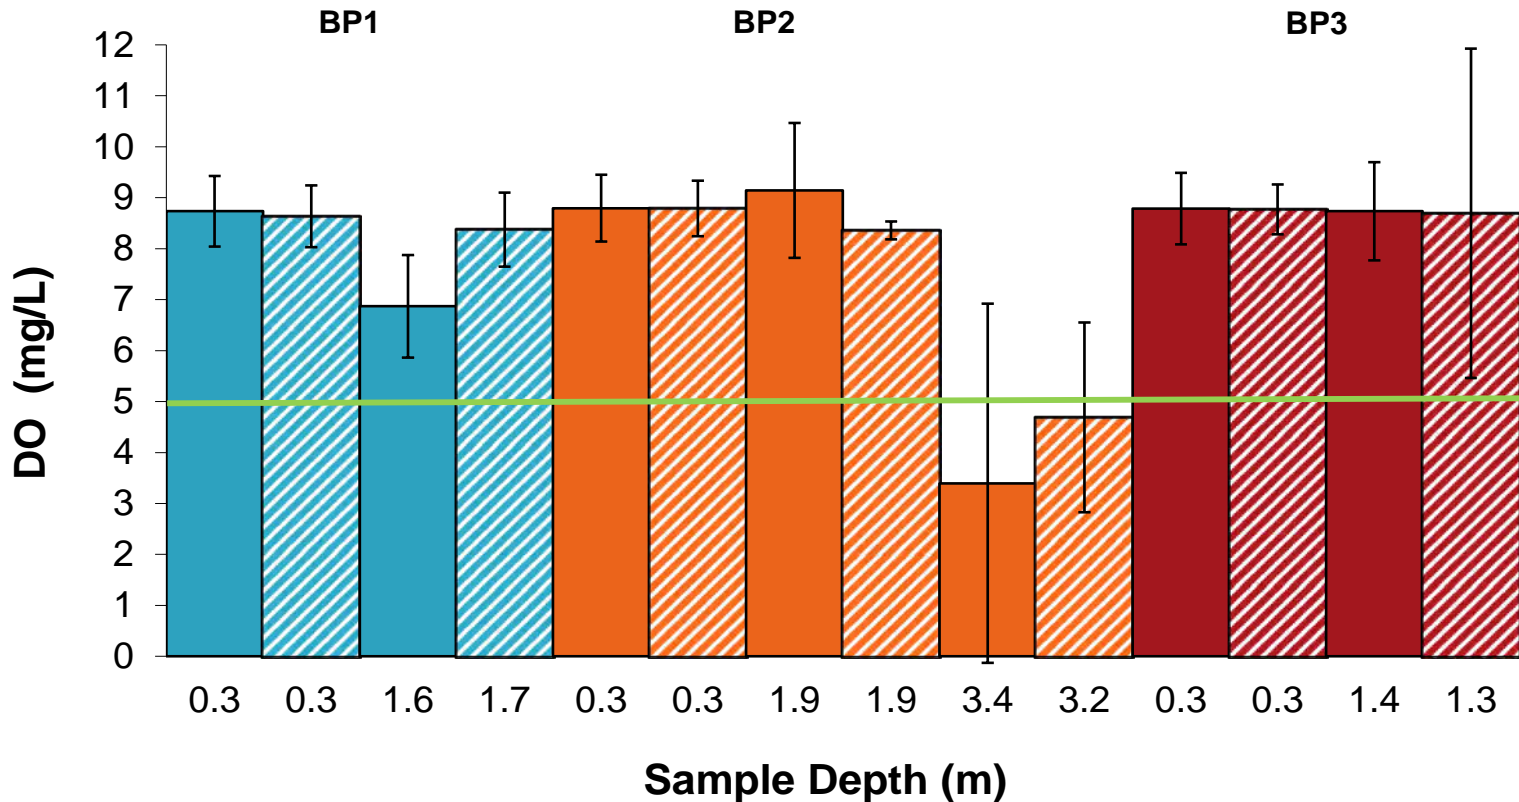
Dissolved Oxygen

Figure x. Dissolved oxygen measurements taken at Bourne Pond, 2010 and 2011. Station averages (± 2 SE) are presented for 2010 (blank bars) and 2011 (striped bars). Five samples were recorded at each depth per season. The green horizontal line marks the QAPP adopted criterion for DO.

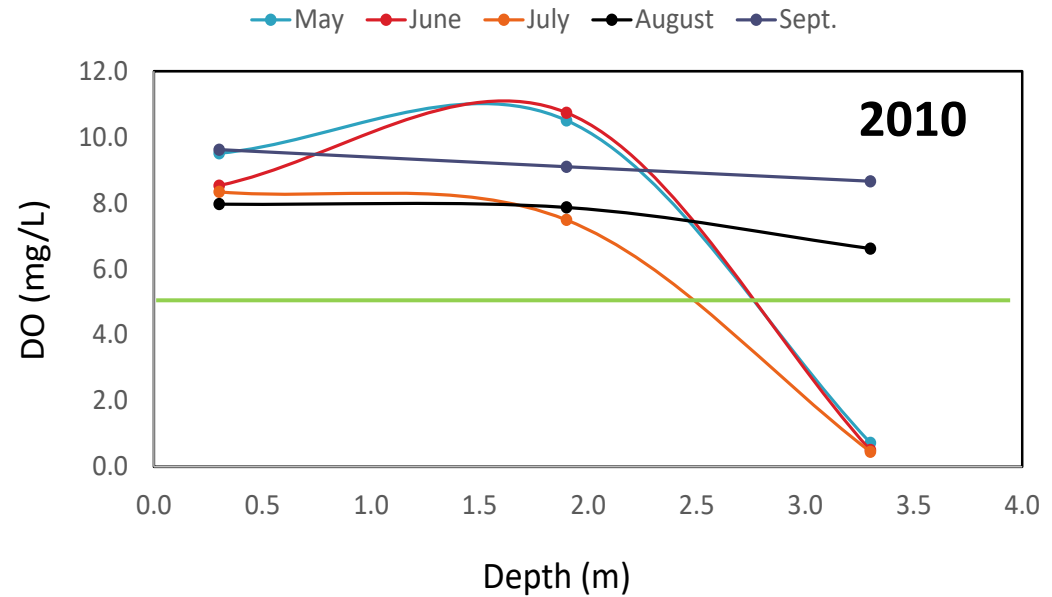
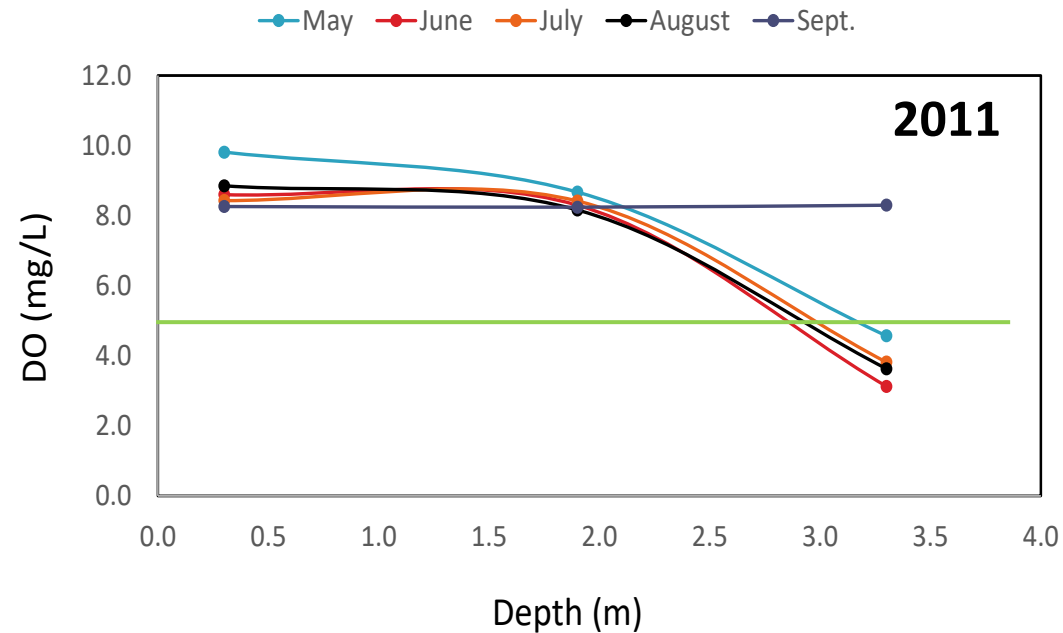
DO Profile at BP2

- Anoxic on bottom in 2010 for May-July
- Nearly hypoxic in 2011 for May-August
- Max. depth = 3.8 m

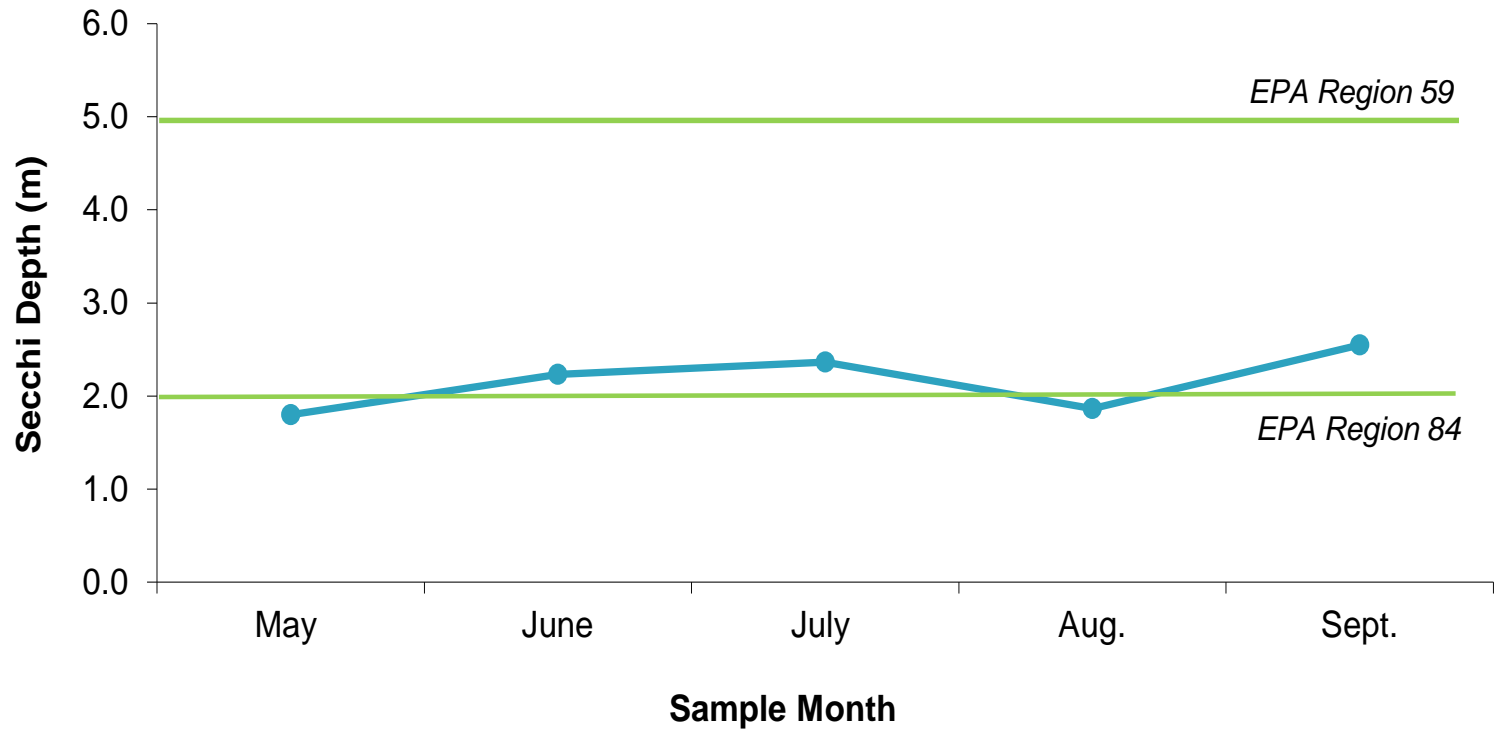
Secchi Disk Depth

Figure x. Average Secchi disc measurements taken at Bourne Pond, 2010 and 2011. Secchi disc depth at two stations were averaged each month (target N = 4, with some missing samples).

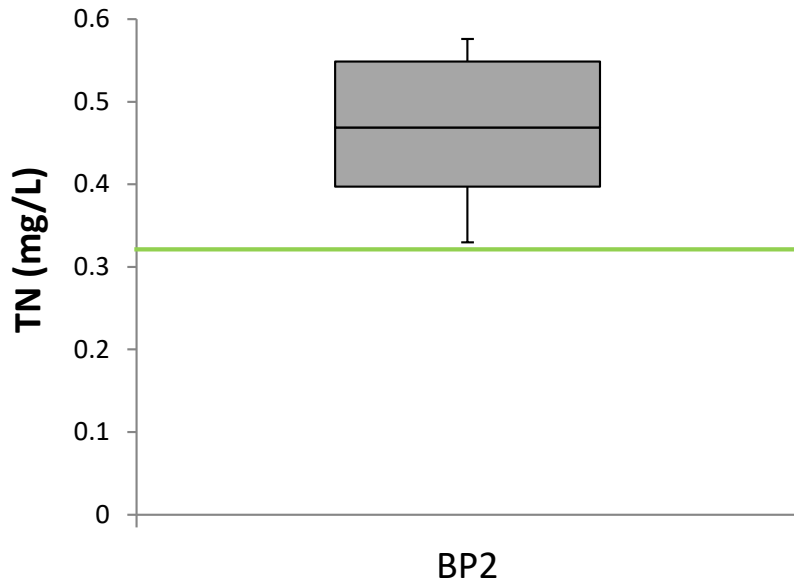
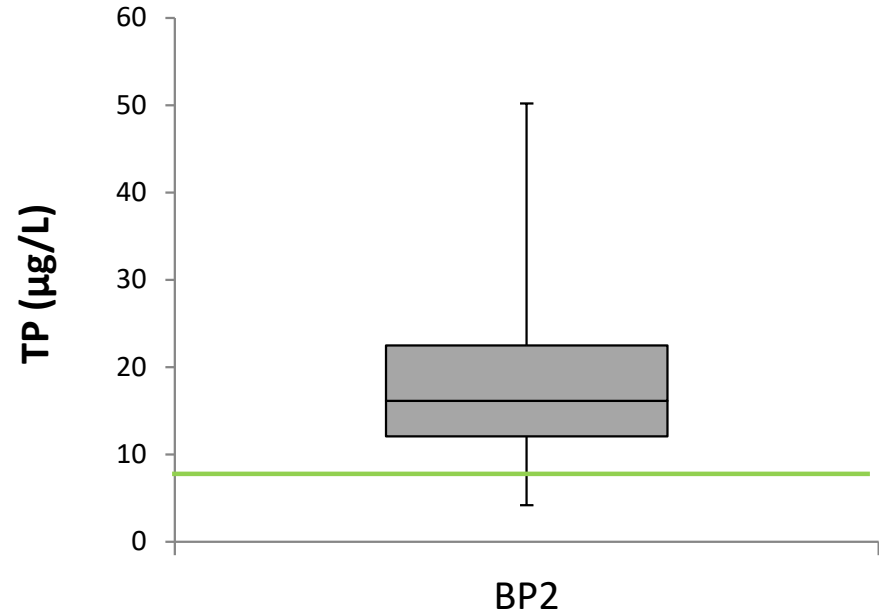
Total Nitrogen

Total Phosphorus

TN and TP surface measurements at Bourne Pond deep station BP2

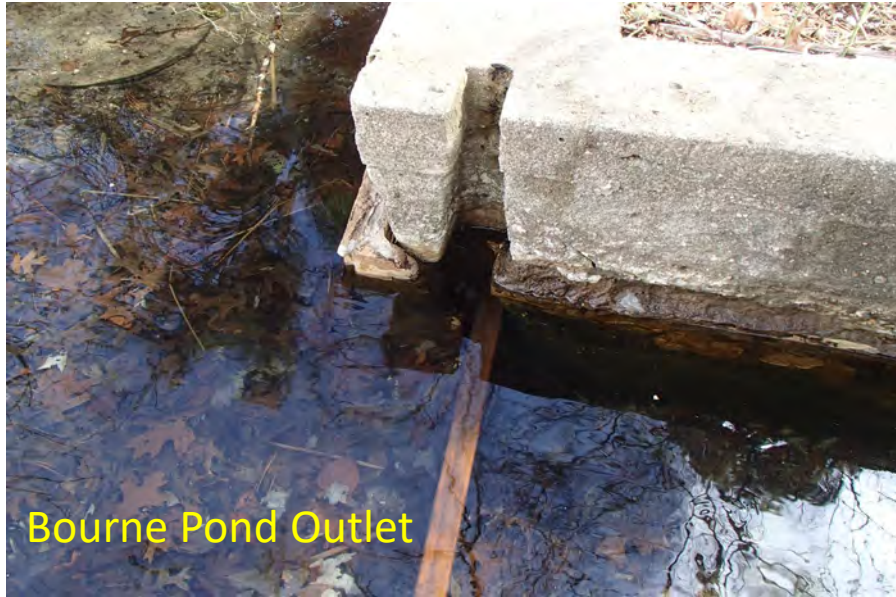
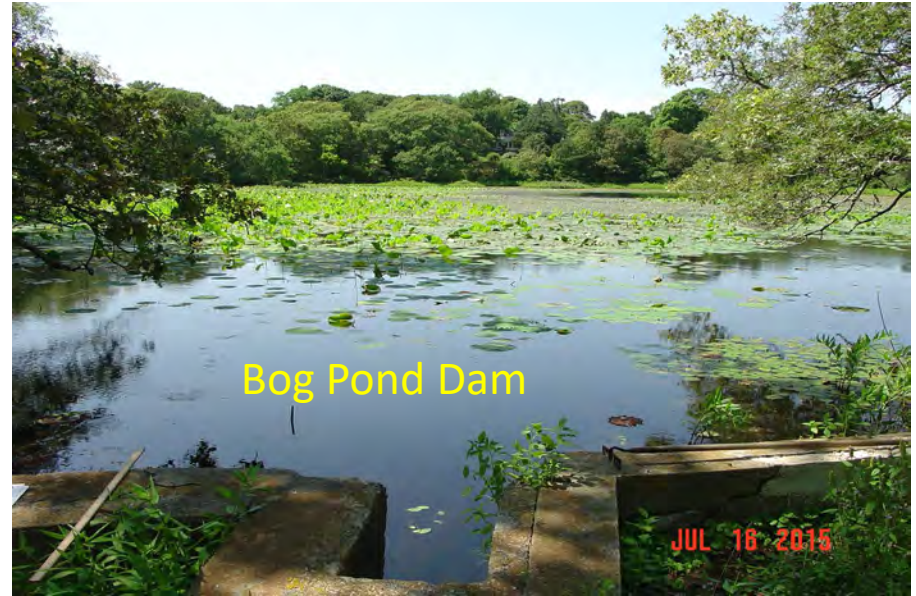
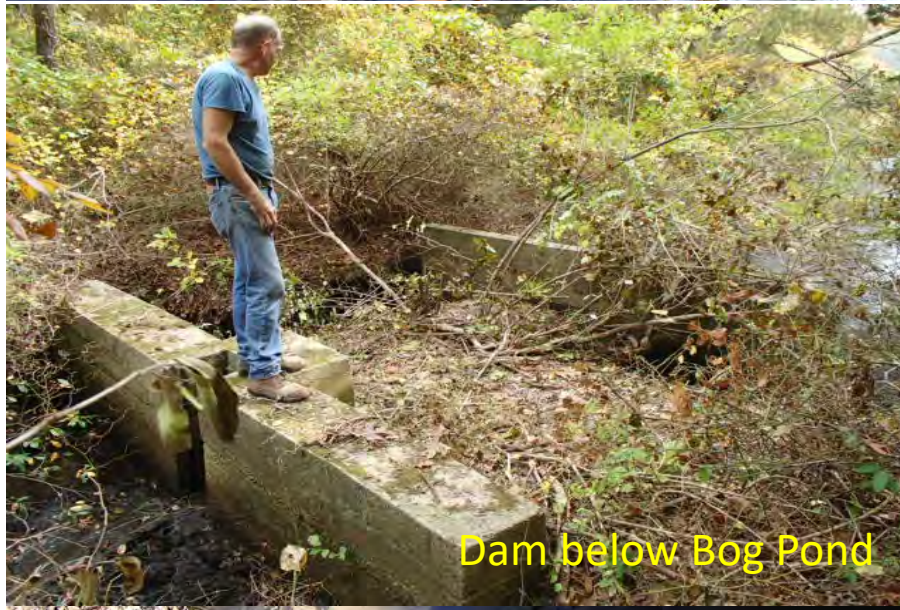
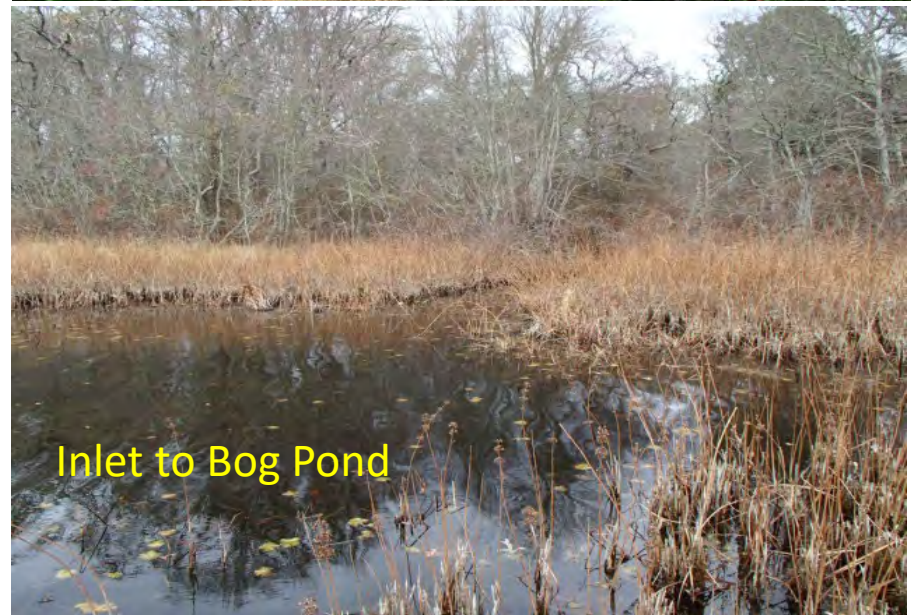
Fish Passage and Stream Flow

- Bourne Pond water and habitat suitable for early life stages of river herring. Bog Pond had limited habitat for river herring.
- Bog Pond Dam blocked fish passage; and the other two dams were partial obstructions.
- Low stream flow in summer and fall.
- Bog Pond channels obstructed by wetland plant growth, but no invasive plants observed in Bourne Pond.

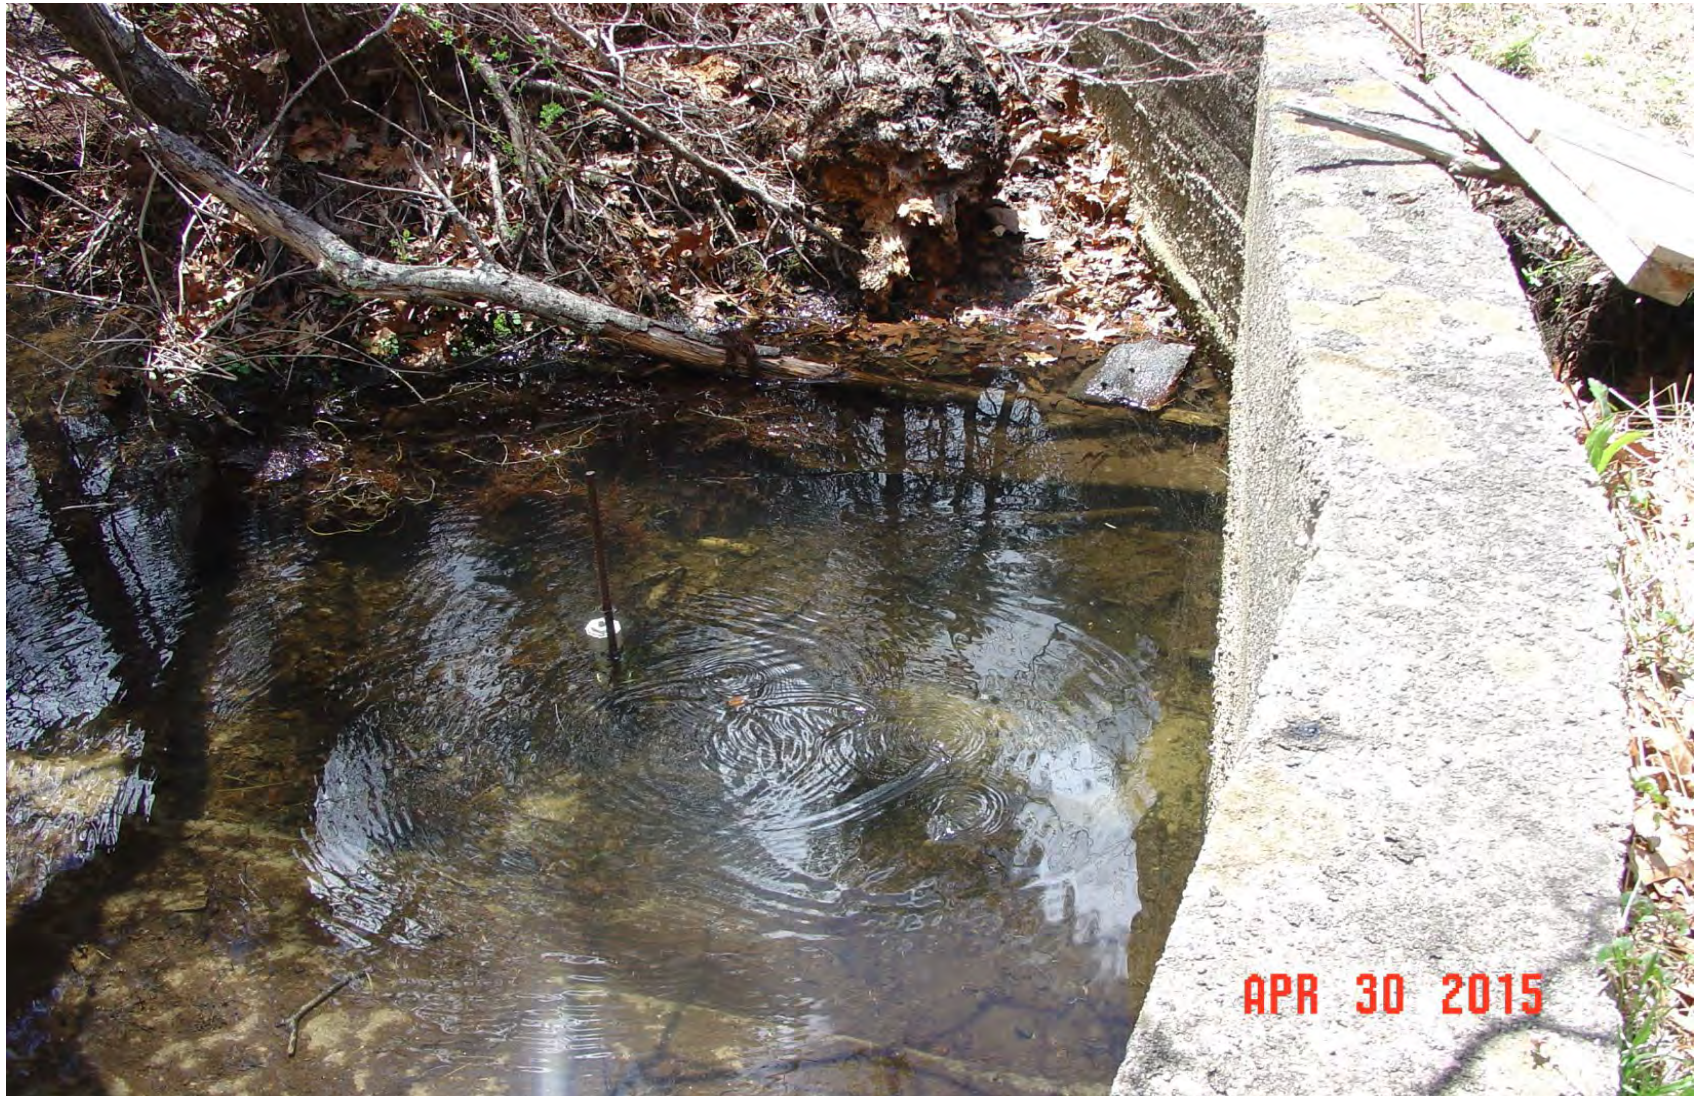
Water surface elevations recorded in 2015 with depth loggers at the Bourne Pond outlet, Bog Pond outlet and stream below Bog Pond

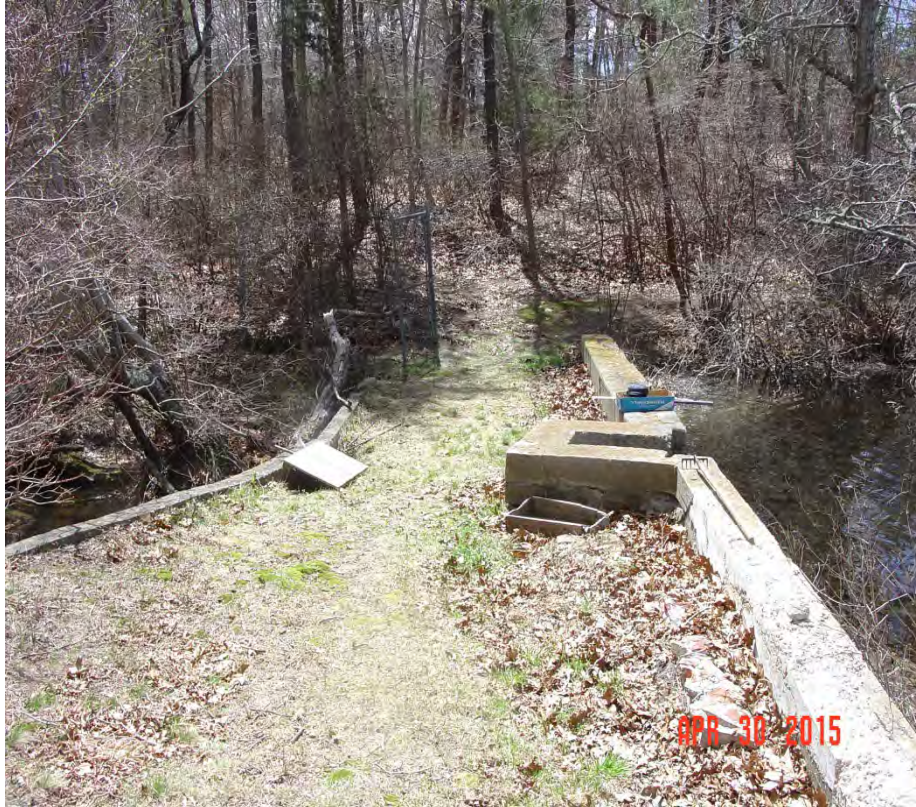
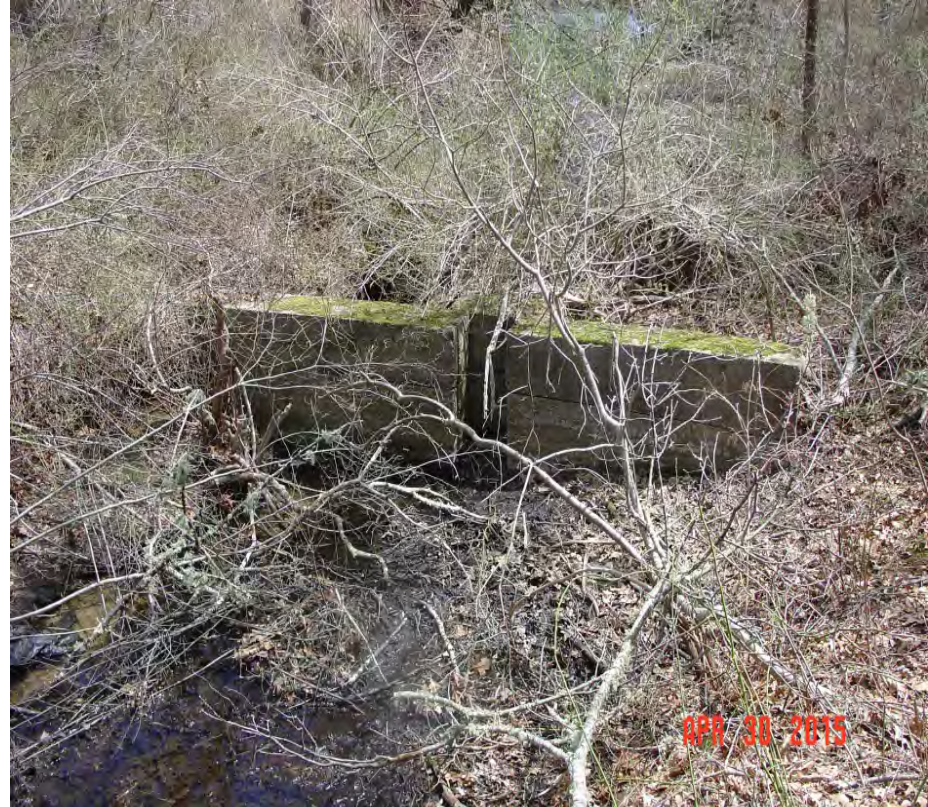
Bog Pond, Falmouth - 2015

Town of Falmouth requests DMF assistance to improve diadromous fish passage

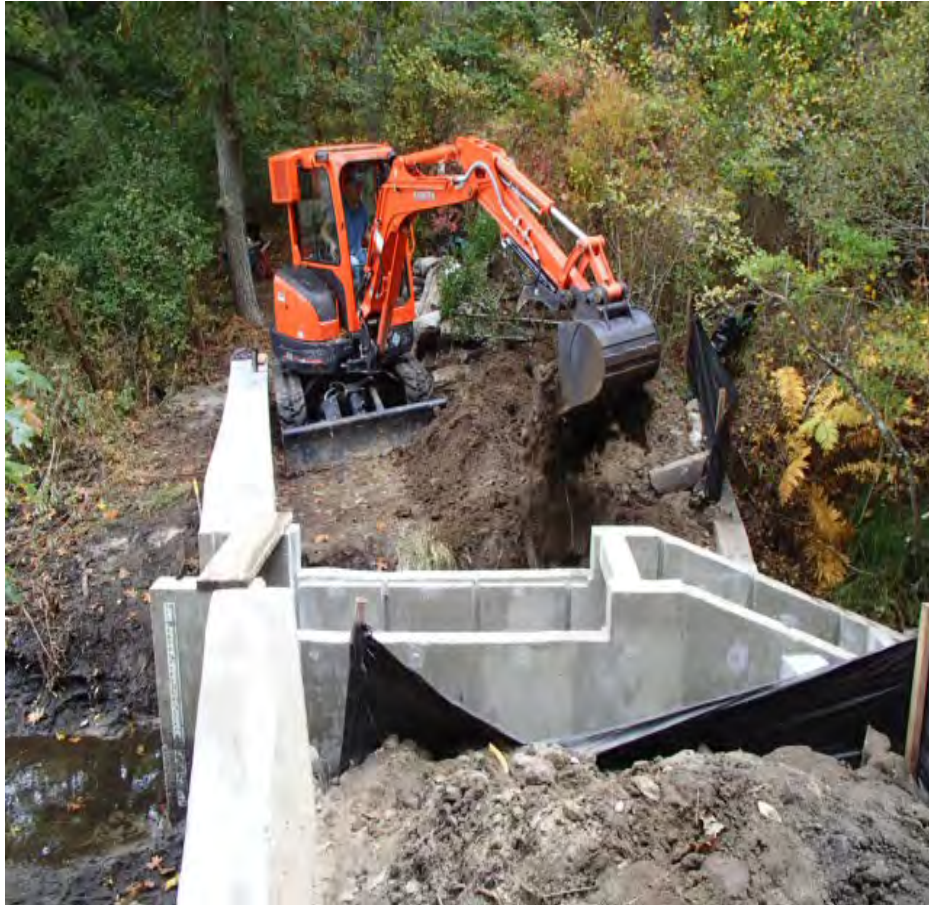
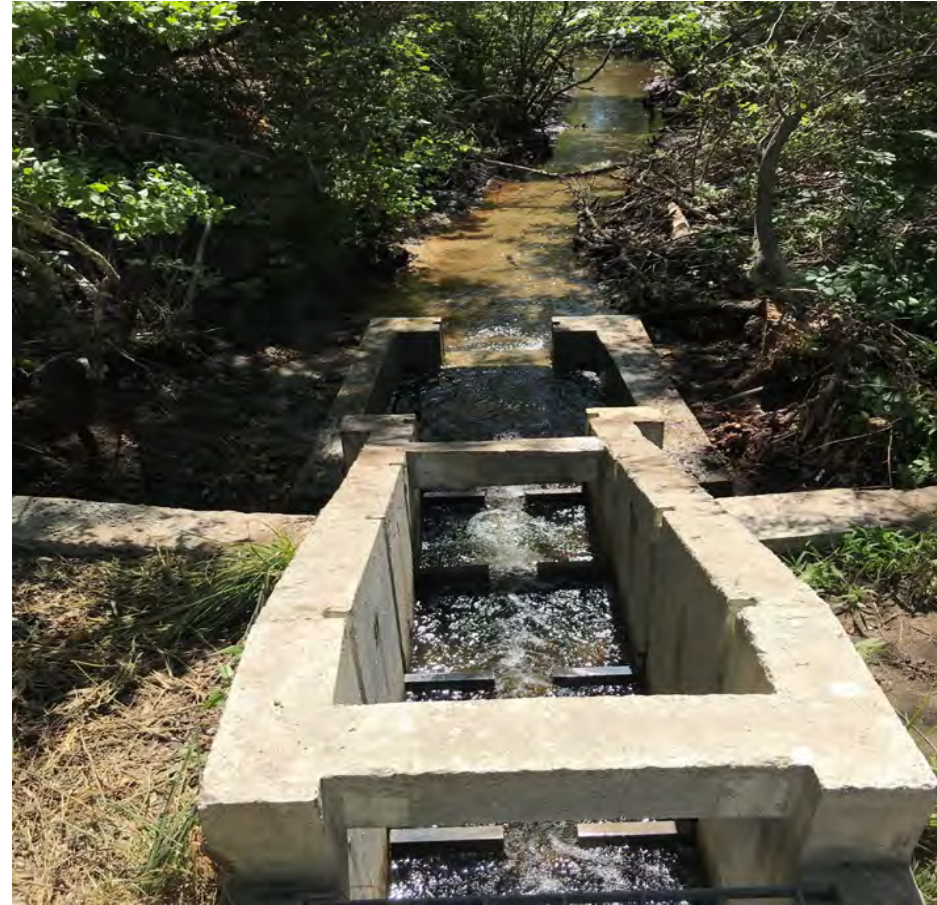
Bog Pond, Falmouth - 2016

Fishway Construction

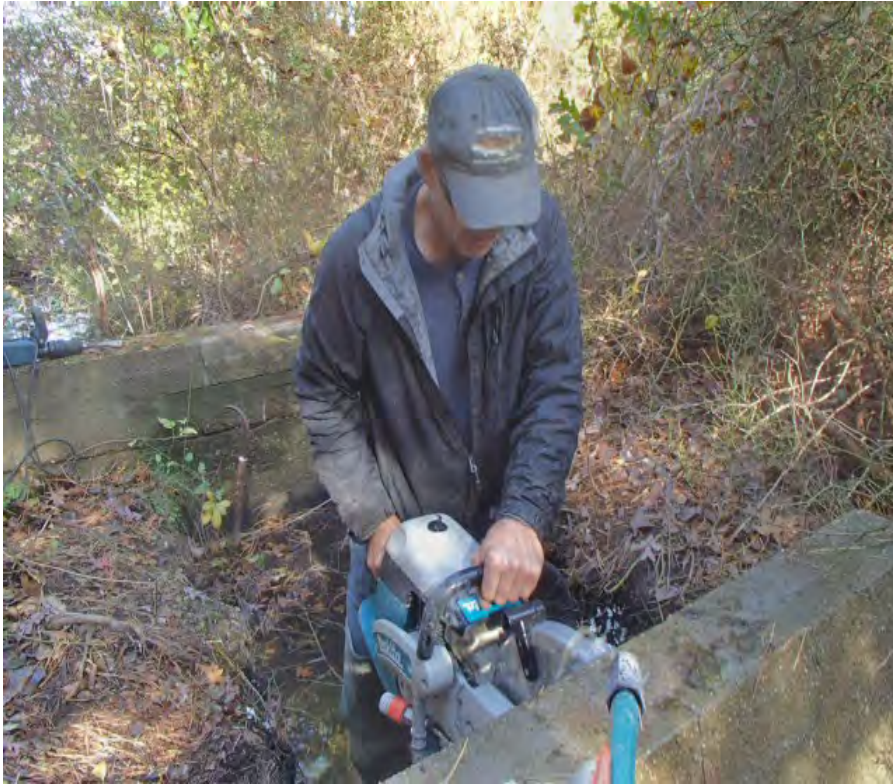
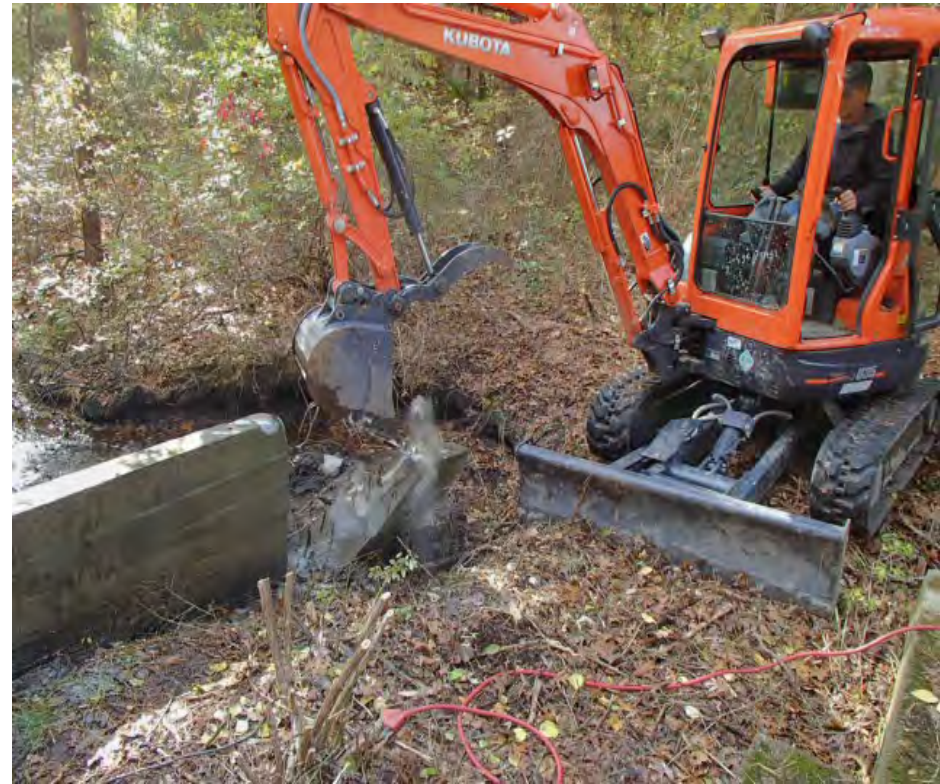
Bog Pond, Falmouth - 2016

Removal of concrete dam in channel between Bog Pond and Caleb Pond

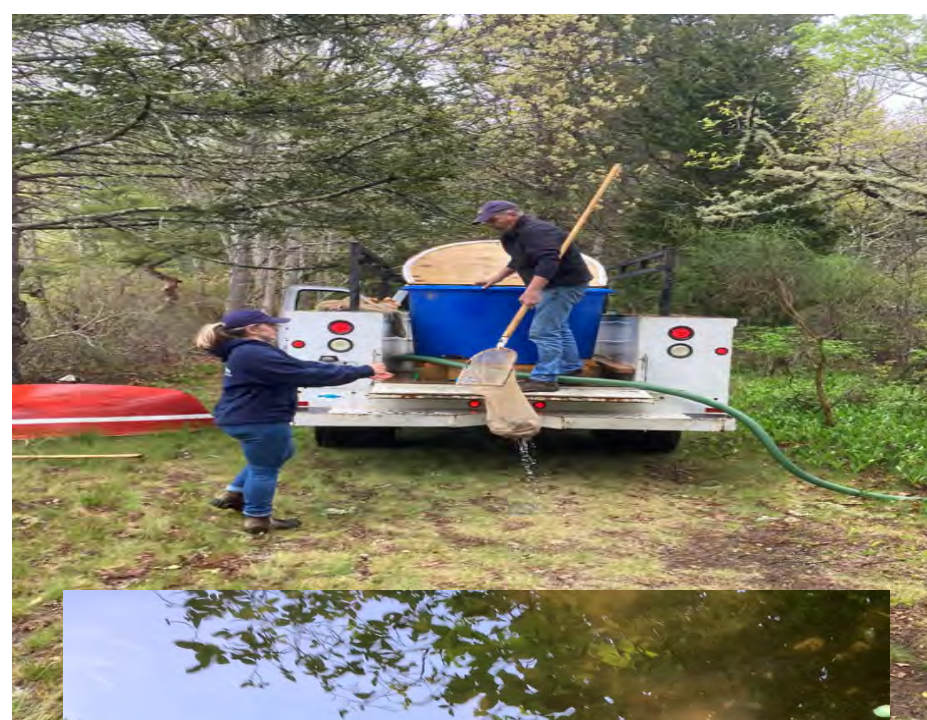
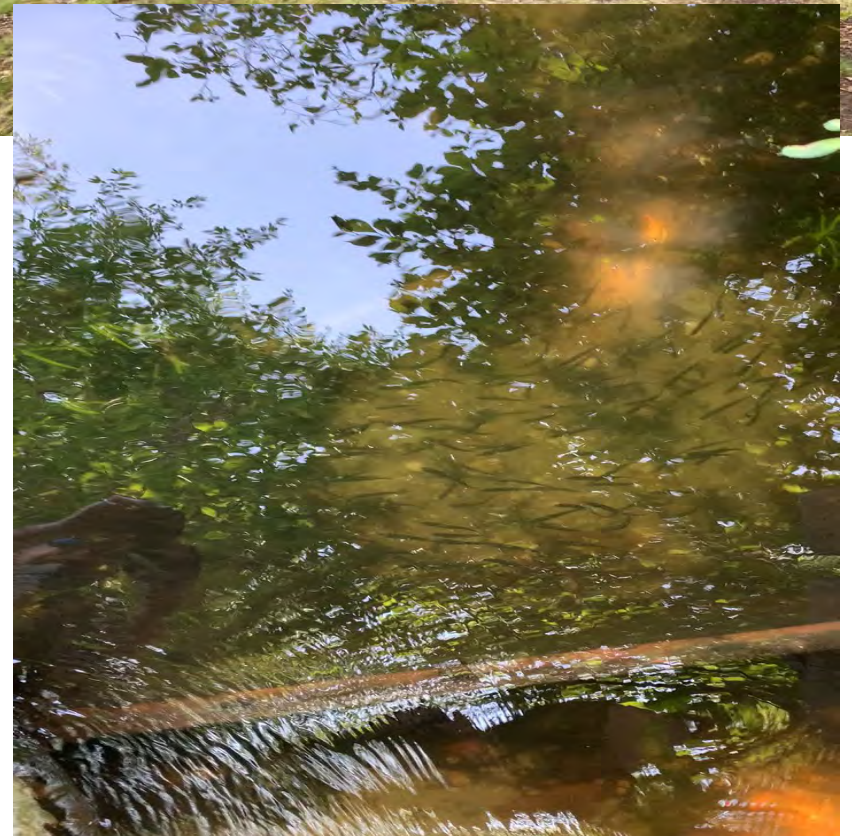
Monitoring. Four years of weekly spring monitoring found few herring. Large run of glass eels occurred each year

Fishway Operations and Maintenance Plan. A fishway O&M was approved by DMF in 2020 with pond level targets for both ponds

Stocking. Began stocking herring in 2022
