# Using Managed Retreat to Address Coastal Erosion in Brewster

## Brewster, Massachusetts

Re: Feasibility Study for Paine's Creek Beach Parking Area Protection and Improvements, Brewster, MA

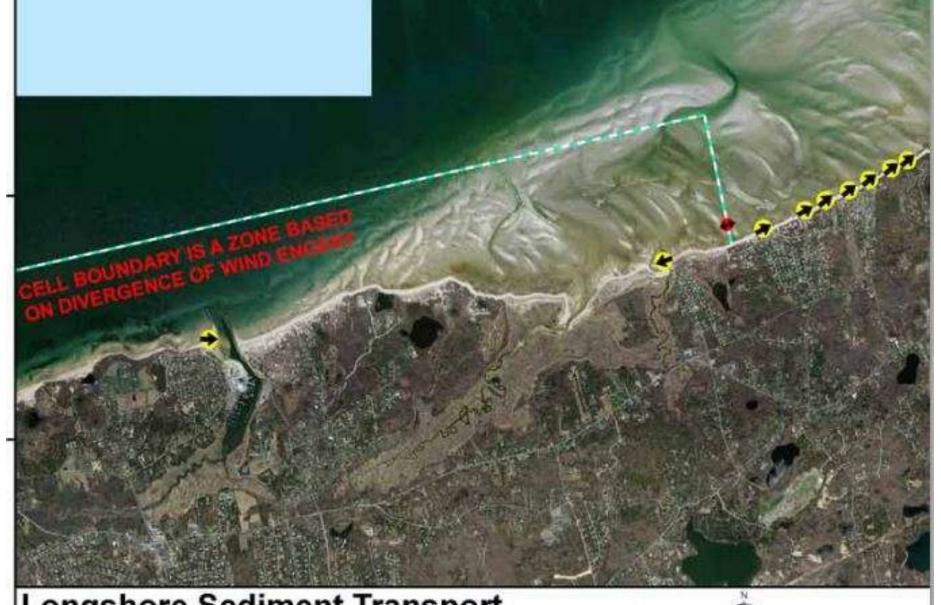
# Longshore Sediment Transport Barnstable County, Massachusetts

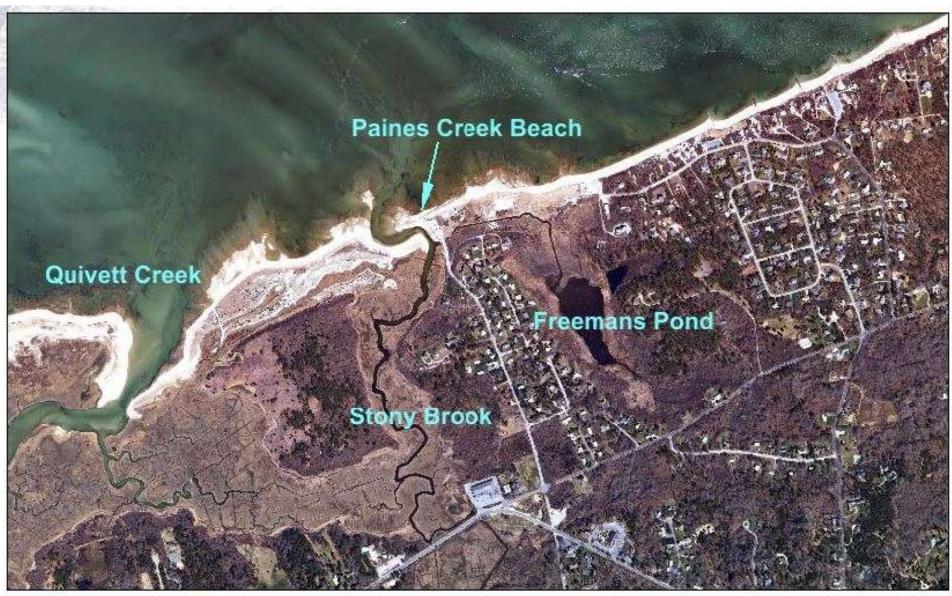
Figure 1. 2005 aerial of Paines Creek Beach, Brewster, MA (Mass GIS).

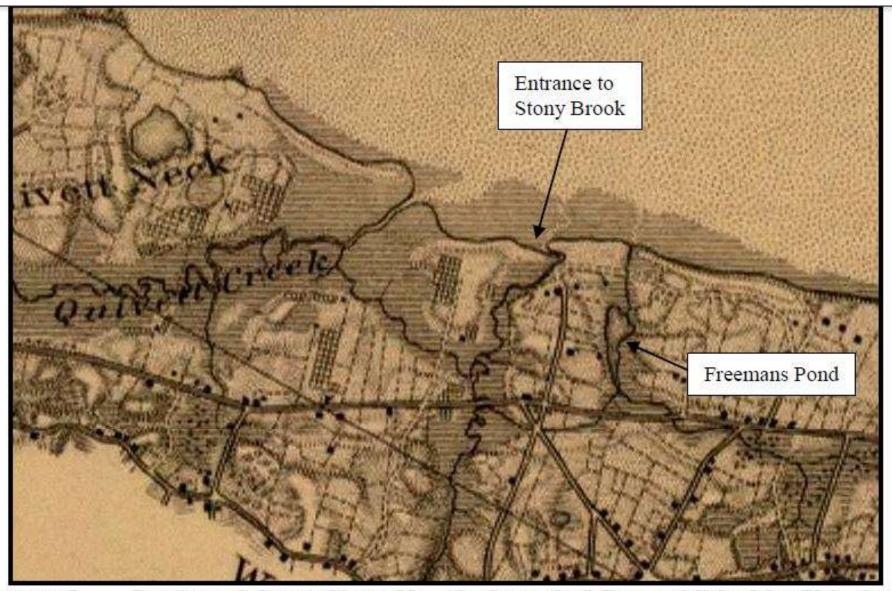
Figure 15. Portion of Coast Chart No. 10, Cape Cod Bay published by U.S. Coast Survey in 1872 (Mass GIS).

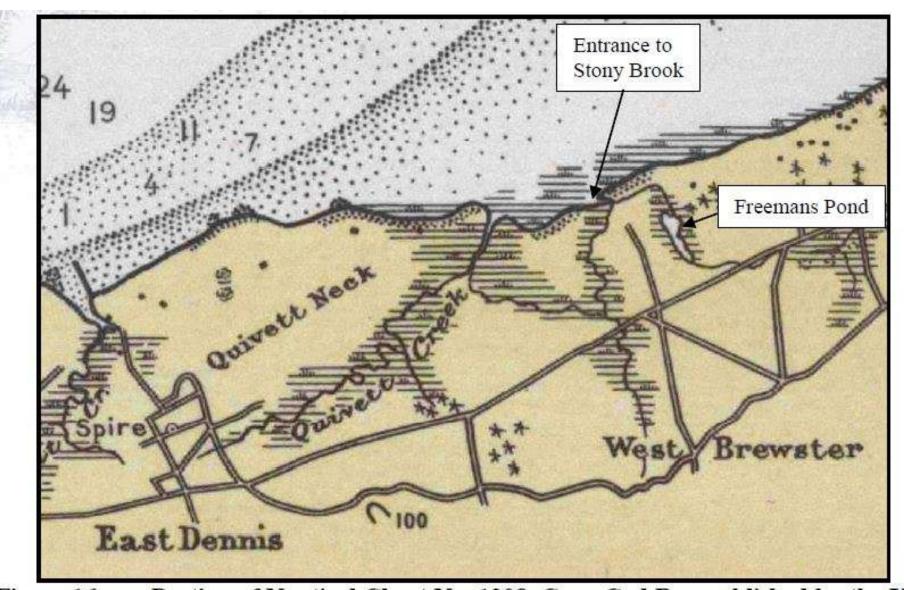
Figure 16. Portion of Nautical Chart No. 1208, Cape Cod Bay published by the U.S. Coast and Geodetic Survey in 1933 (Mass GIS).

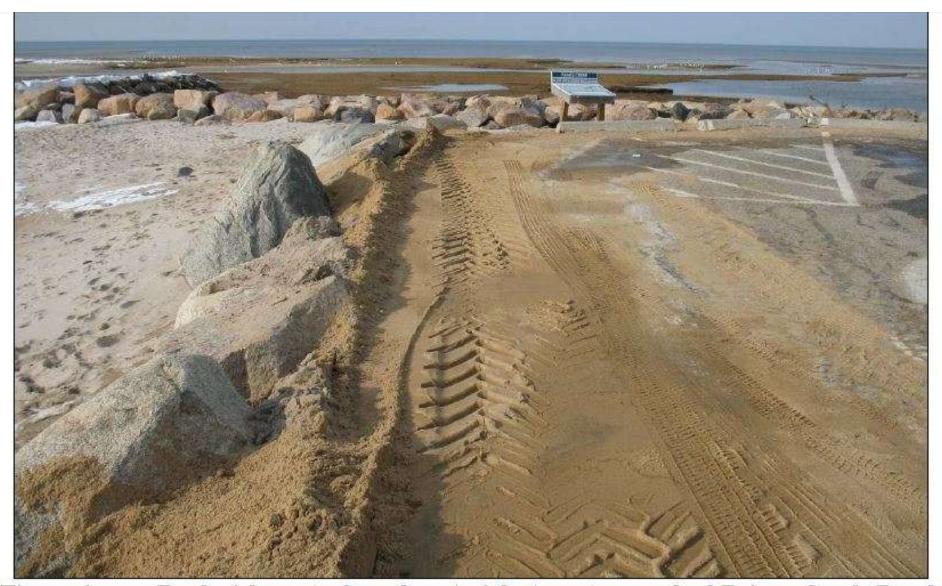
Figure 6. Replenishment of sand material at western end of Paines Creek Beach parking area (photo taken January 23, 2009).

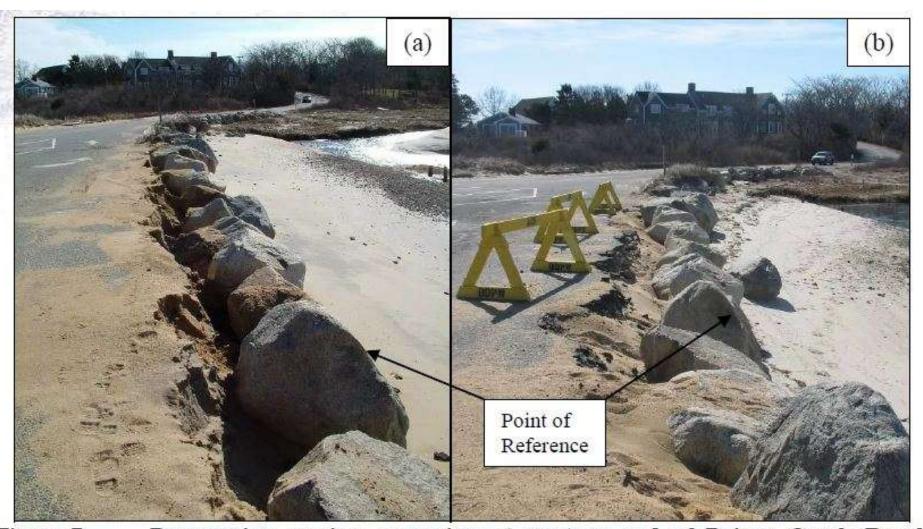
Figure 7. Progressive erosion occurring at western end of Paines Creek Beach parking area. Panel (a) is photo taken on February 13, 2009 (looking southeast) while panel (b) shows same view taken on March 26, 2009.

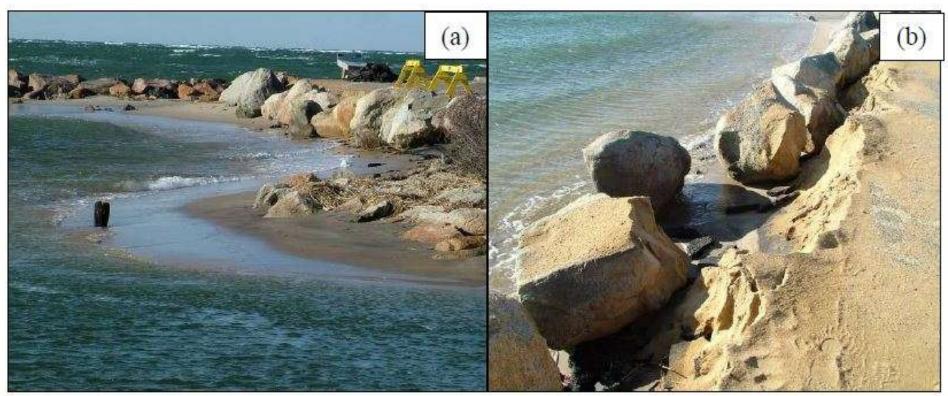
Figure 8. Elevated water level and ensuing erosion at western end of Paines Creek Beach parking area. Panel (a) shows elevated water level encroaching on parking area while panel (b) shows displaced boulder and erosion of sand fill.

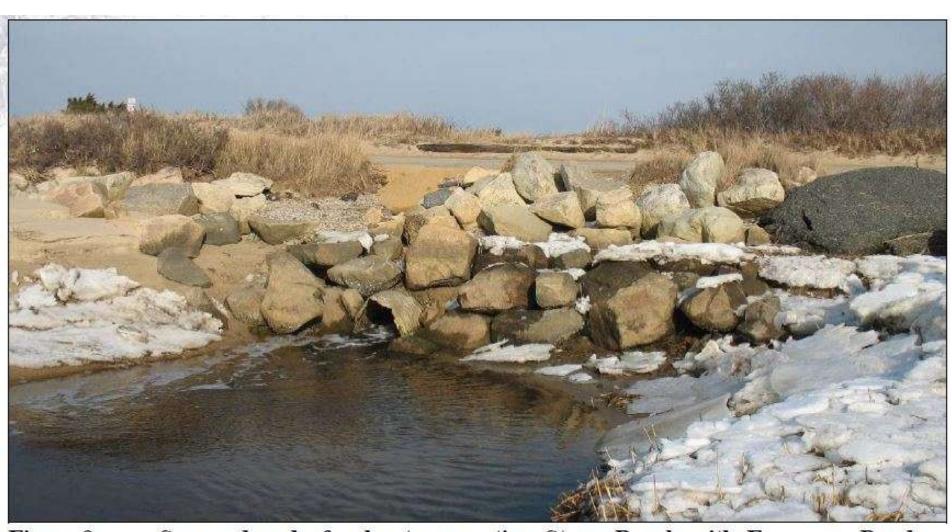
Figure 9. Seaward end of culvert connecting Stony Brook with Freemans Pond showing deteriorating embankment protection (photo taken January 23, 2009).

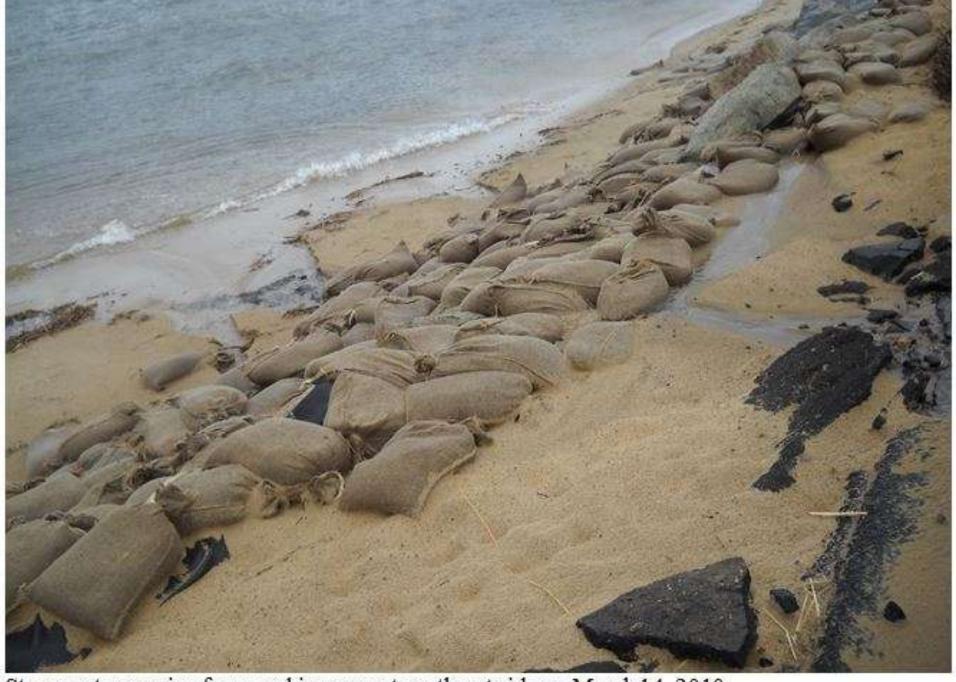
Stormwater erosion from parking area at southeast side on March 14, 2010.

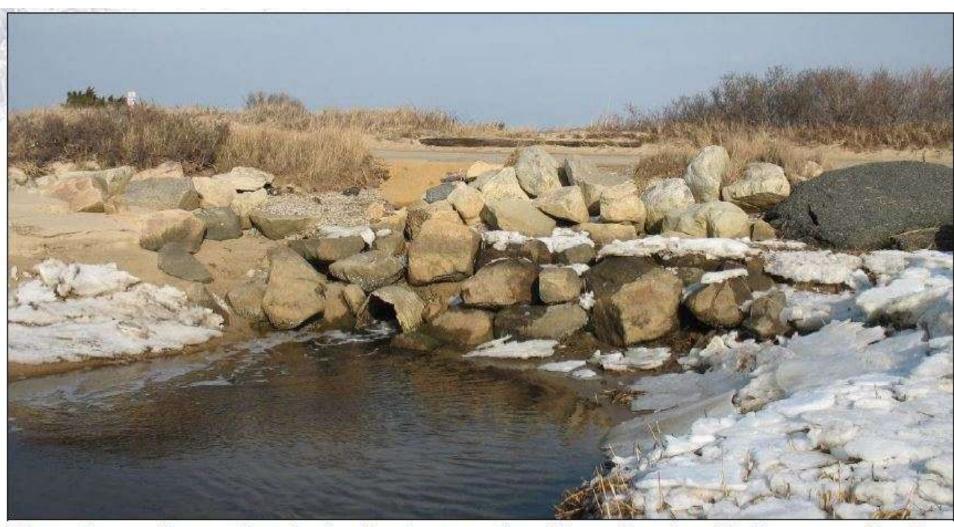
Figure 9. Seaward end of culvert connecting Stony Brook with Freemans Pond showing deteriorating embankment protection (photo taken January 23, 2009).

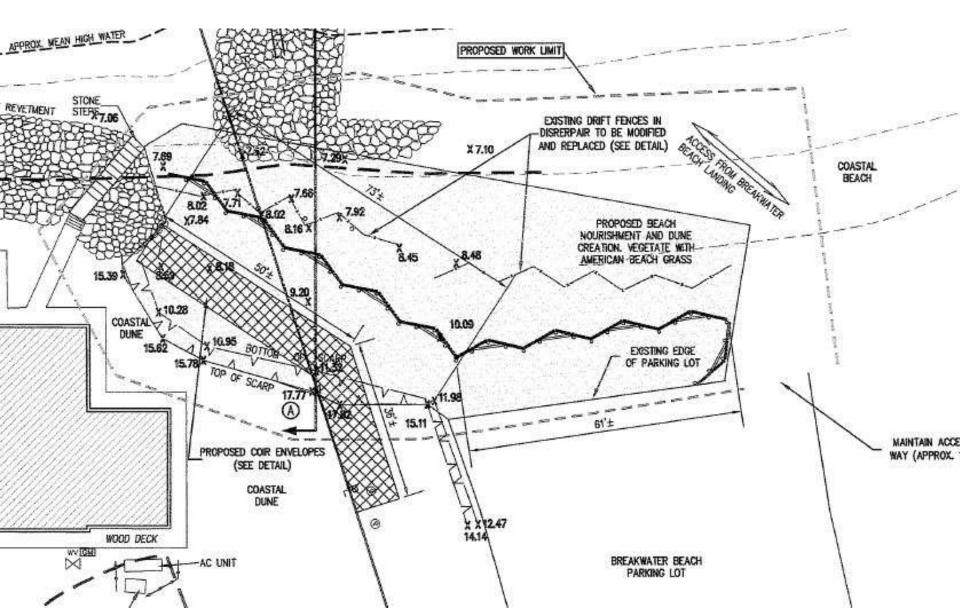
## End scour from revetment to west

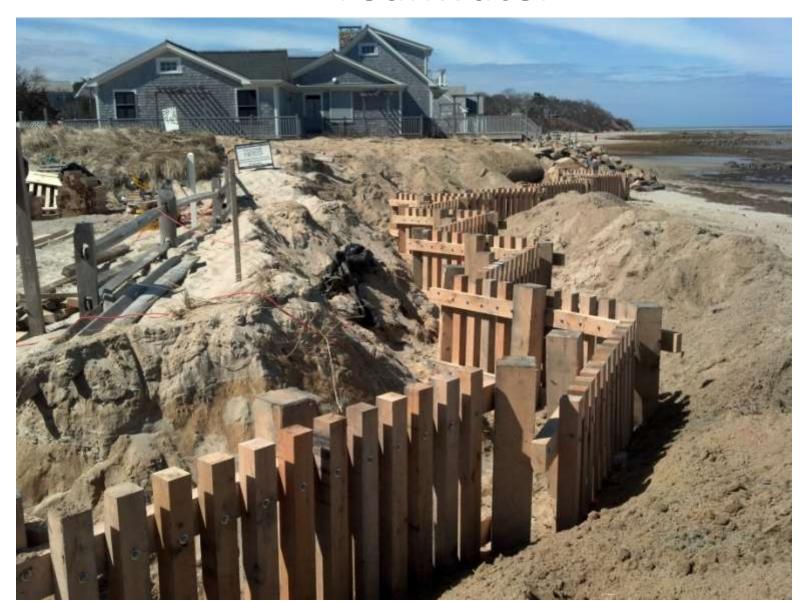
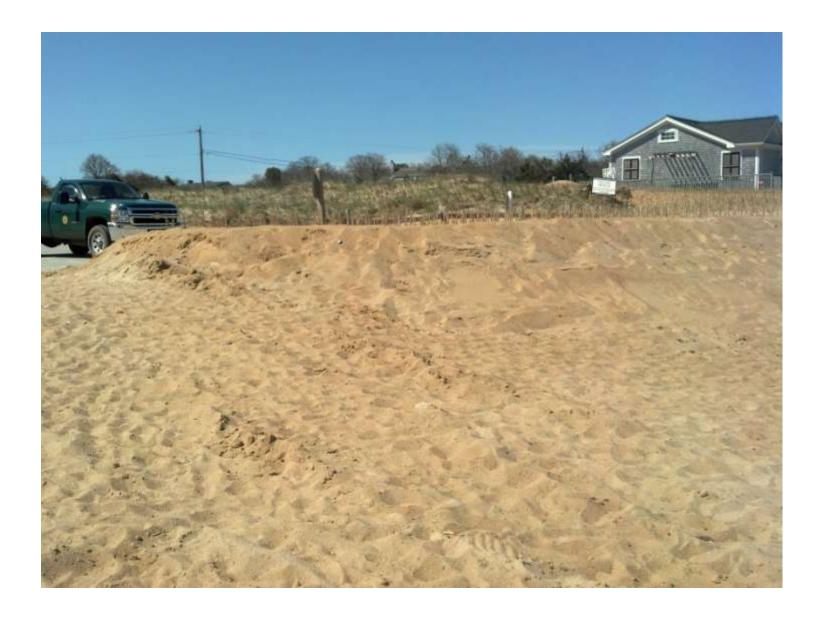
# Sturdy sand fence in sacrificial dune at Breakwater

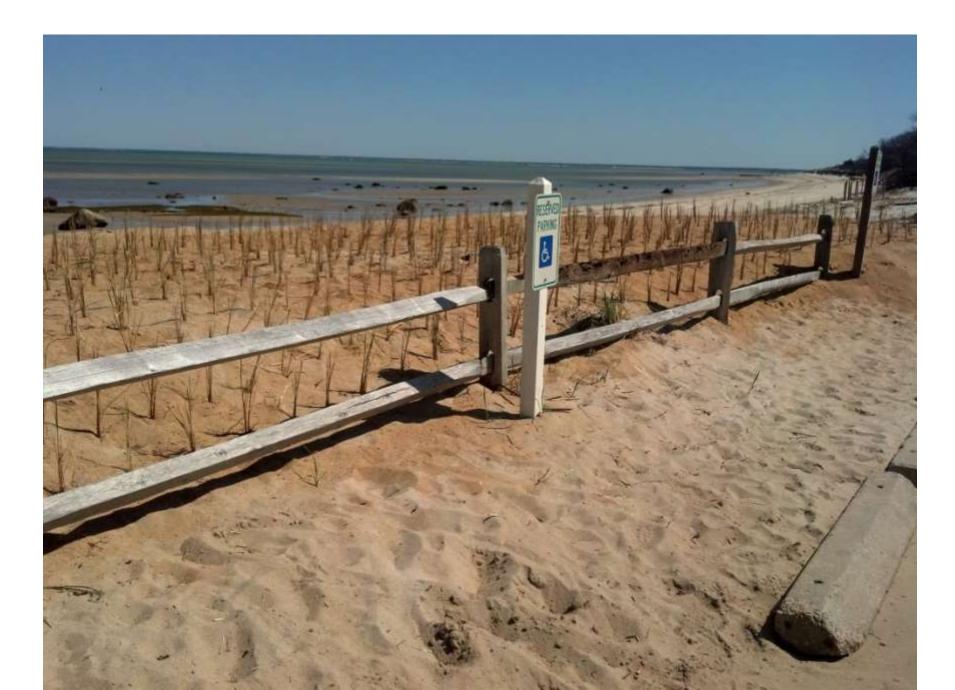
Sturdy fence buried under new dune located slightly further from active beach.

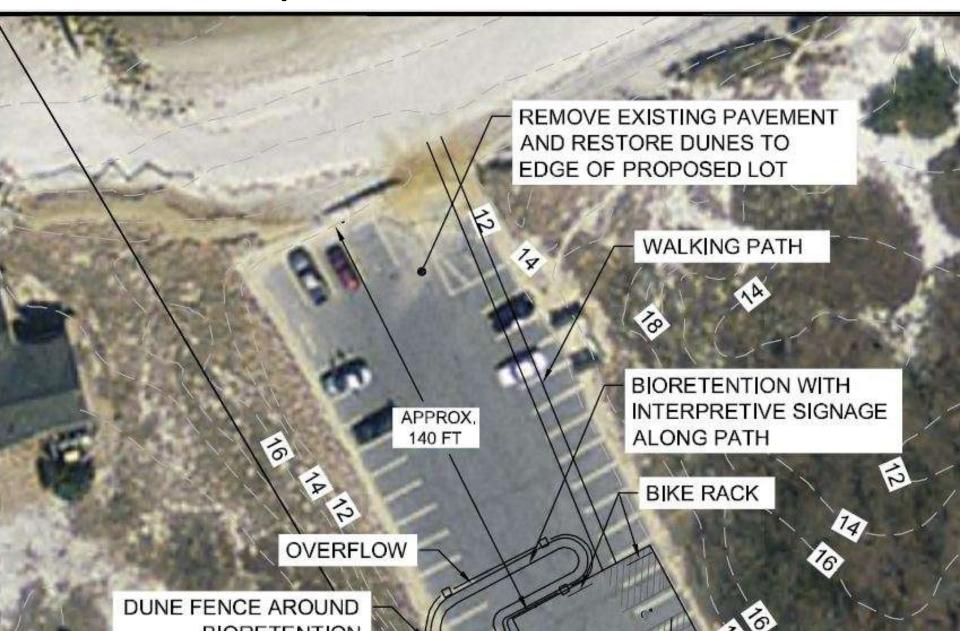
## Concept: Retreat and rebuild

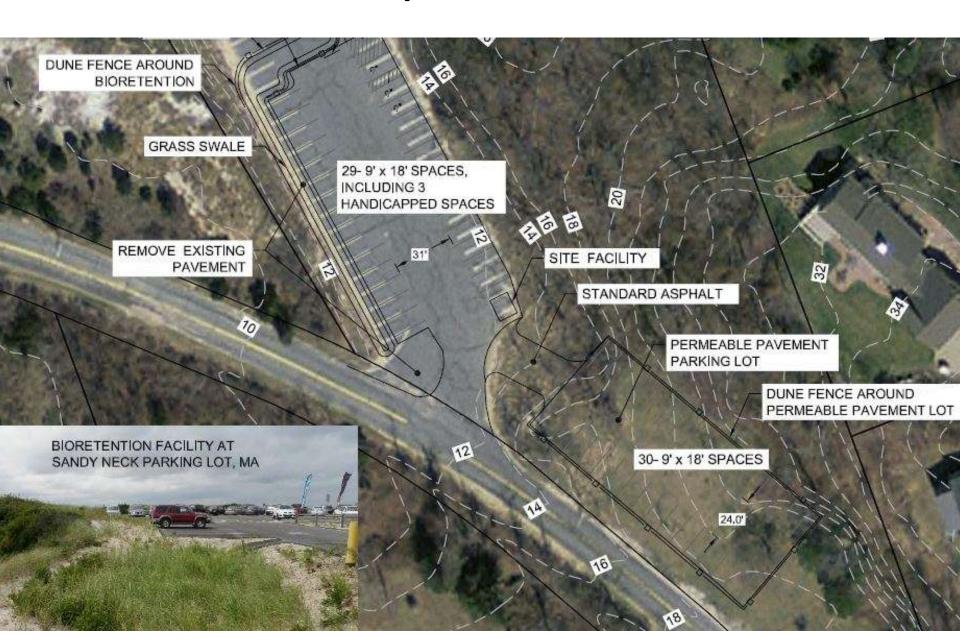
# New replacement lot

- Restore area to coastal dune, add beach sand to increase elevation to match surrounding, plant beach grass and shrubs.
- Articulating concrete mat under sand to allow vehicle traffic access through dunes for emergency response, coastal nourishment projects.
- Seasonal boardwalk through dunes to beach.
- Interpretive displays.
