5TH ANNUAL CAPE COASTAL CONFERENCE

Case Study: Muddy Creek Restoration Project

Muddy Creek Restoration Project

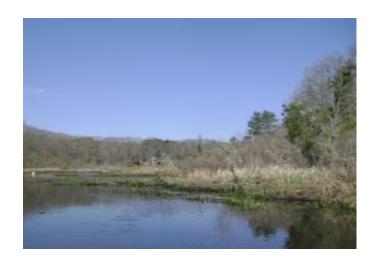
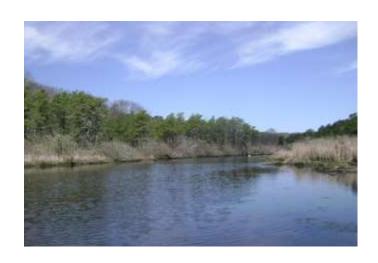
Pre- and Post Wetlands

- 56 acres of wetlands restored
- Long-Term Restoration Benefits
 - Increased Salinity and Tidal Range
 - Reduction of Invasive Stands Improved Biodiversity
 - Expansion of Tidal Mud Flats and Low Marsh Communities
 - New and Expanded Brackish & High Marsh Communities
 - Improved Habitat for several High Priority Species/Populations of migratory waterfowl & other migratory species.

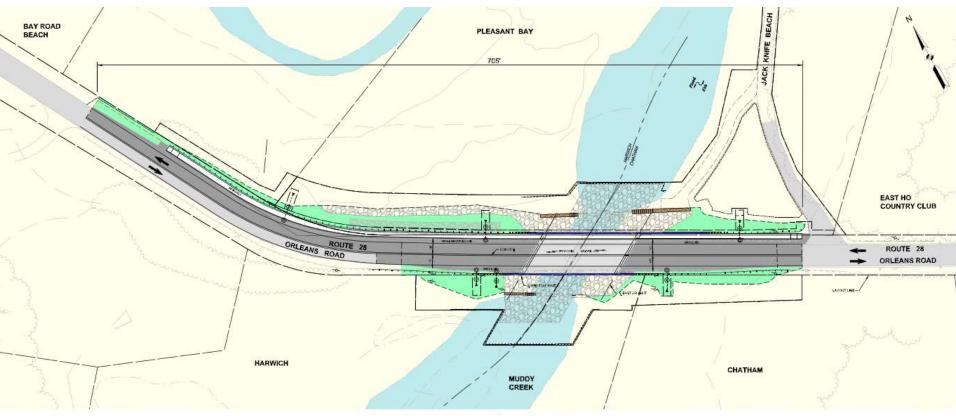
MUDDY CREEK RESTORATION BRIDGE PROJECT ROUTE 28 OVER MUDDY CREEK

PROPOSED BRIDGE STRUCTURE

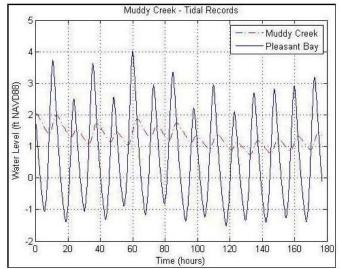
Tide gage records from November 2009 for instruments deployed both upstream and downstream of the Route 28 culvert along Muddy Creek. In 2009, Pleasant Bay was connected to Muddy Creek through a pair of stone box culverts. The stone box culverts were approximately 2.5-feet wide, 3.75-feet in height, and 100-Figure 4. feet in length. Figure 3. Muddy Creek Top of Bank Surveys **DER 2015** ACRE June 2016 ACRE July 2016 **ACRE September 2016**
