5TH ANNUAL CAPE COASTAL CONFERENCE

COONAMESSETT RIVER RESTORATION PROJECT

Elizabeth H. Gladfelter, Ph.D.
Conservation Commission
Town of Falmouth

COONAMESSETT RIVER
RESTORATION & DAM REMOVAL
FALMOUTH, MA

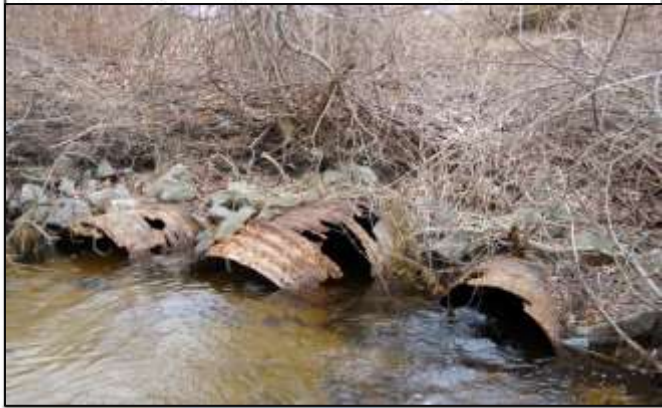
John Parker Road Culvert: design and permitting to replace with a bridge or similar

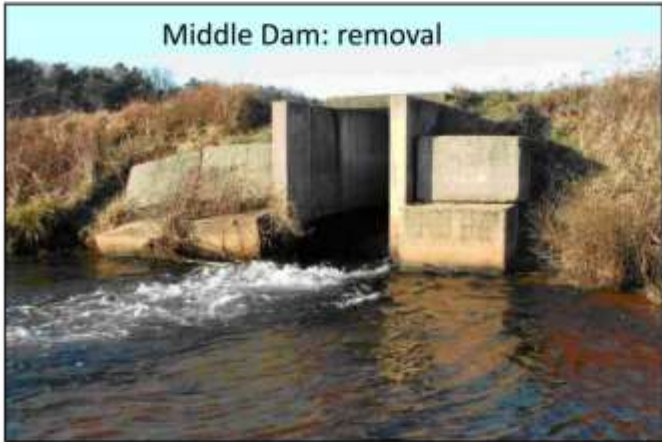
Middle Dam: removal

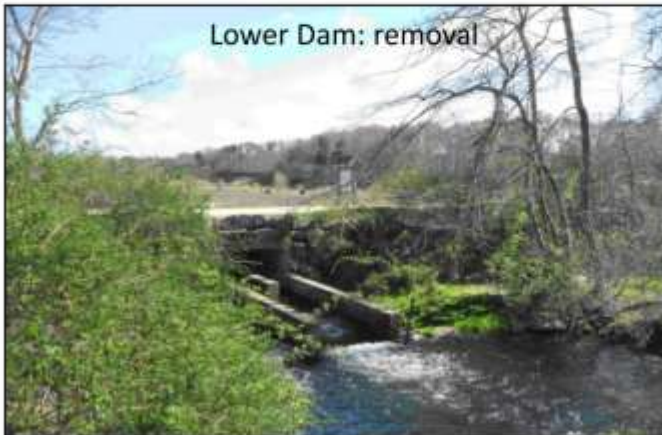
Lower Dam: removal

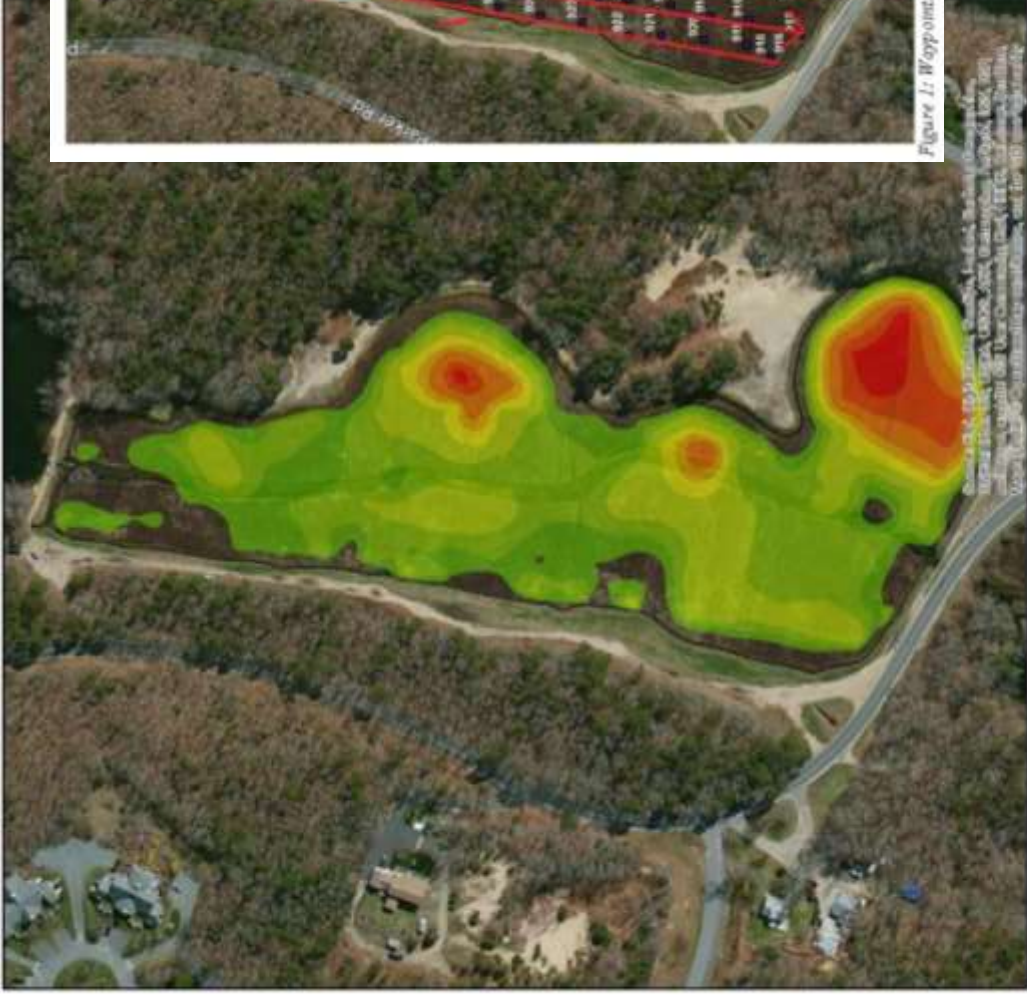
Coonamessett River Bogs - Upper section

Ground Penetrating Radar Survey 12/7/2016
Depths measured from soil surface to bottom of peat deposit. Approximately 2 feet of sand overlies all peat deposits throughout bog.

Created on: 12/21/2016
By: Maggie Payne, Resource Soil Scientist
USDA NRCS

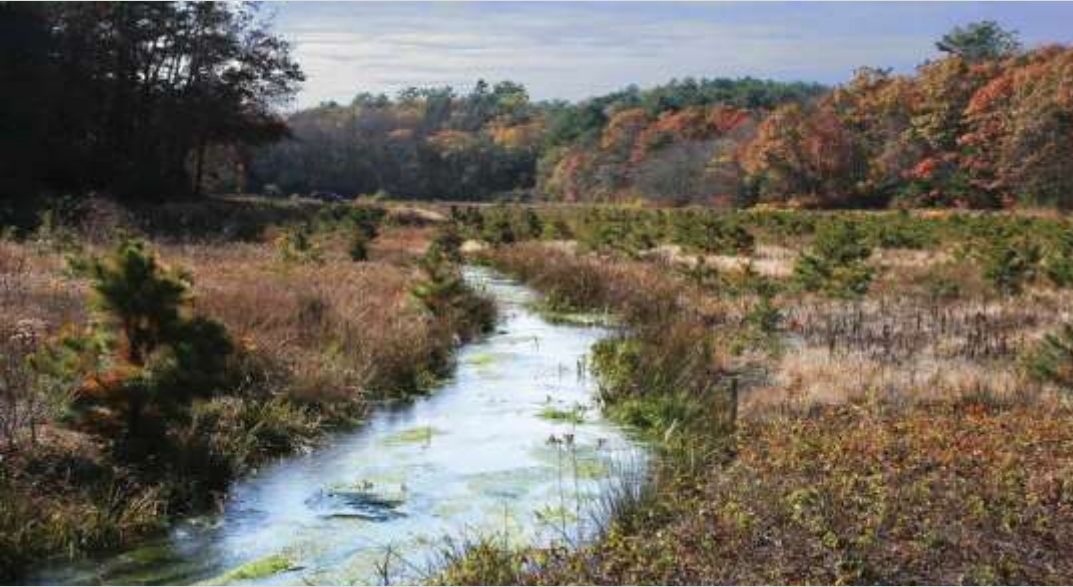
BEFORE

Eel River Plymouth

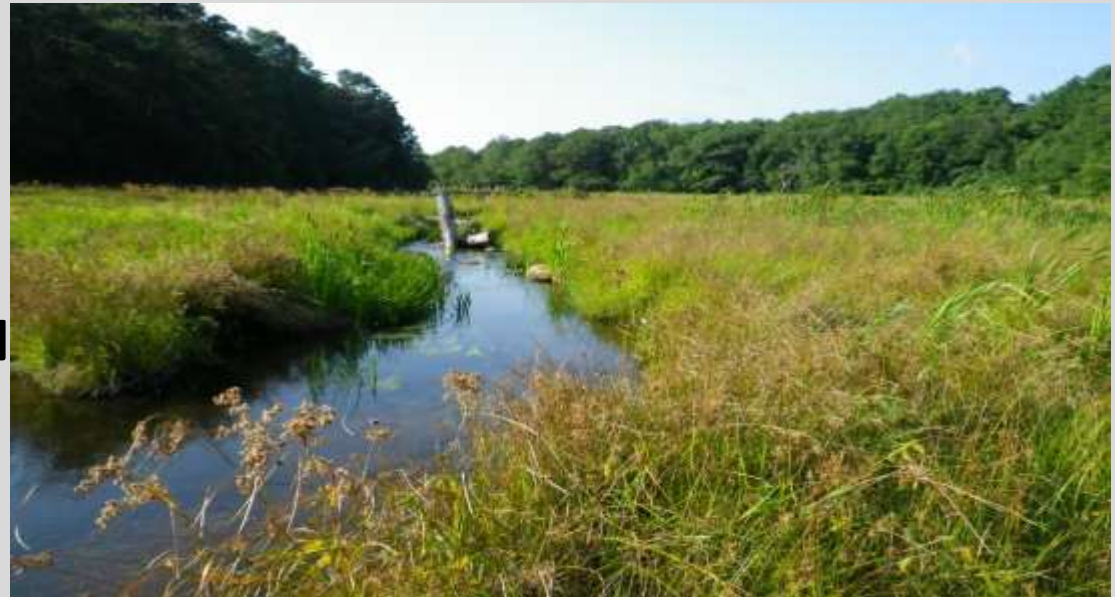
AFTER

3 YEARS POST RESTORATION
