Reducing Coastal Erosion and Coastal Storm Damage While Minimizing Impacts

Based on SITE SPECIFIC Criteria

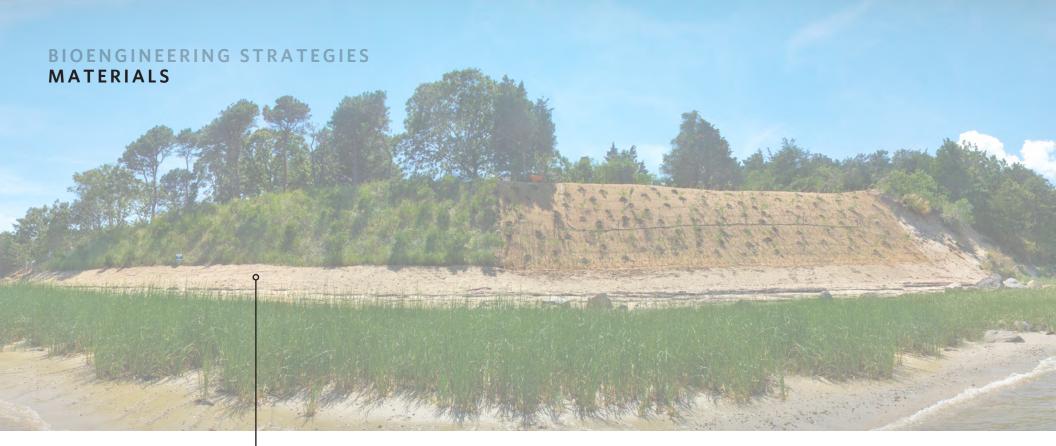
Adds stability and protection to the toe of a bank and provides a window of opportunity to establish vegetation.

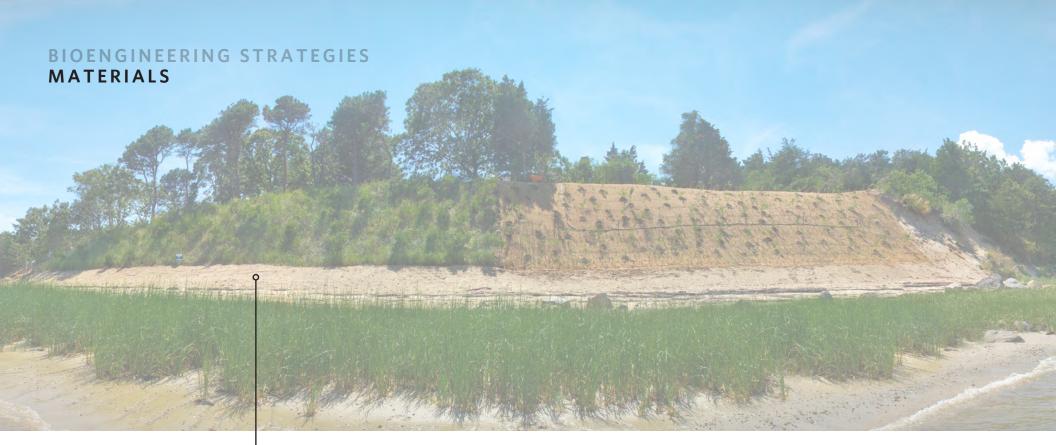
Adds stability and protection to the toe of a bank and provides a window of opportunity to establish vegetation.

ROBUST ANCHORING SYSTEM

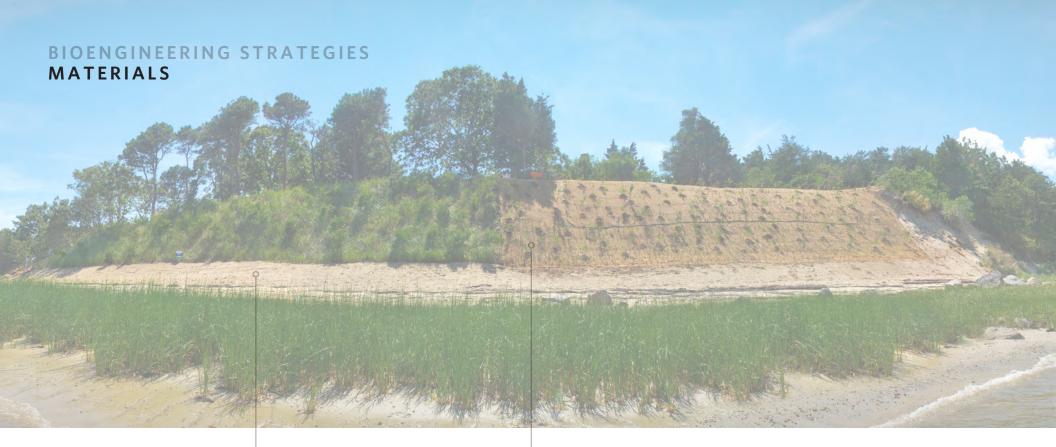
Coir Fiber Rolls

Adds stability and protection to the toe of a bank and provides a window of opportunity to establish vegetation.

- Resists degradation from the marine environment.
- Absorbs some of the force of wave energy unlike many hard solutions that deflect the energy of wave action to surrounding areas.
- Materials life-expectancy to stabilize sediments matches the time required to ESTABLISH NATIVE PLANTS.

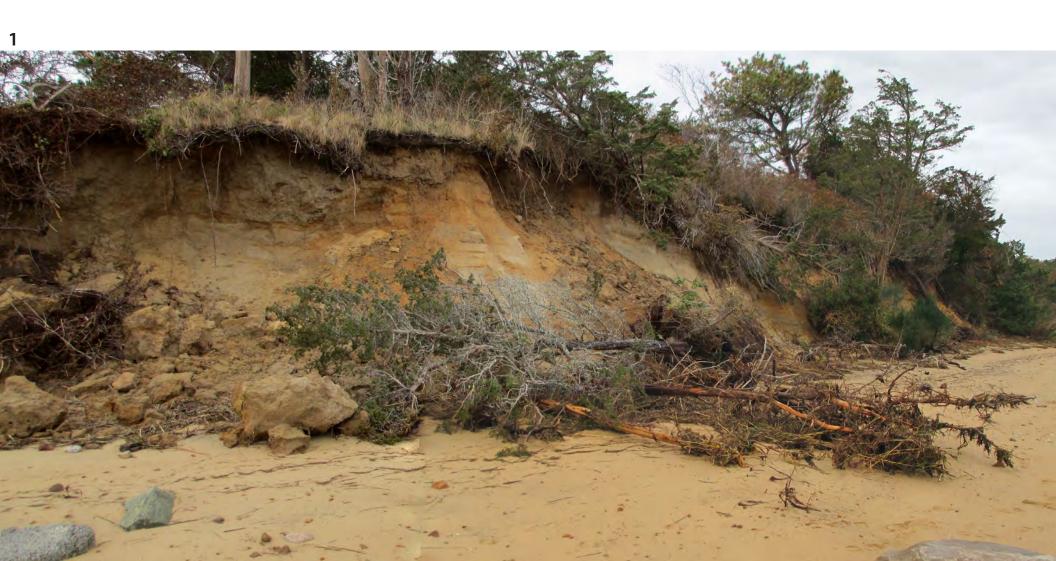
Importance of Establishing a Stable Slope

• If the slope of the bottom of the bank is steeper that the upper bank, it is likely unstable and prone to slumping or collapses .

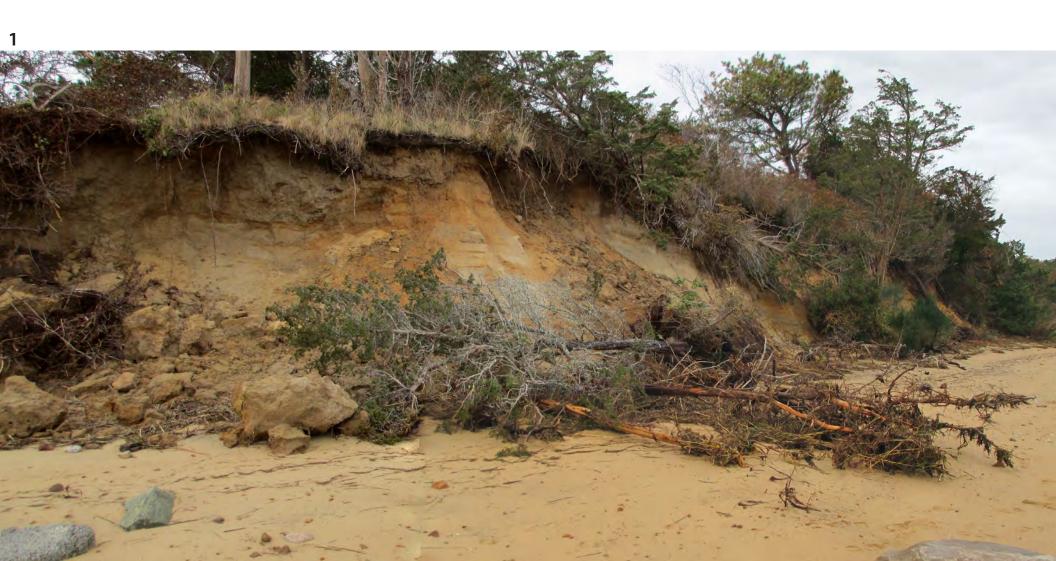
Importance of Establishing a Stable Slope

- Utilizing a portion of the upper bank can create a more stable slope angle.
- Adds increased stability and storm damage prevention to the bank.
- Without this step, an investment in bioengeneering can be lost due to bank collapses.

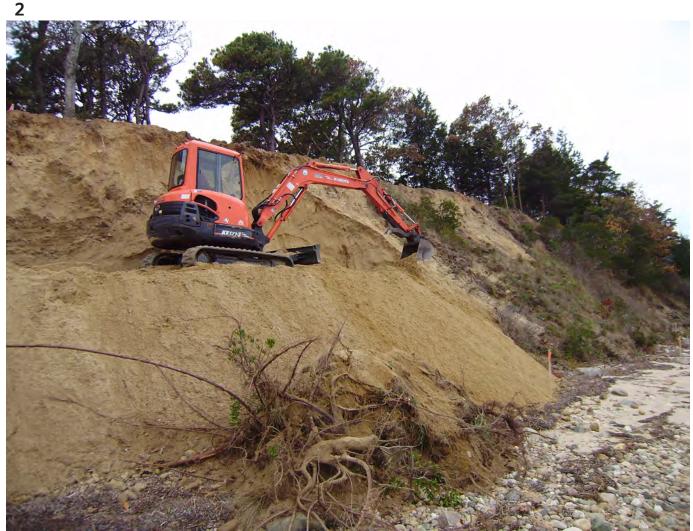
Stabilizing toe of bank - Fiber rolls

- Installation begins at the base of the array and proceeds up bank.
- Proper anchoring strategy to hold toe protection in place.
- Synthetic filter fabrics DO NOT ENHANCE success of a bioengineering project.

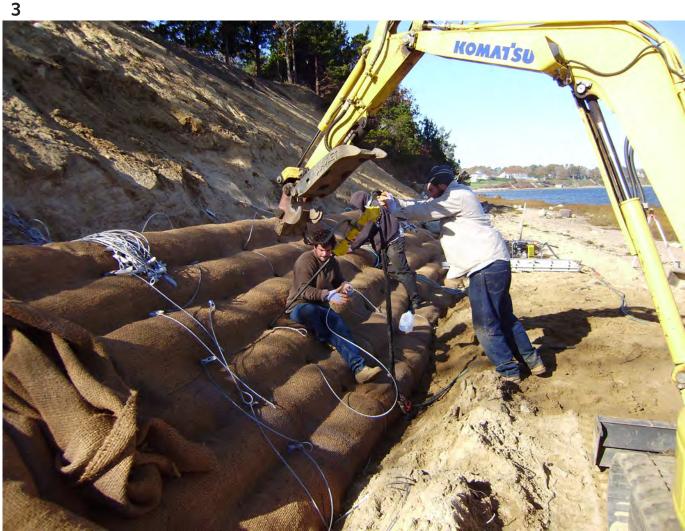
Stabilizing toe of bank - Pre-vegetated fiber rolls

- Use of pre-vegetated fiber rolls along top of array.
- Added vegetation to the root matrix.
- Full season of plant growth prior to installation.

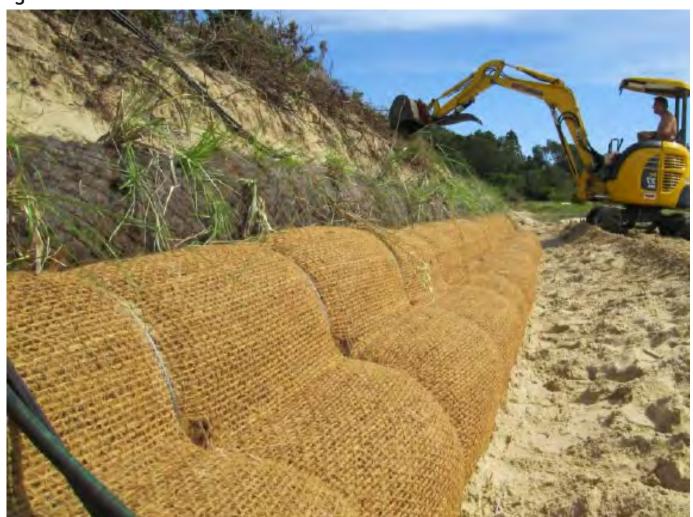
Stabilizing soils above toe protection

- Native salt tolerant grasses are seeded into the bank prior to installation of erosion control blankets.
- Protect soils from erosion and helps to retain moisture to promote seed germination.

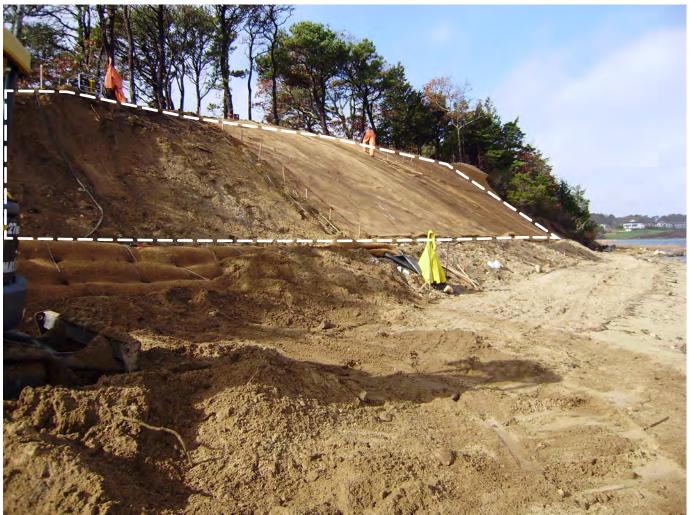
Stabilizing soils above toe protection

- 6" deep lock-in trench at top and bottom of slope.
- Overlap blankets a minimum of 6".
- Use appropriate staking to match the sediment.
- Only run orientation of blankets perpendicular to the contours (up and down slope).

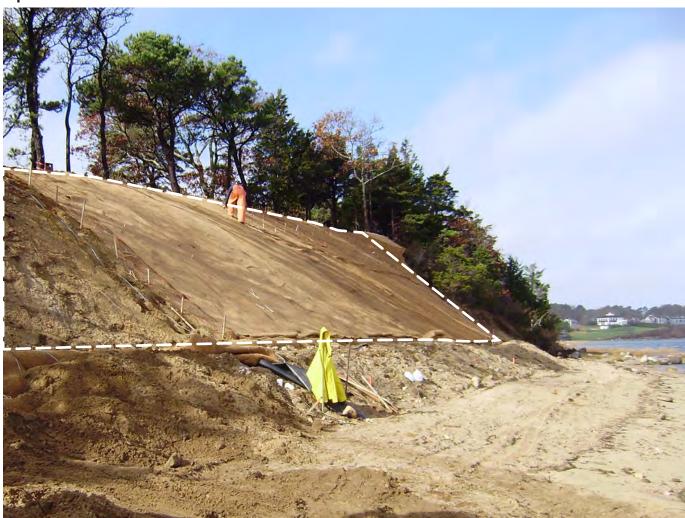
Native shrub species

- Native beach plum and bayberry planted through erosion control blanketing.
- Temporary above ground irrigation for plant establishment.

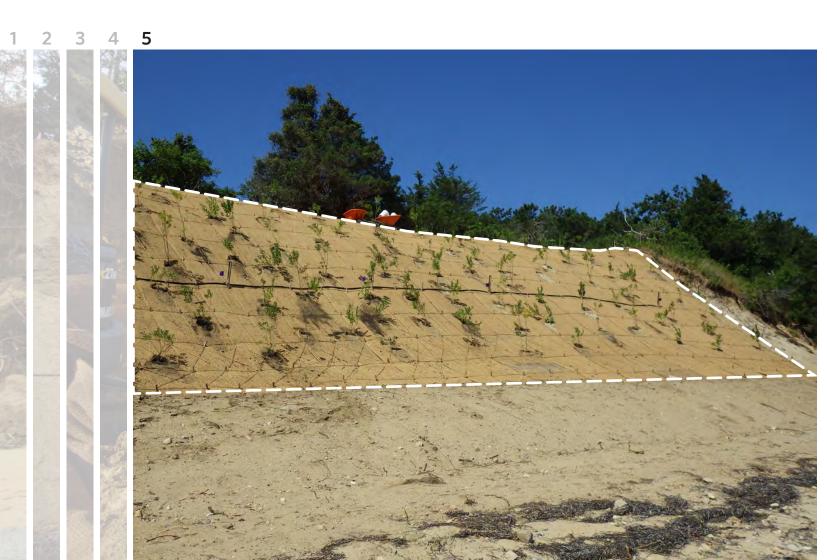
• Establishment of native vegetation after two seasons of growth.

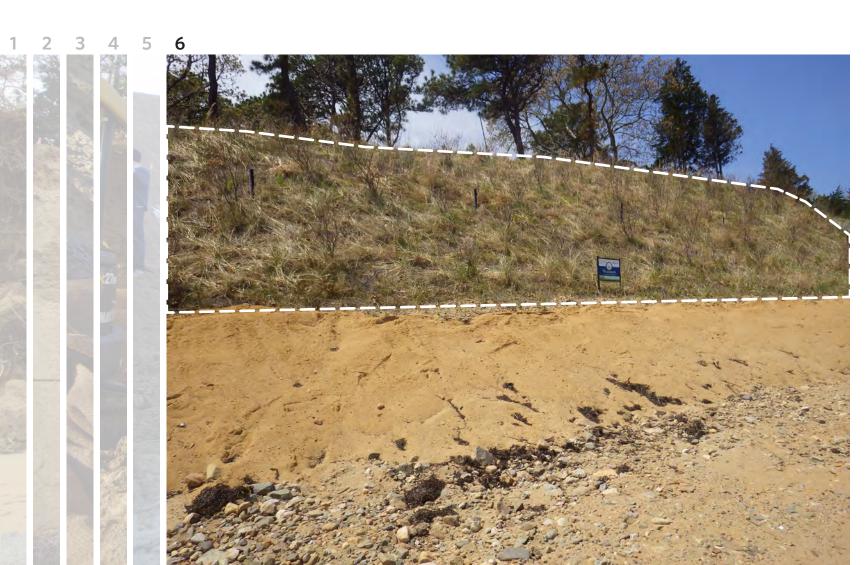
Condition of fiber roll array following Hurricane Sandy 11/2012

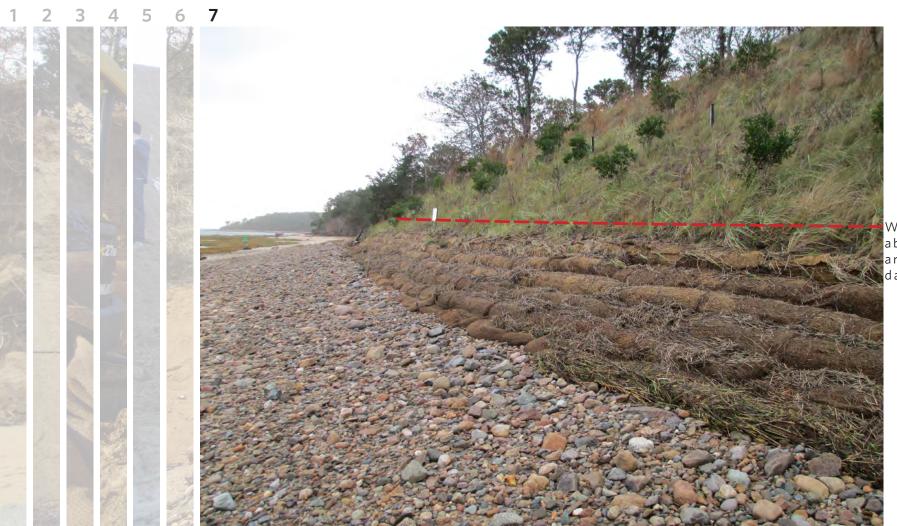
Waves reached above fiber roll array with no damage.

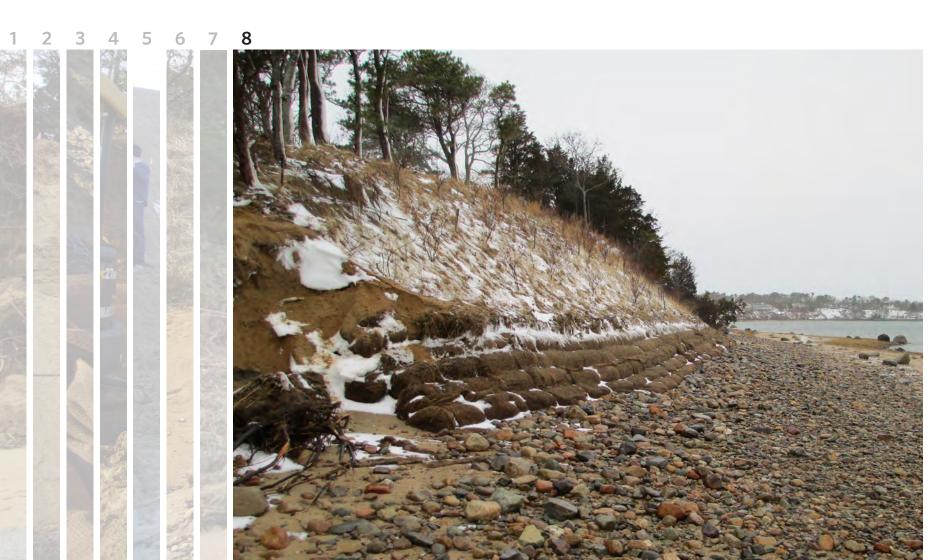
Condition of fiber roll array following named stormed Nemo 2/2013

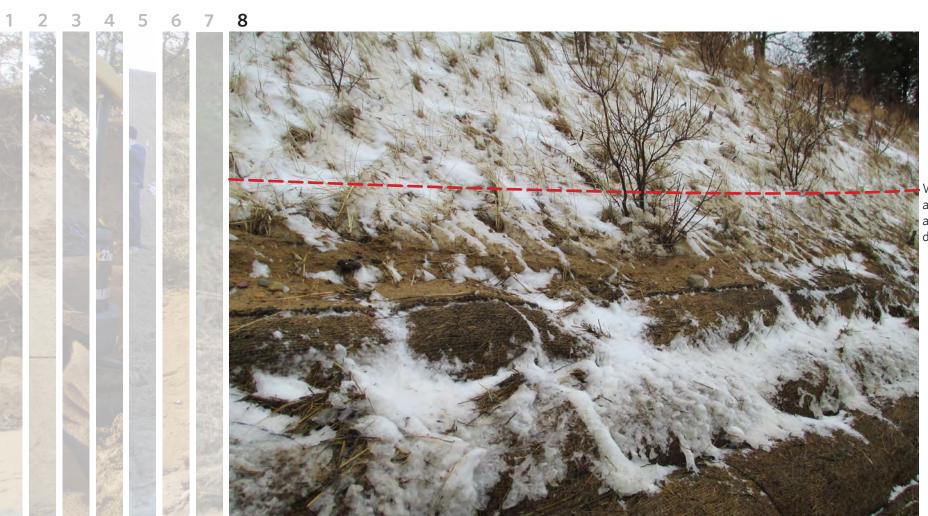
Waves reached above fiber roll array with no damage.

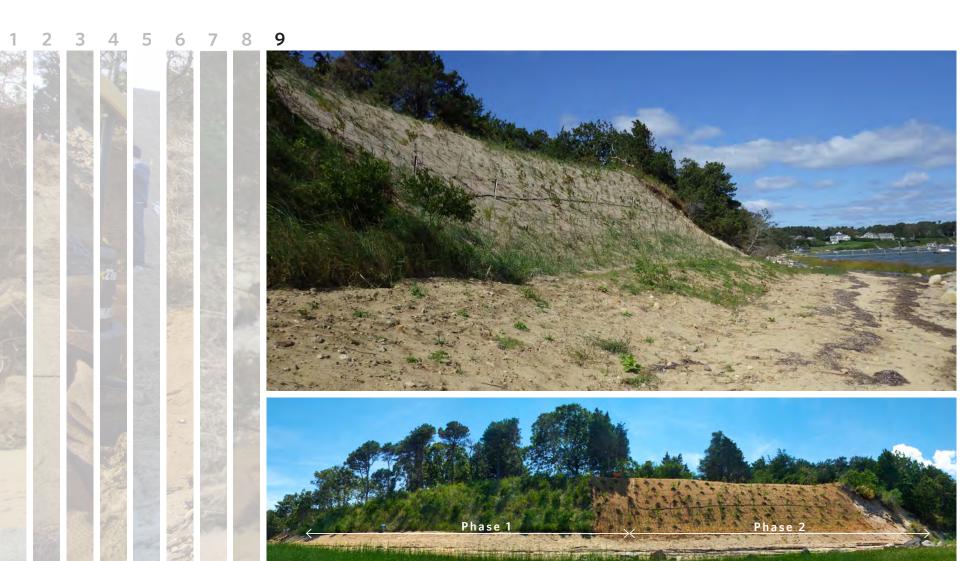
Fiber roll array increased in length by 90' 6/2013
