Green Infrastructure for Coastal Resilience
March 28, 2017

Dead Neck & Sampson's Island Backpassing and Nourishment

John S. Ramsey, P.E., D.CE
Applied Coastal Research and Engineering, Inc.

Project Sponsors: Three Bays Preservation & Mass Audubon Society

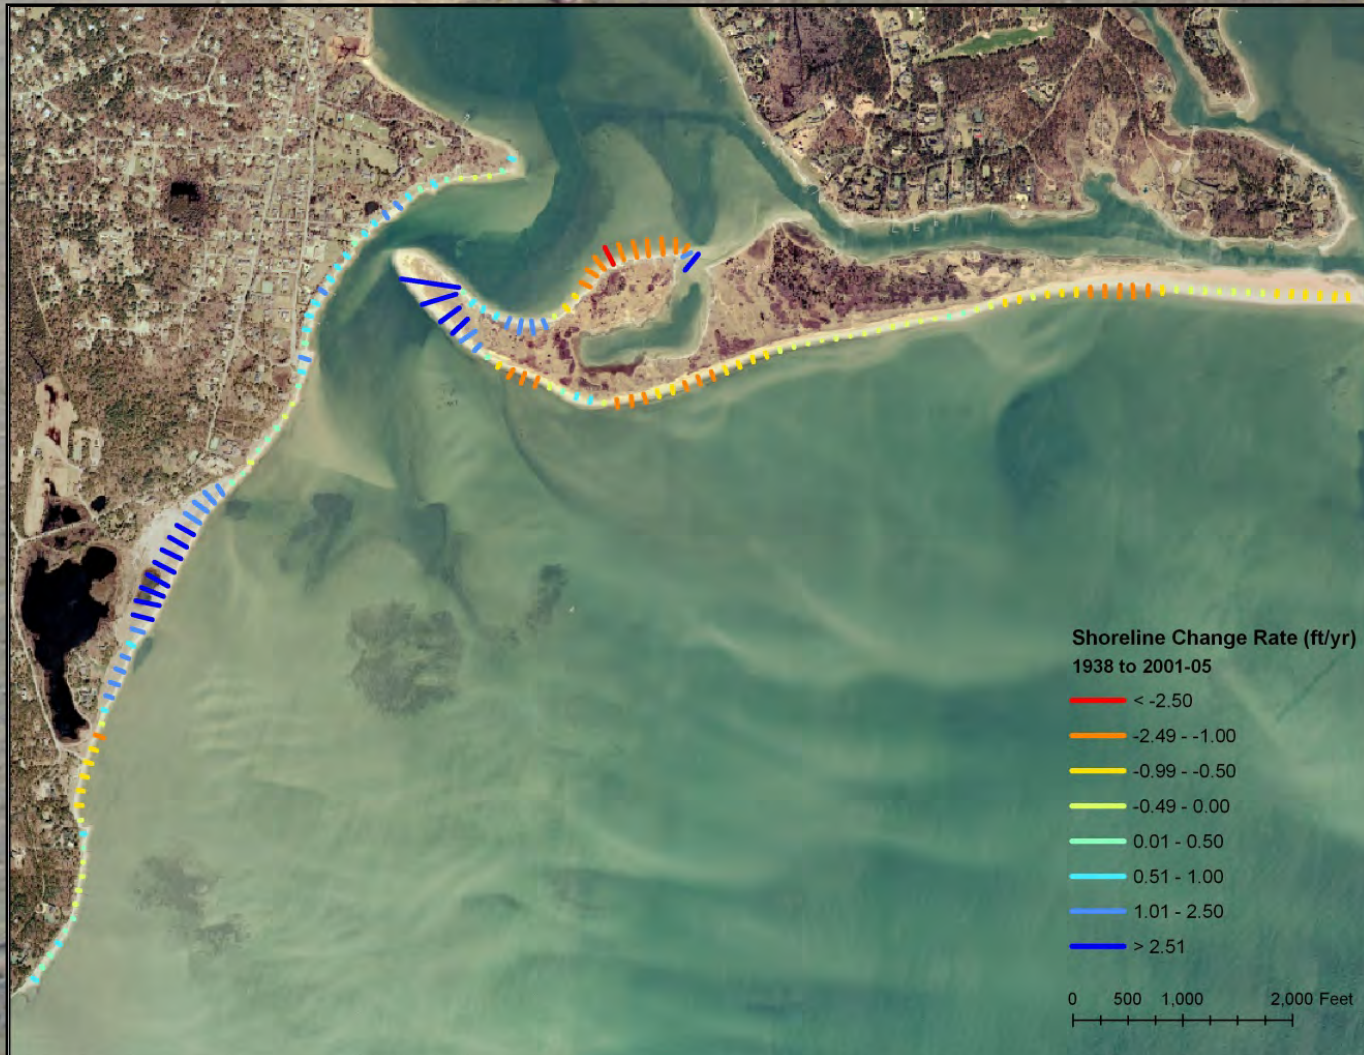
Historical Shoreline Change (1938-2001)

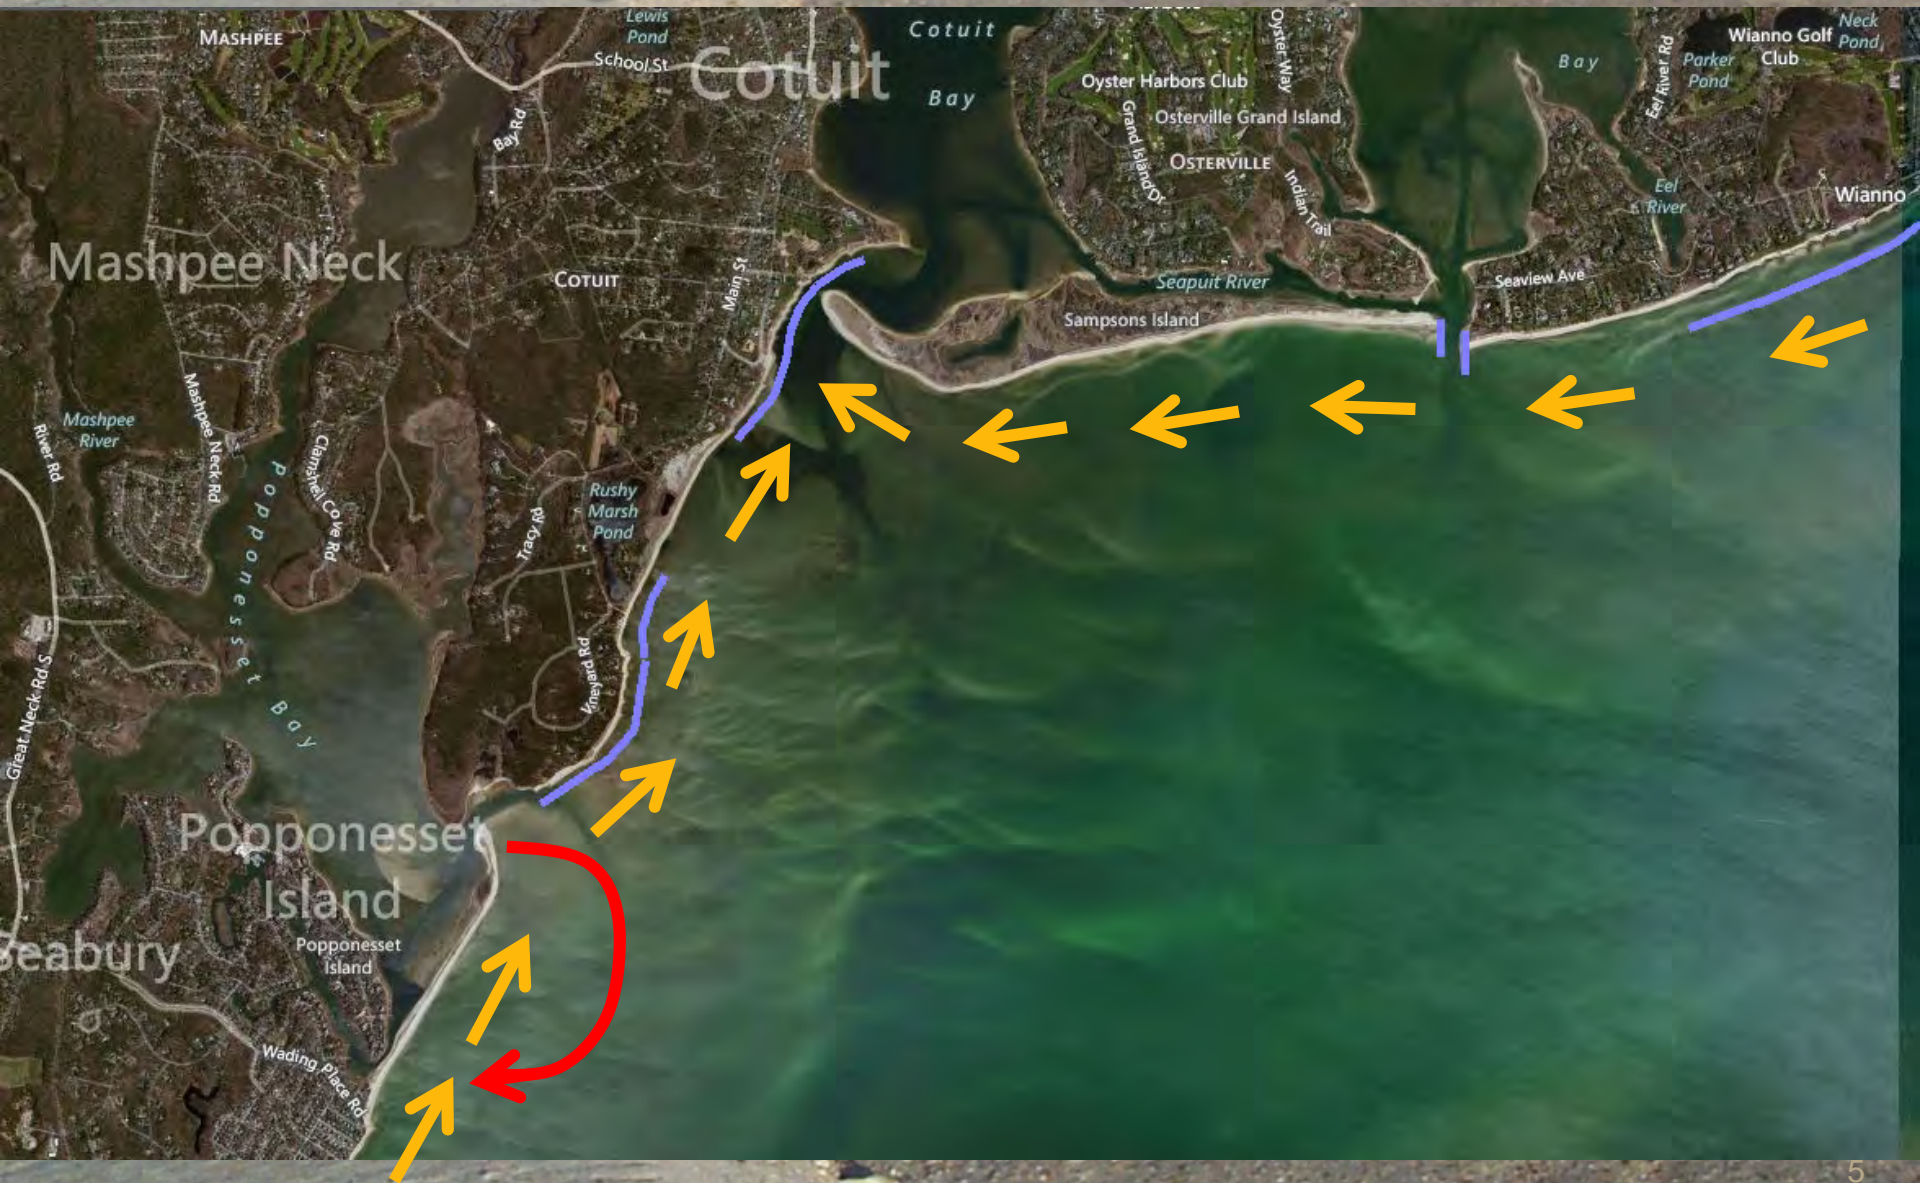
Regional Littoral Transport

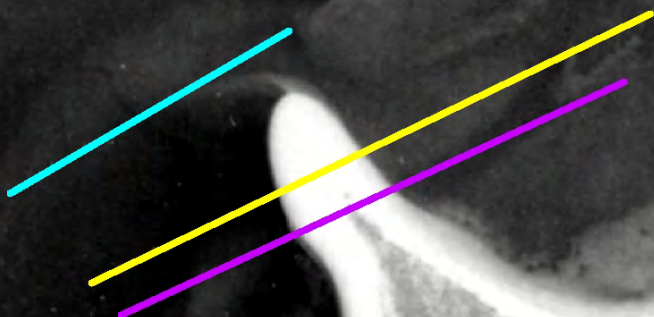
1952

- Channel 1934
- Channel 1947
- Channel 1967

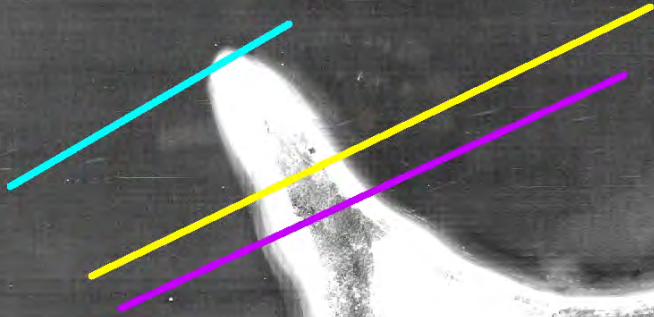
1968

- Channel 1934
- Channel 1947
- Channel 1967

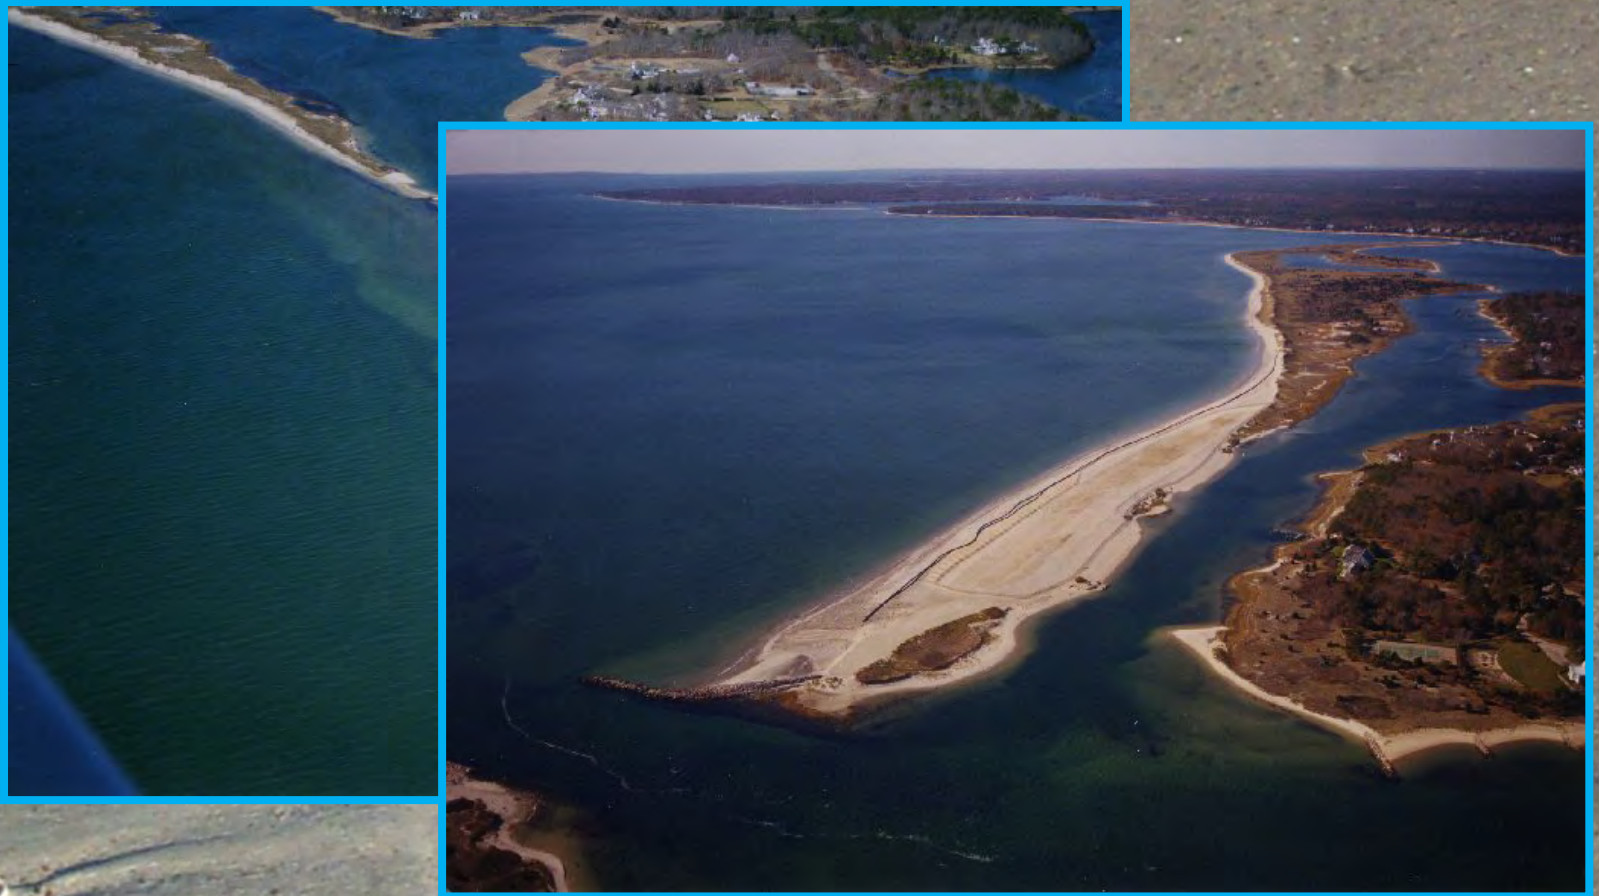
230,000 Cubic Yard Nourishment (1999-2000)

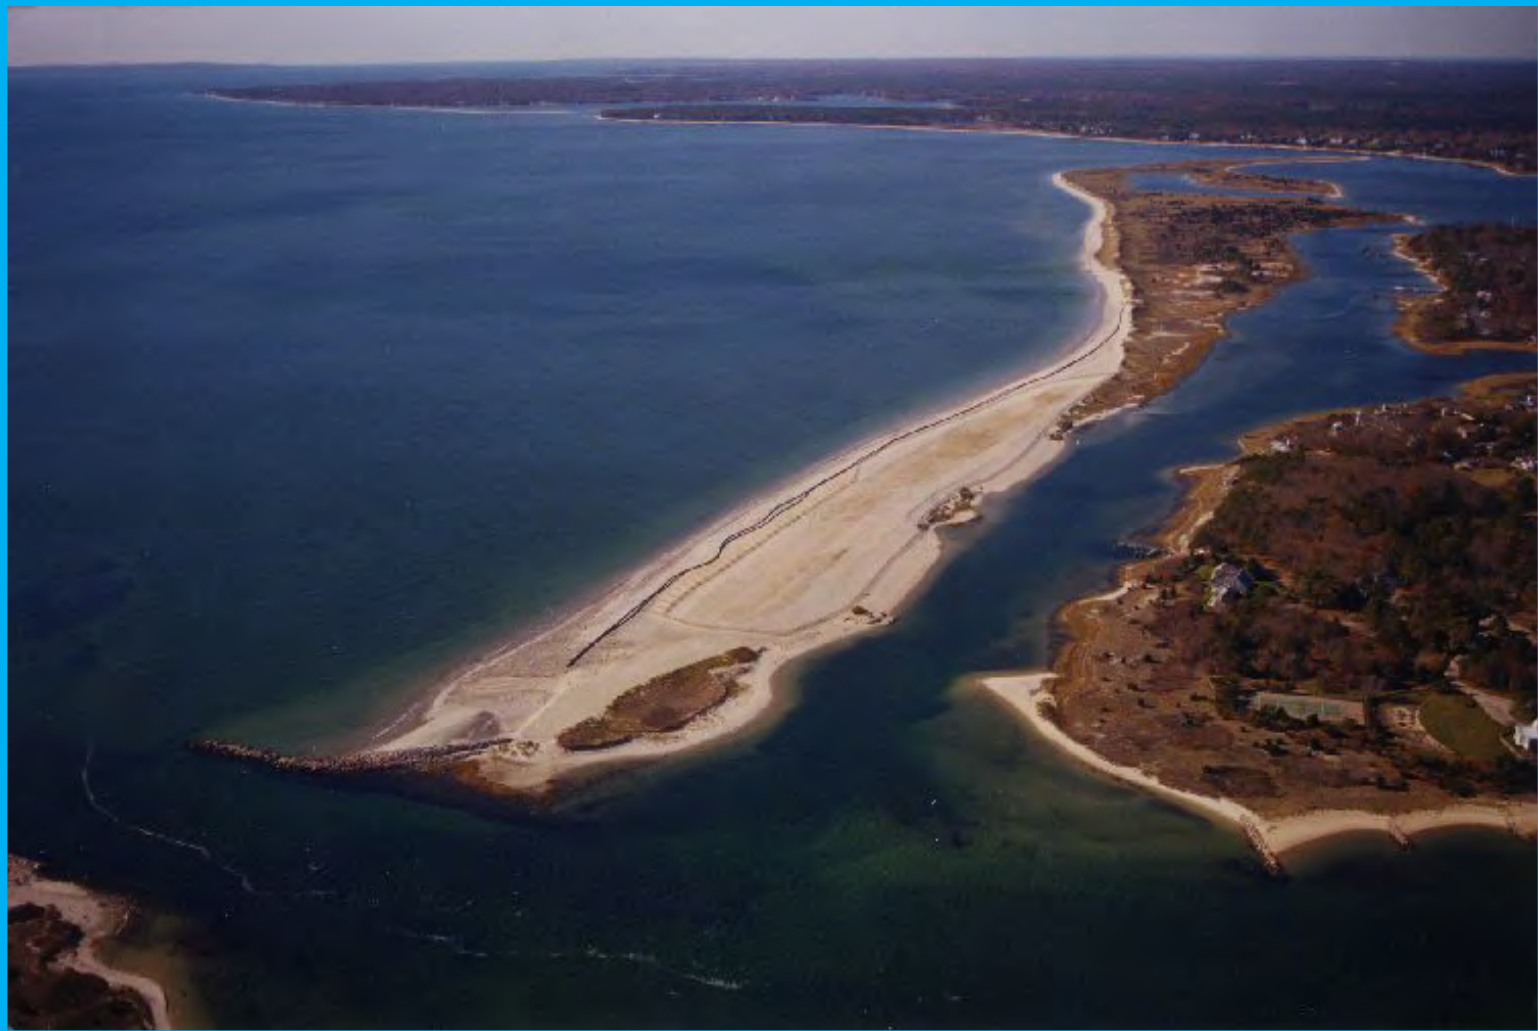
Shoreline Surveys (Since 2002)

“How is the 1999 beach fill performing?”

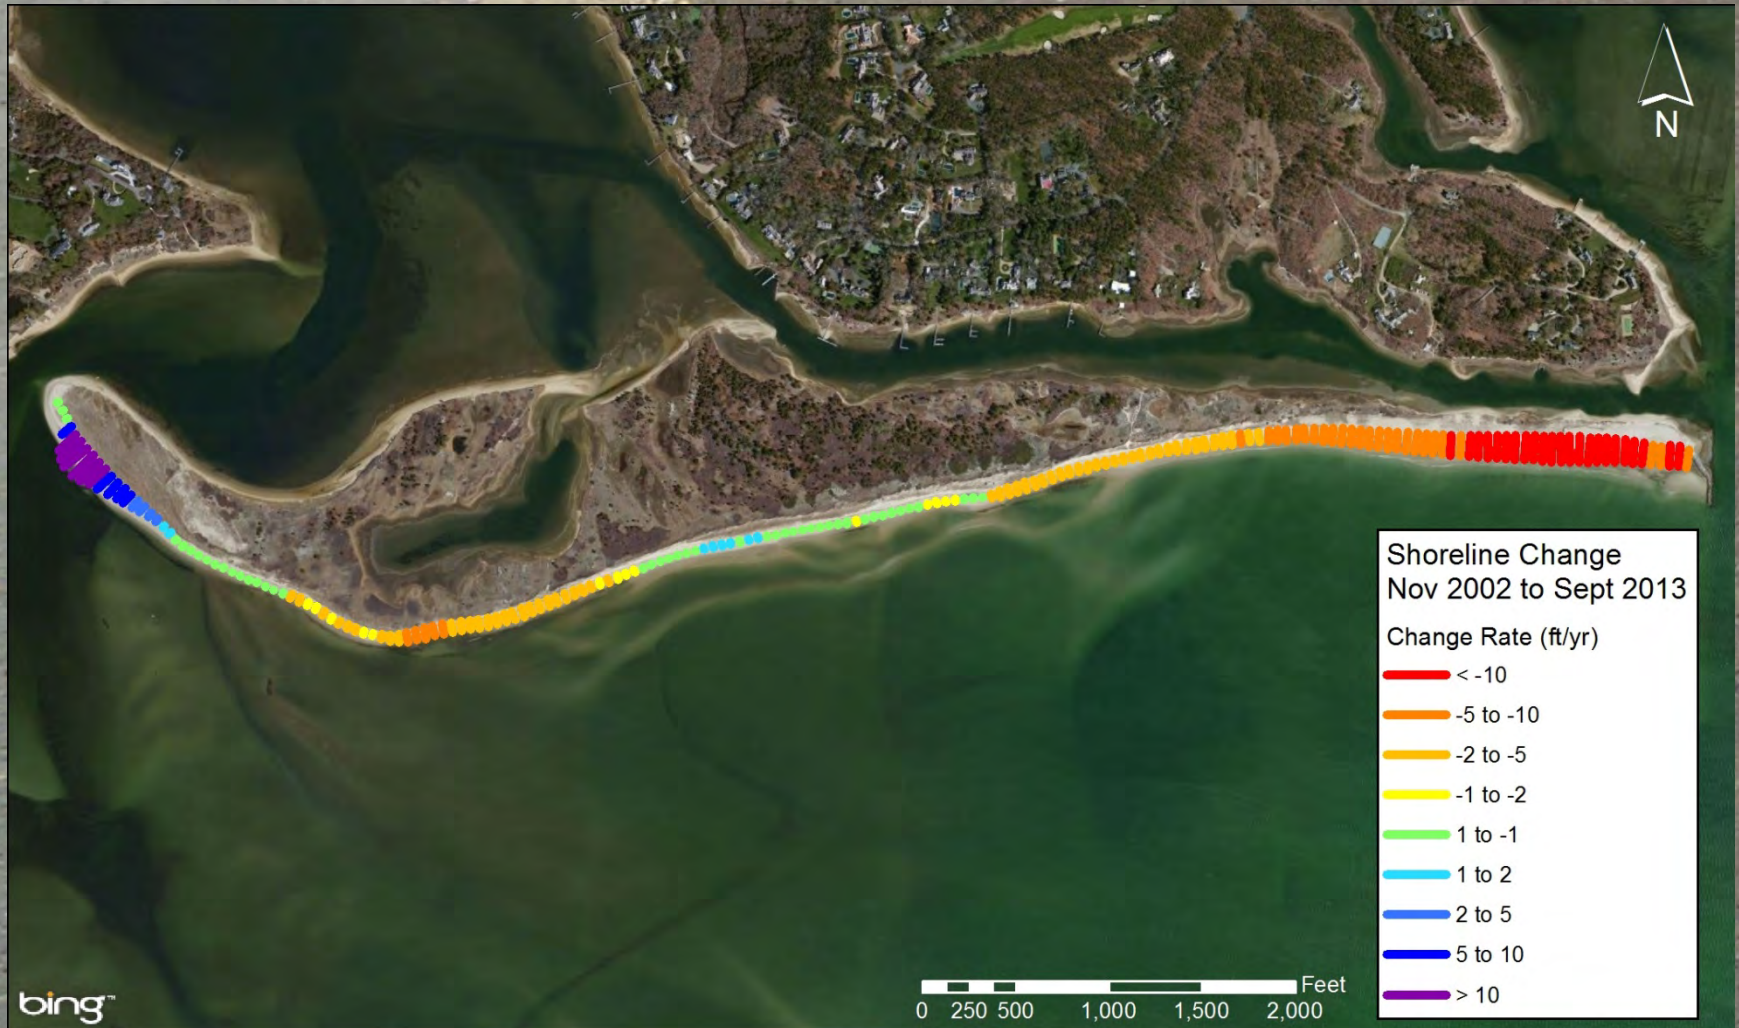
Shoreline Surveys (Since 2002)

“How is the 1999 beach fill performing?”

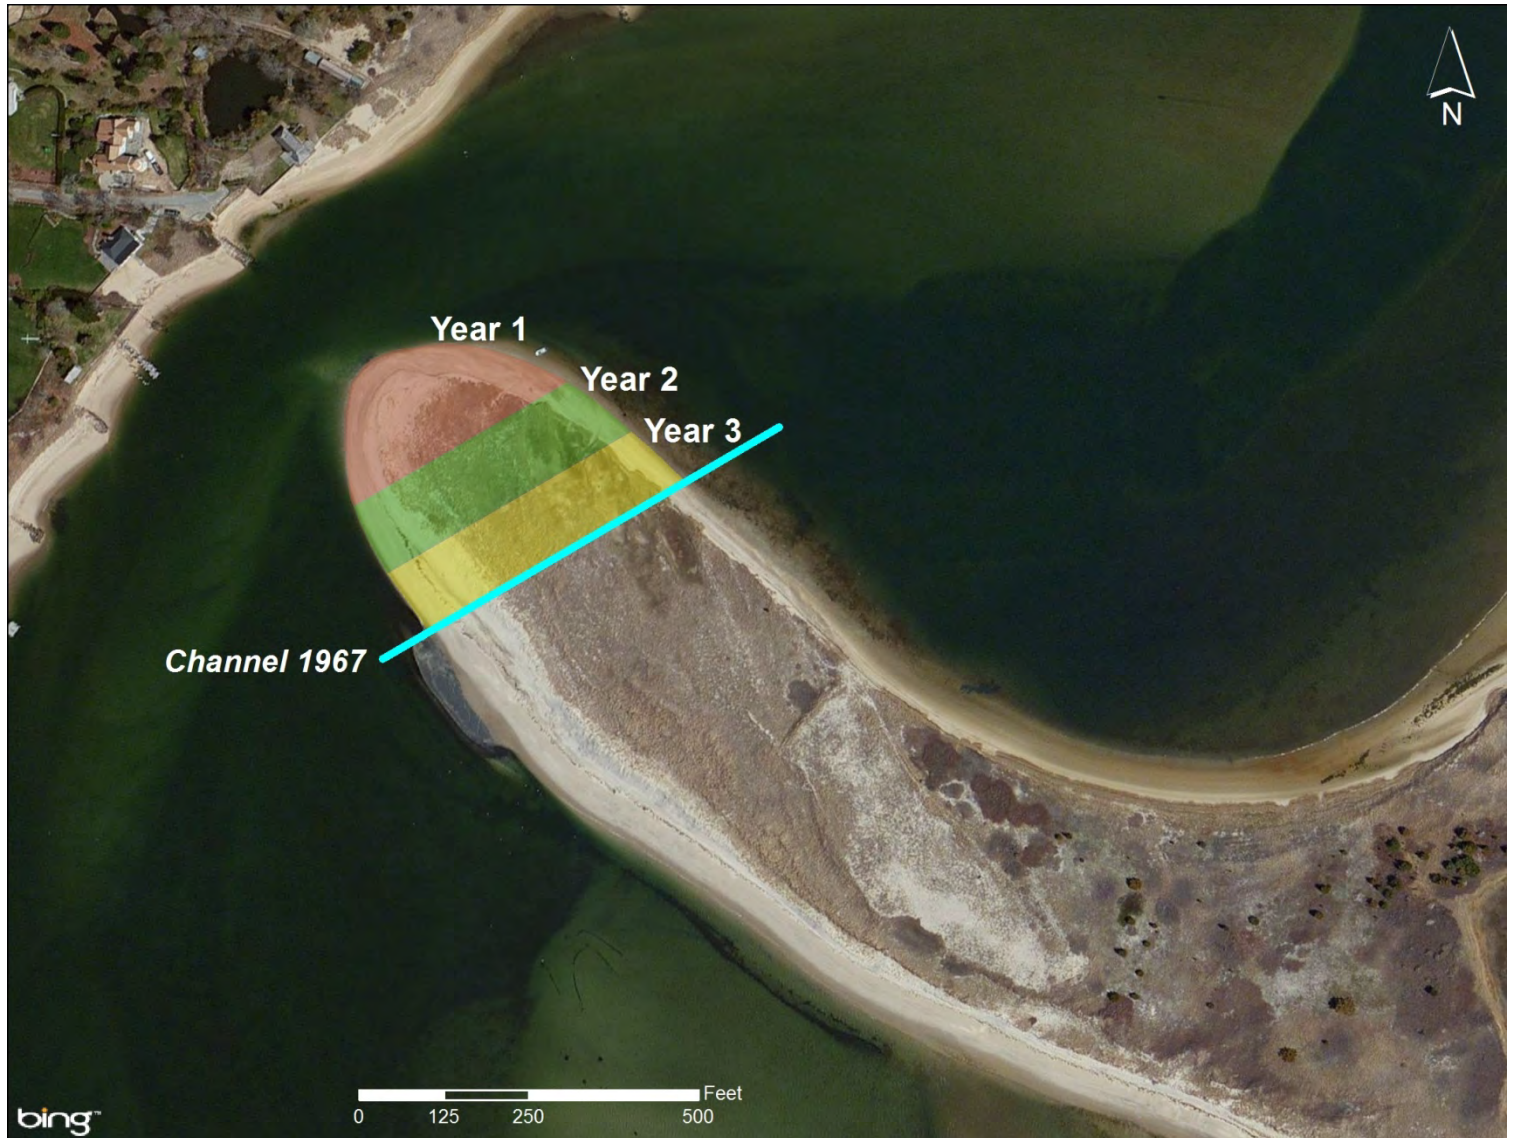
Proposed Dredging Schedule

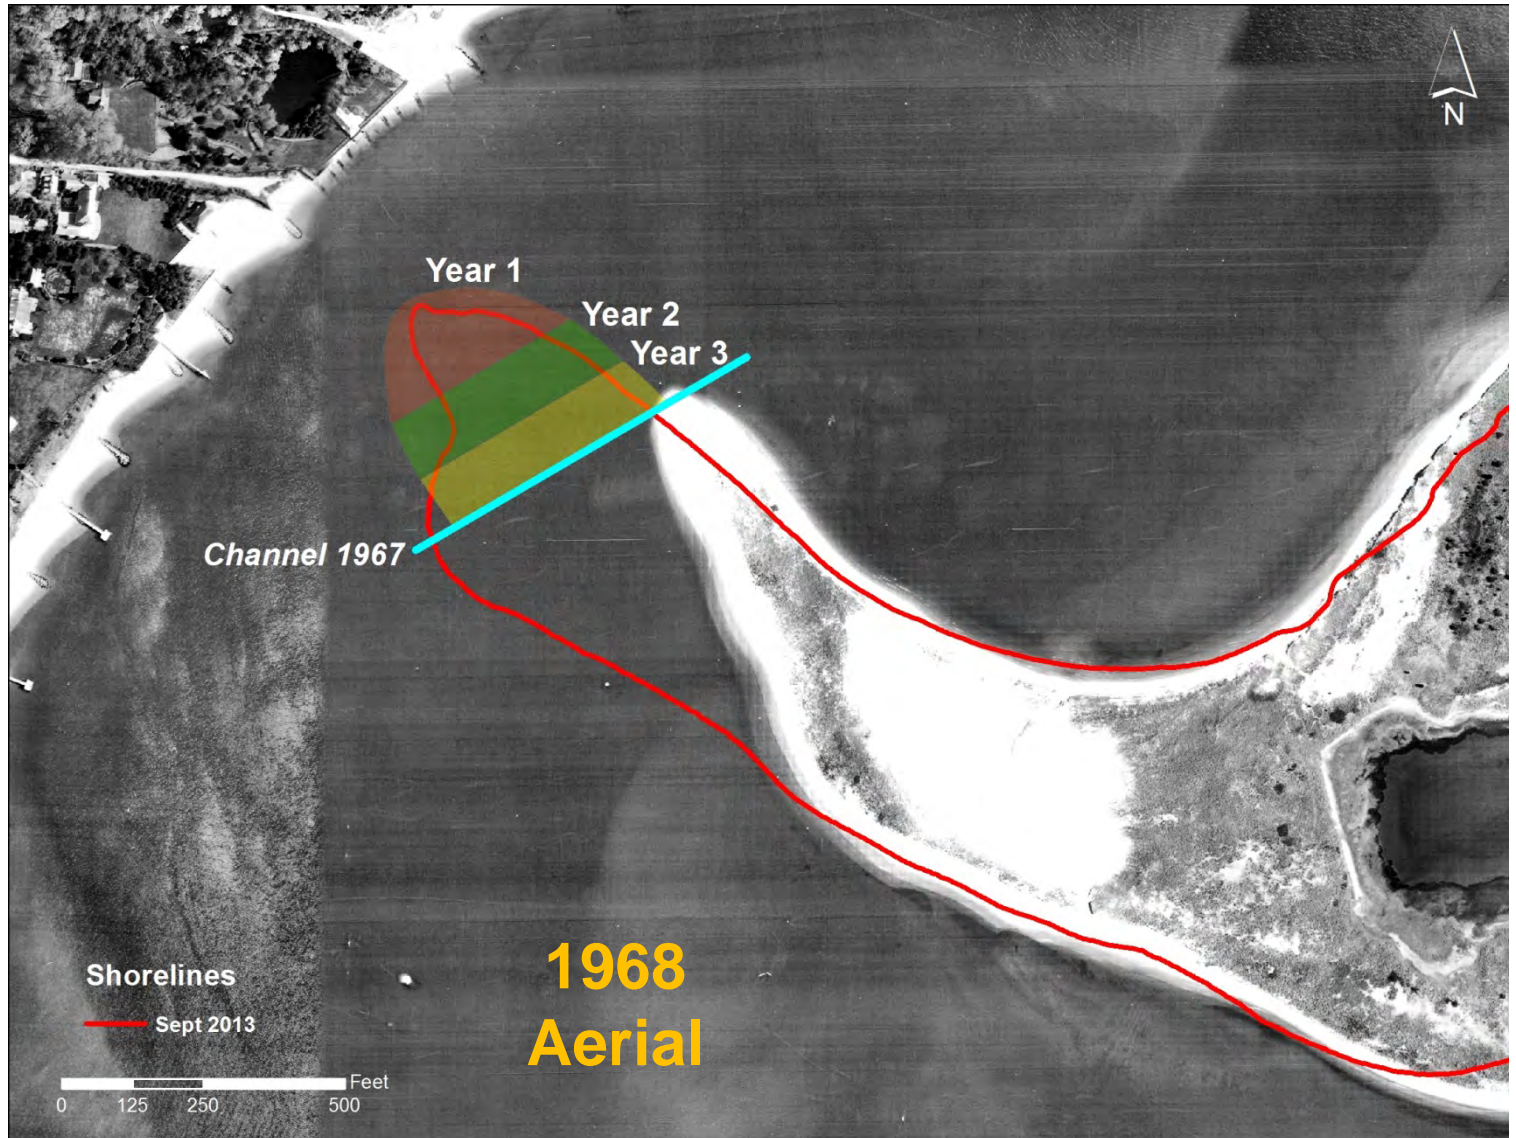
Proposed Dredging Schedule

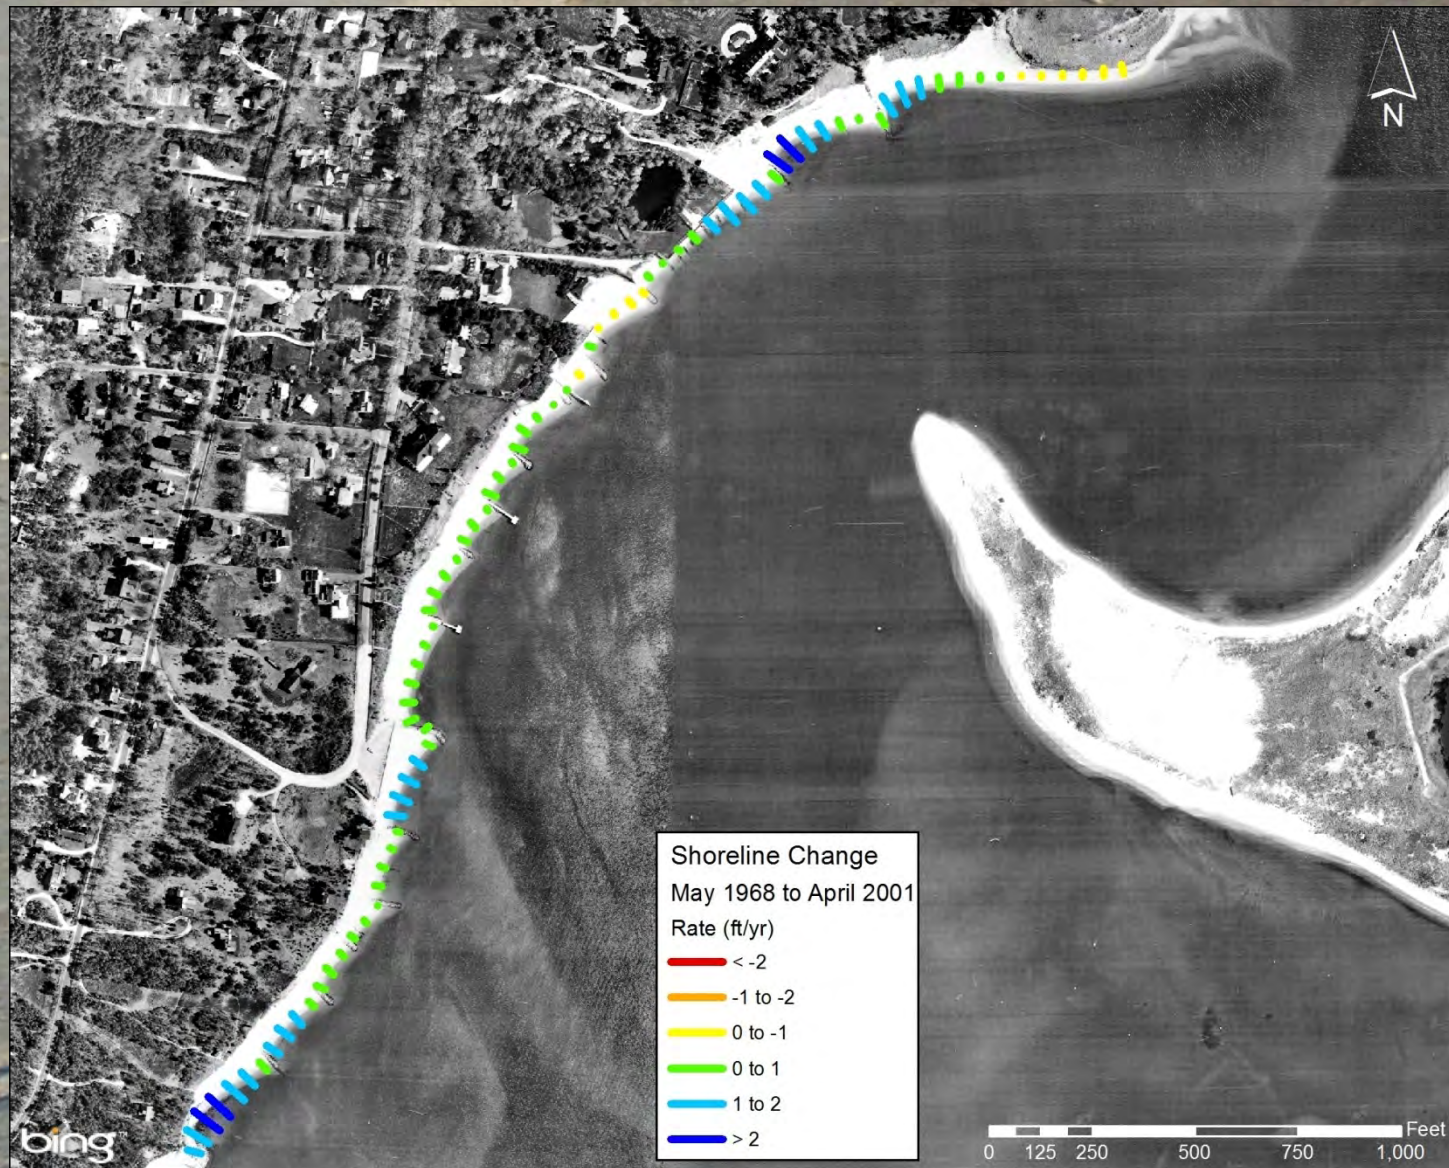
Historical Shoreline Change (1968-2001)

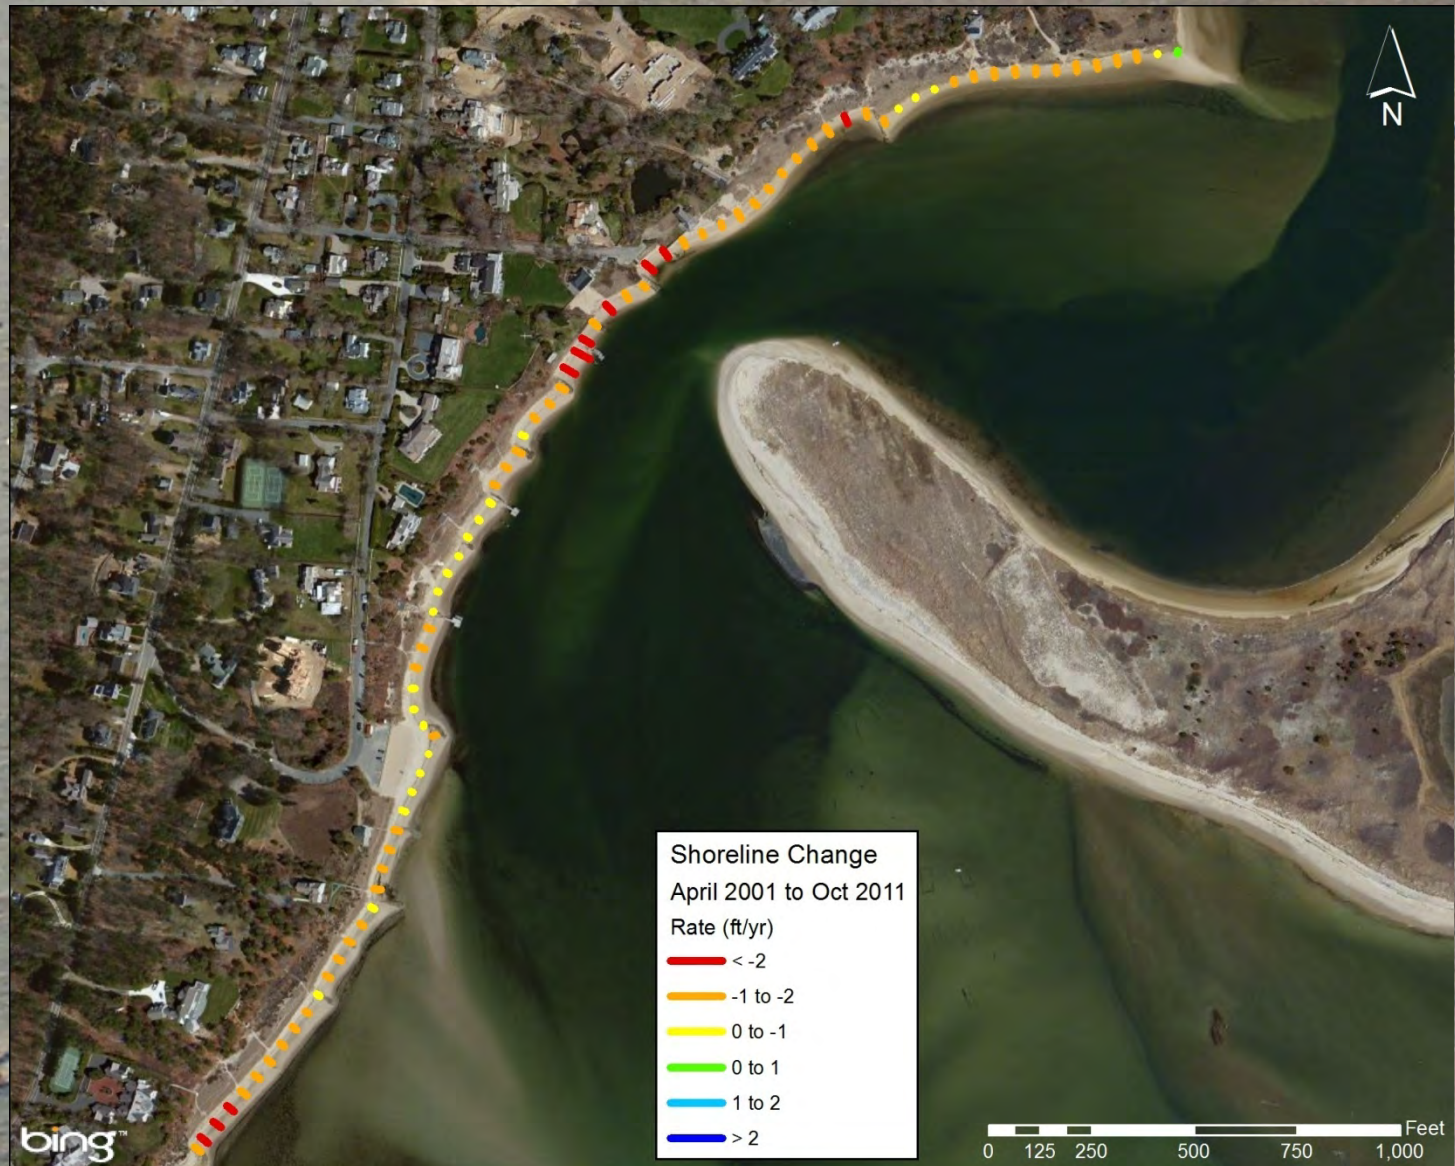
Historical Shoreline Change (2001-2011)

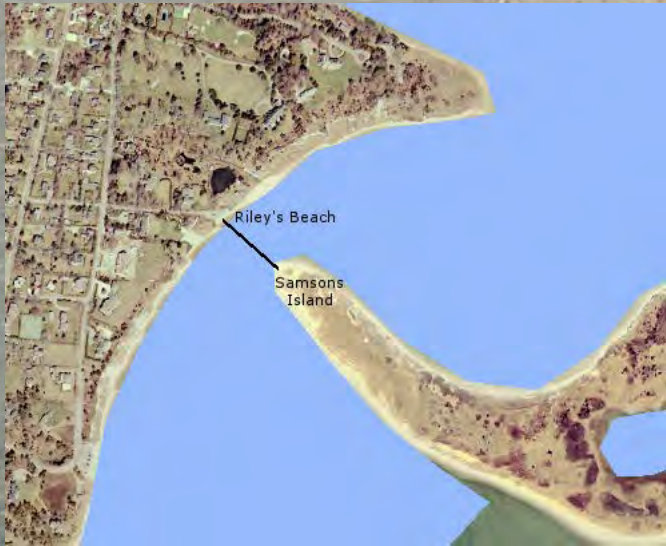
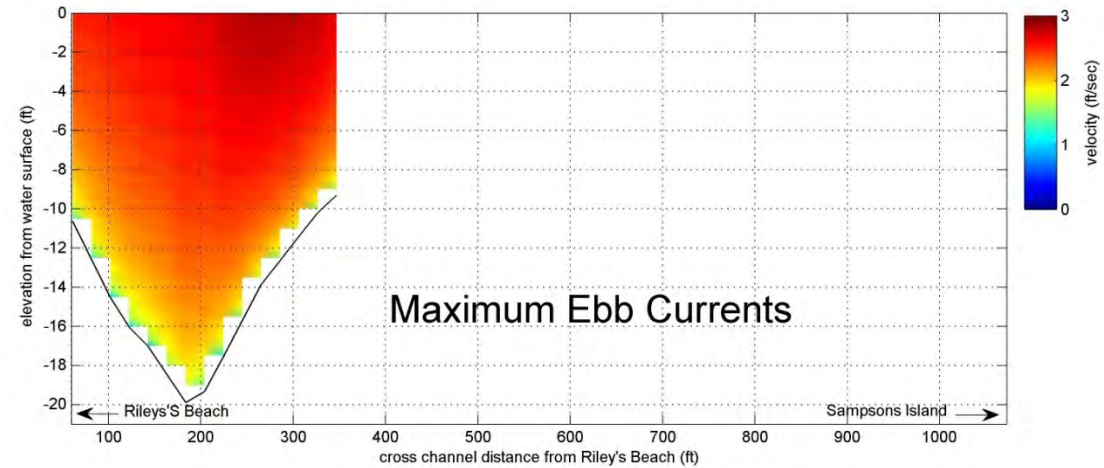
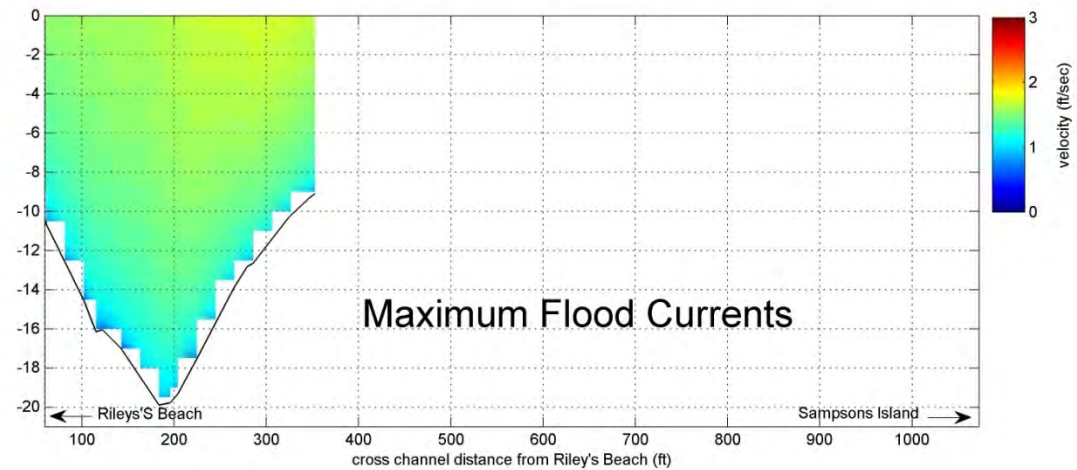
Influence of channel width on currents

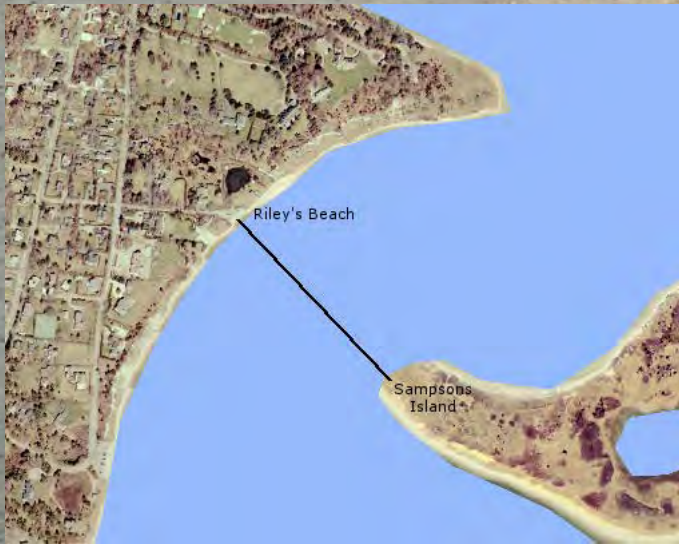
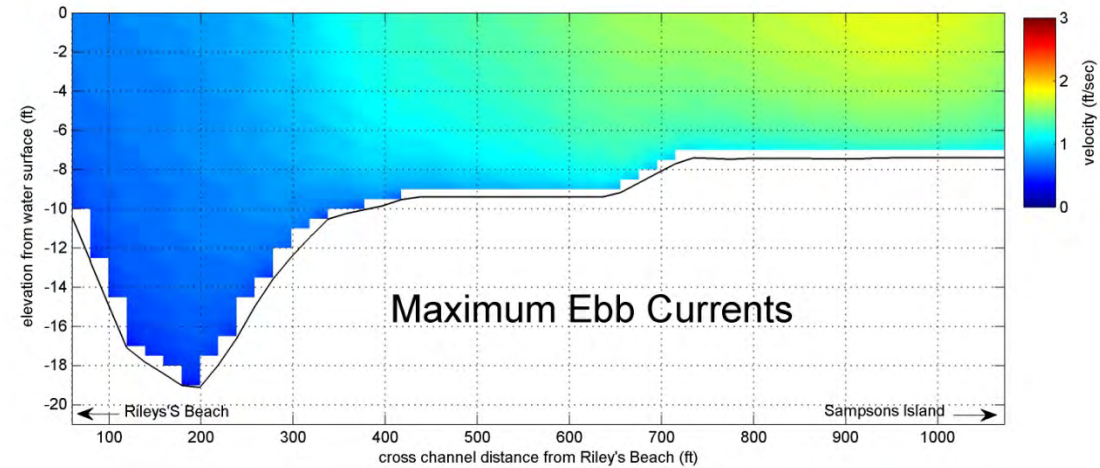
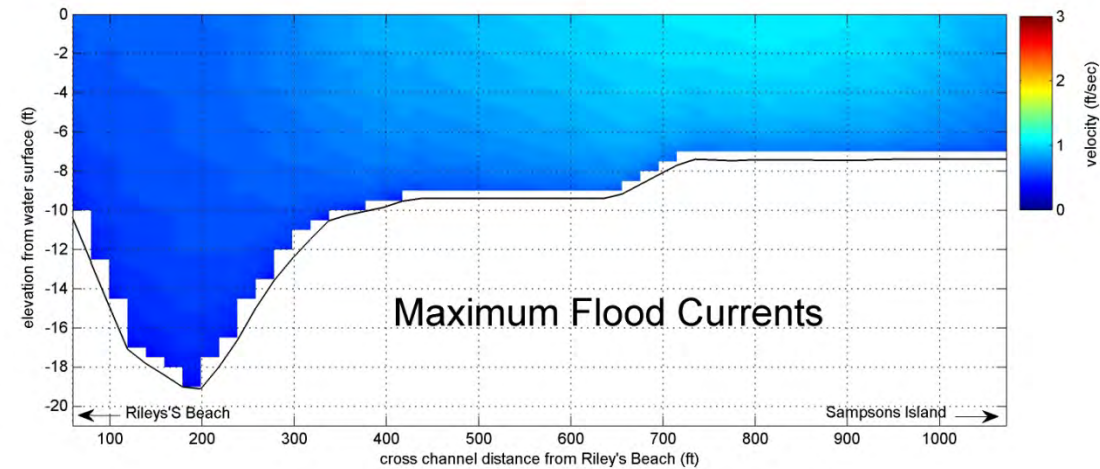
Influence of channel width on currents

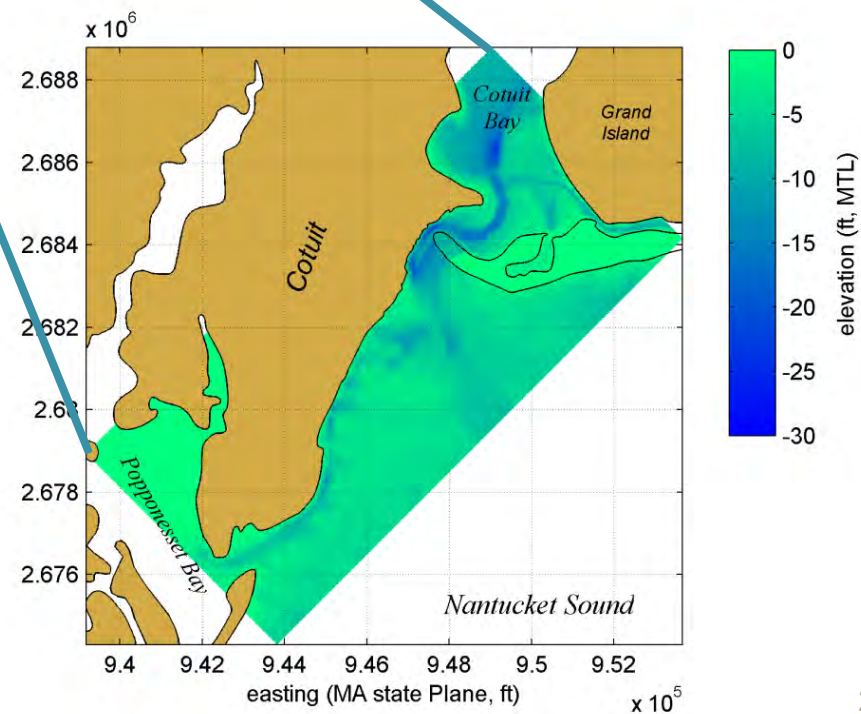
Wave Modeling Grids

Coarse
Fine

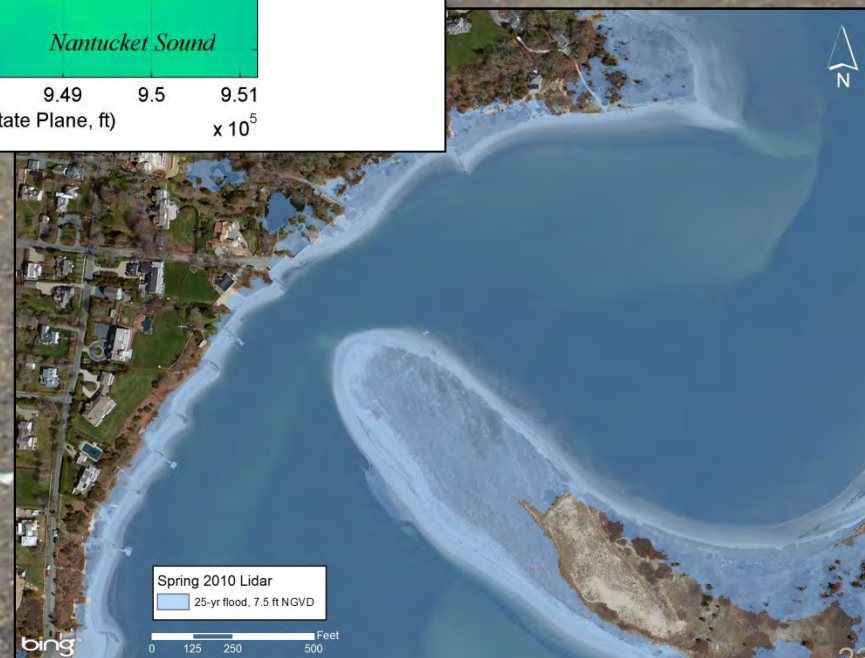
Existing and 800-ft Spit Removal

Modeled 25, 50, and 100-year Storm Events

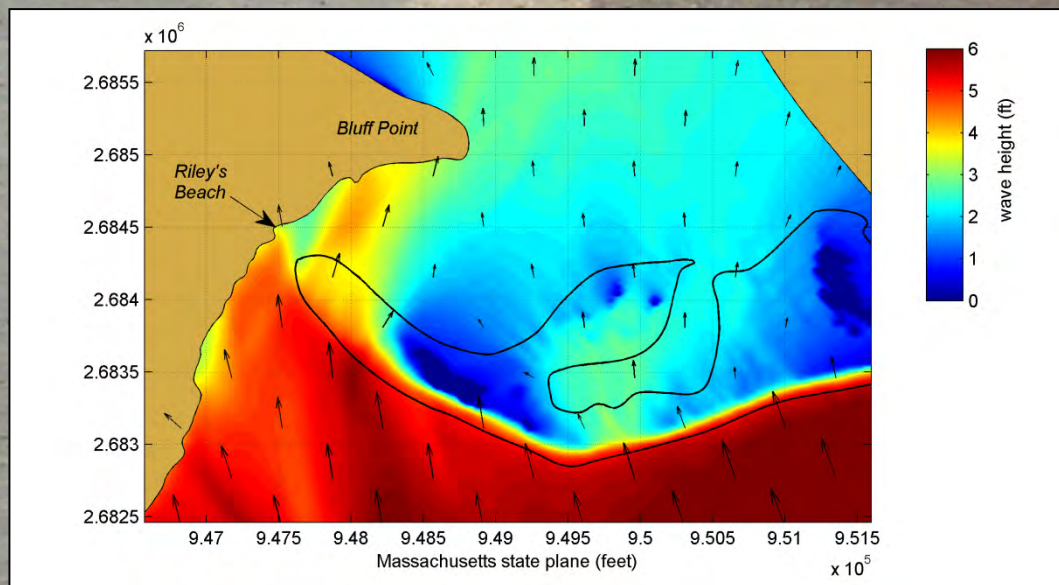
Fine Grid Model (10 m Cells)

100-year Storm from South

Existing Conditions

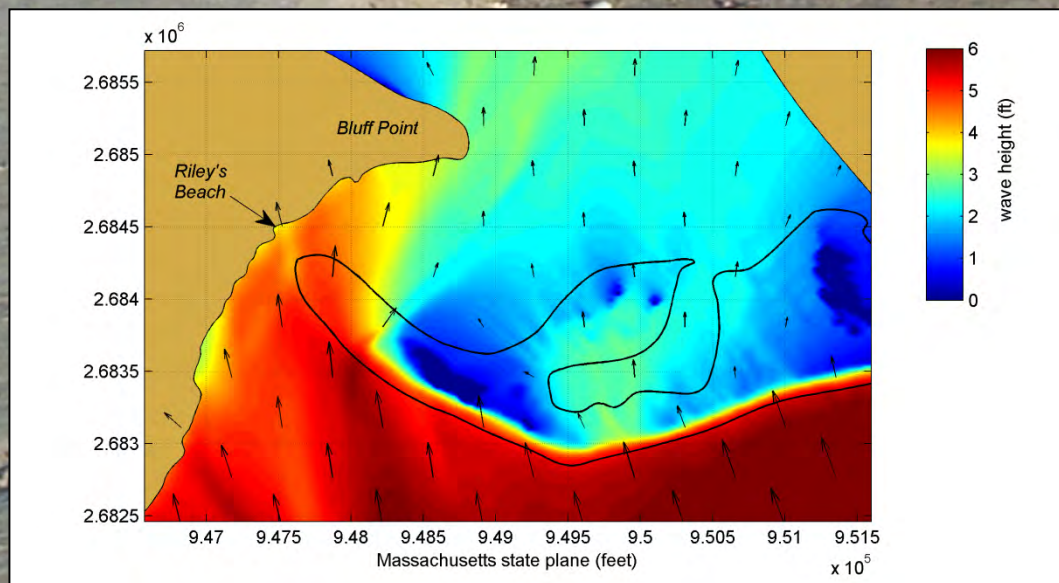
800-ft Spit Removal

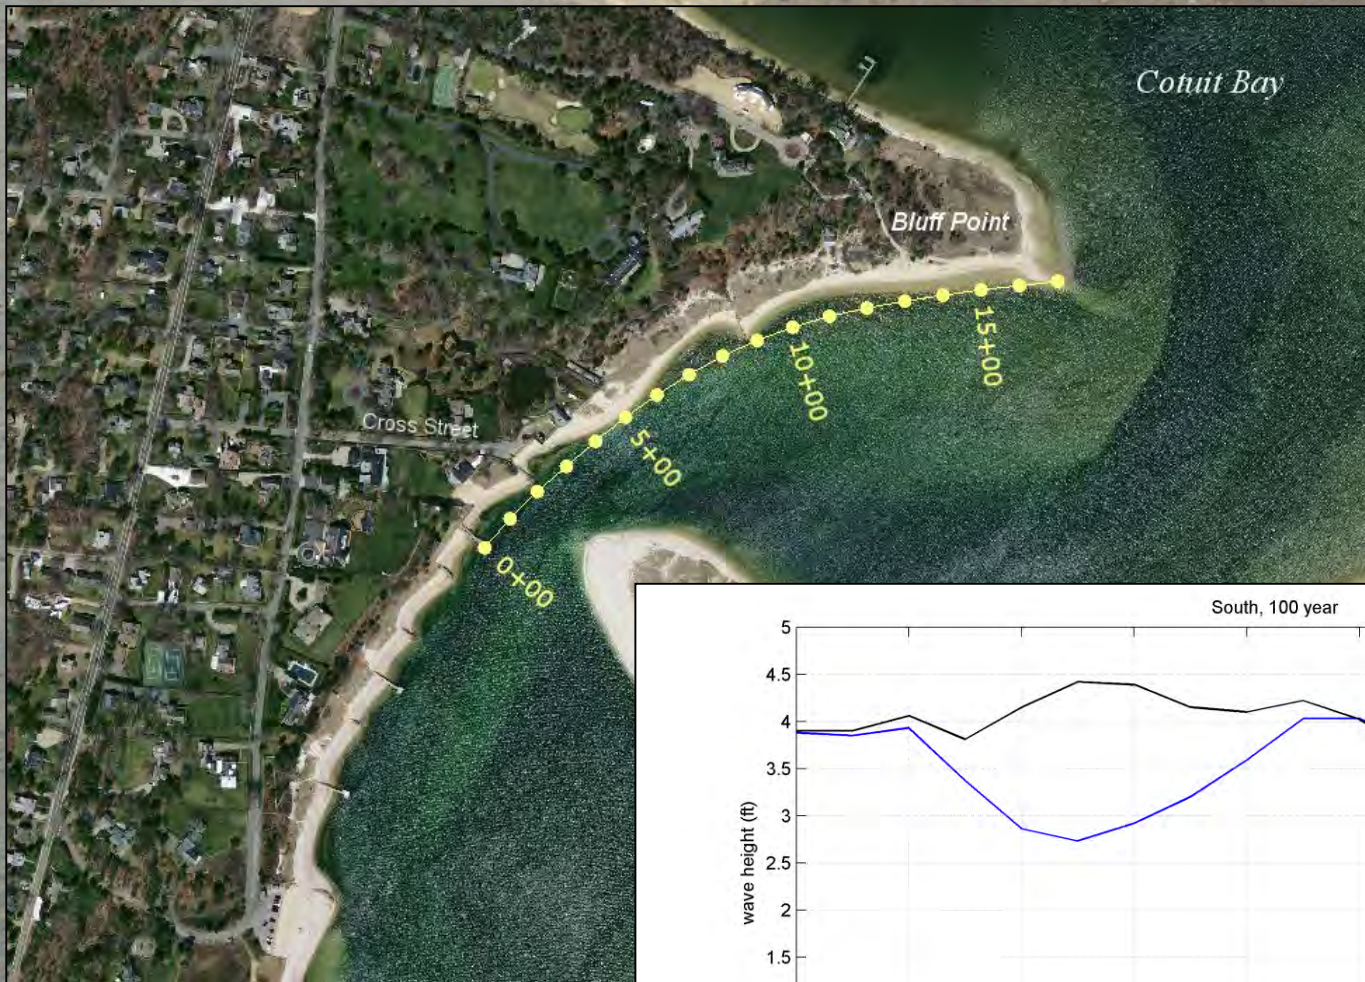
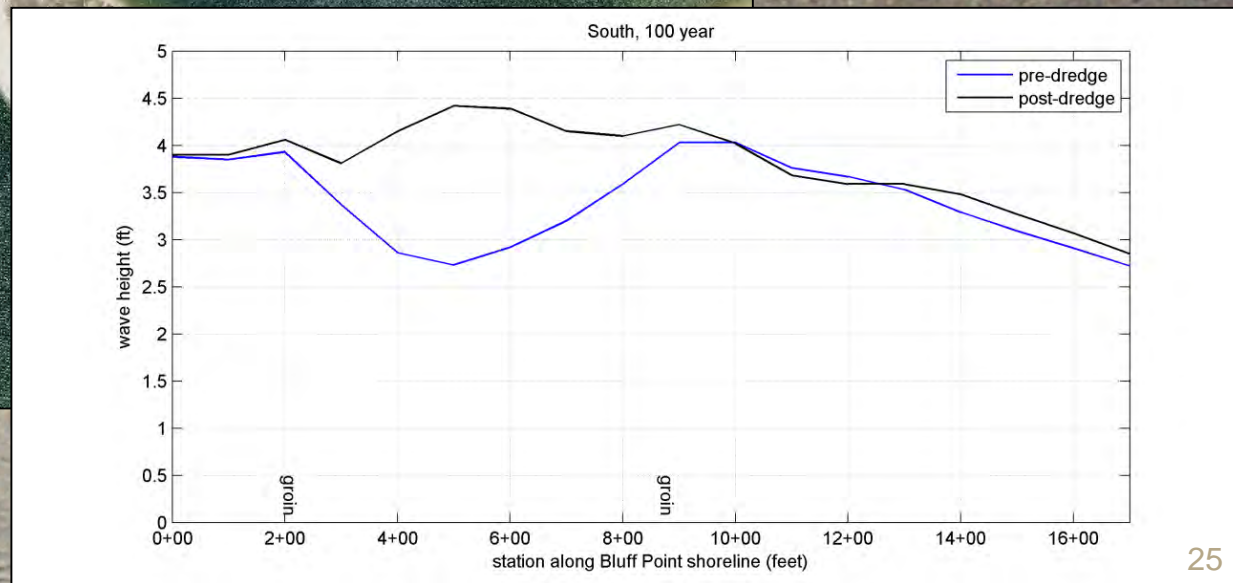
Wave Height Difference

100-year Storm from South
