Green Infrastructure for Coastal Resilience
March 28, 2017

Dead Neck & Sampson's Island Backpassing and Nourishment

John S. Ramsey, P.E., D.CE
Applied Coastal Research and Engineering, Inc.

Project Sponsors: Three Bays Preservation & Mass Audubon Society

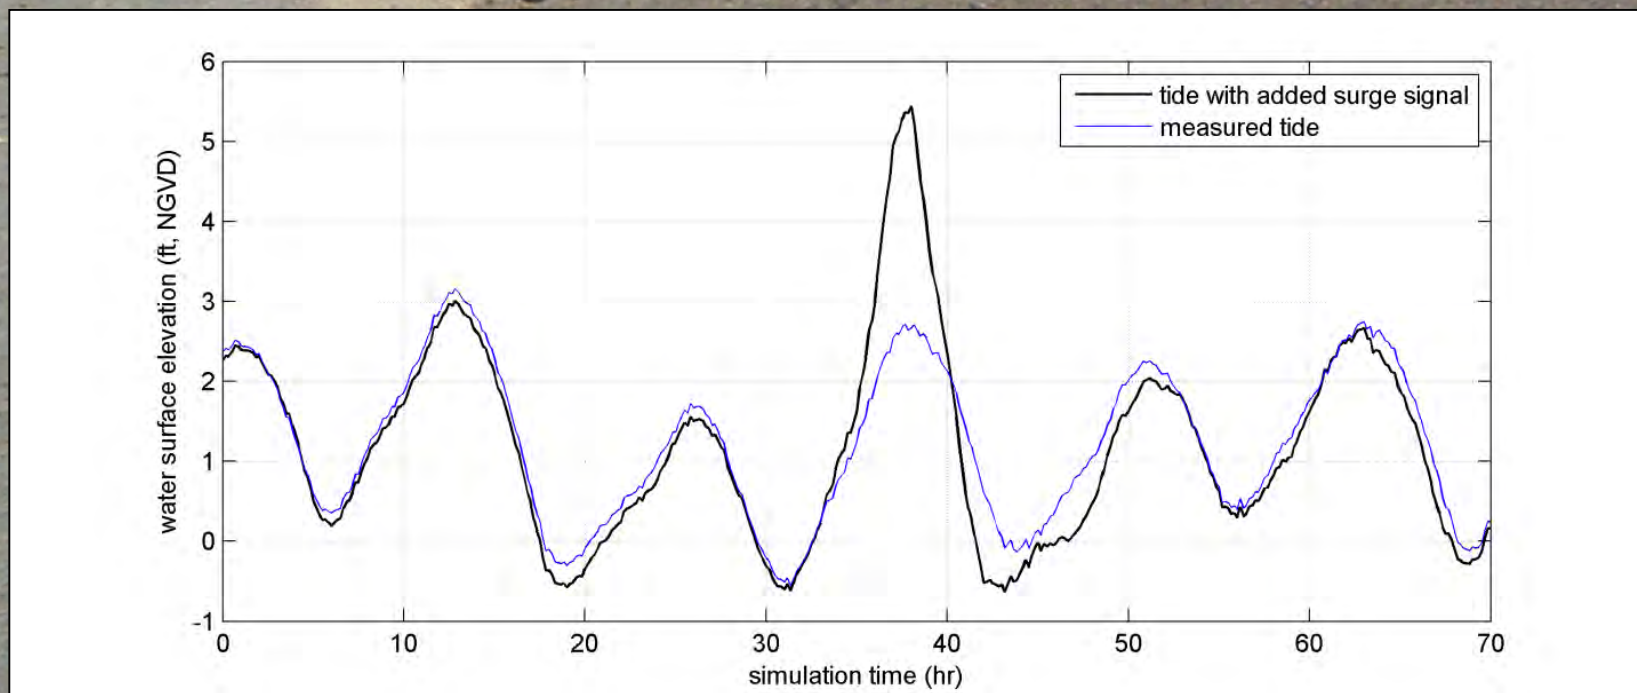
Storm Surge - Hydrodynamic Analysis

10-year Storm Surge – Similar to Hurricane Bob

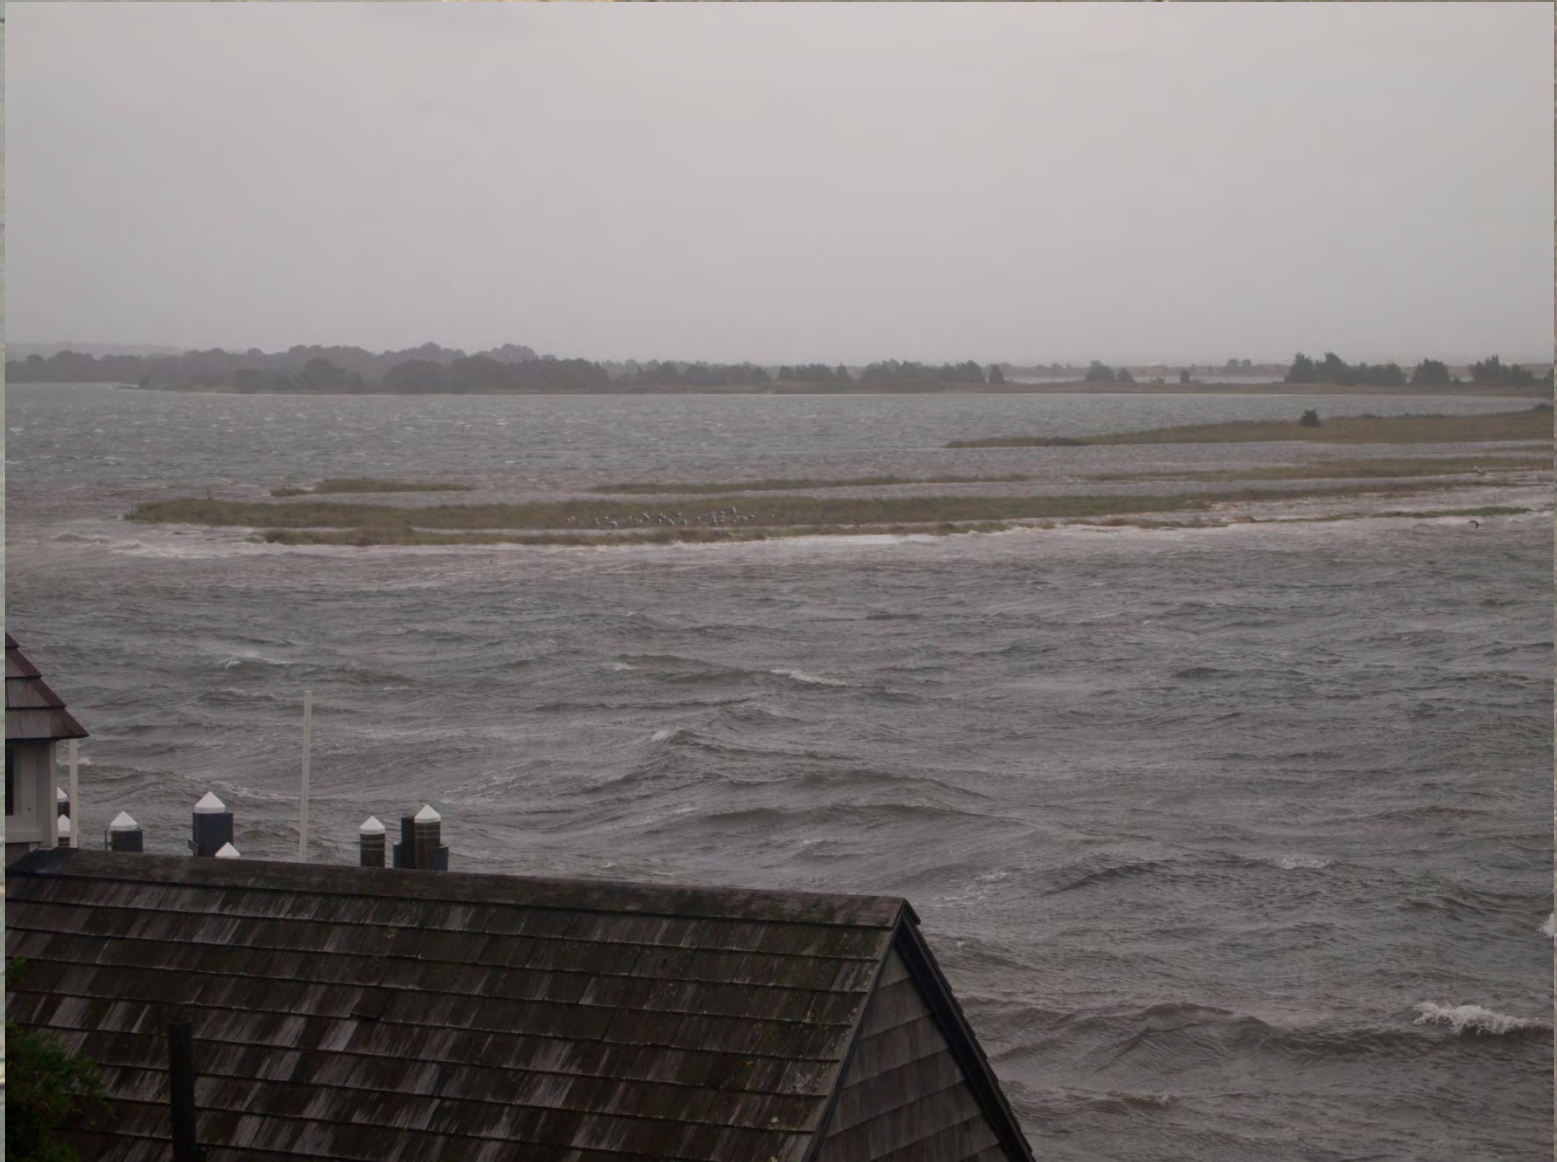
Low Elevation of the Spit

Hurricane Irene 2011 ~ 4 Year Return Period Water Level

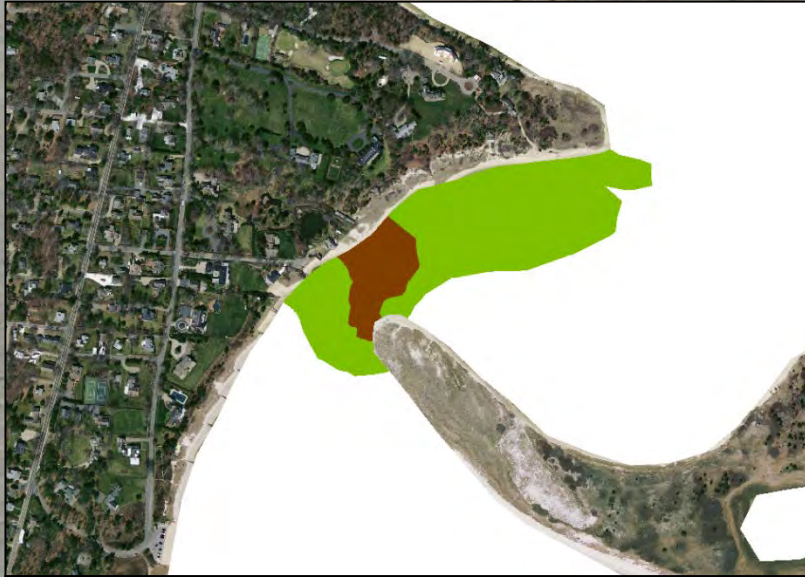
Hydrodynamic Analysis – Existing Conditions

10-year Storm Surge – Similar to Hurricane Bob

Green > 2ft/sec and Red > 3 ft/sec

**Existing Conditions
Flood Tide**

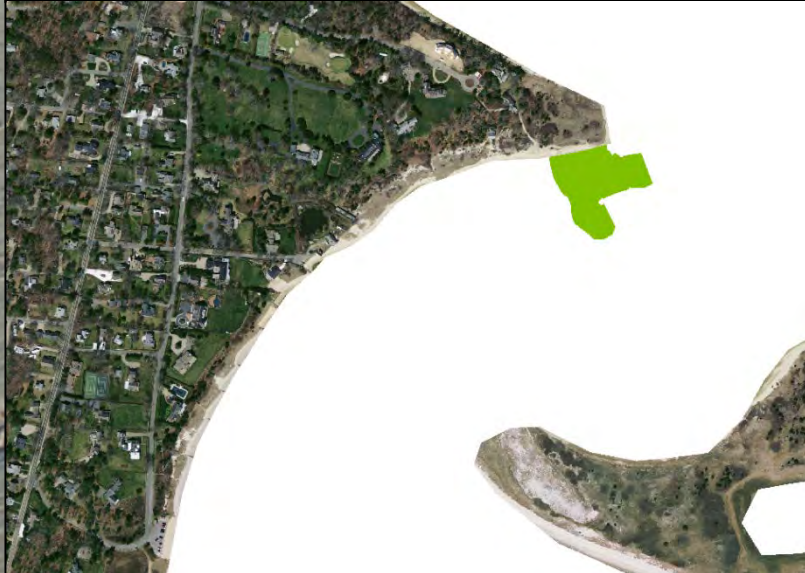
**800-ft Spit Removal
Flood Tide**

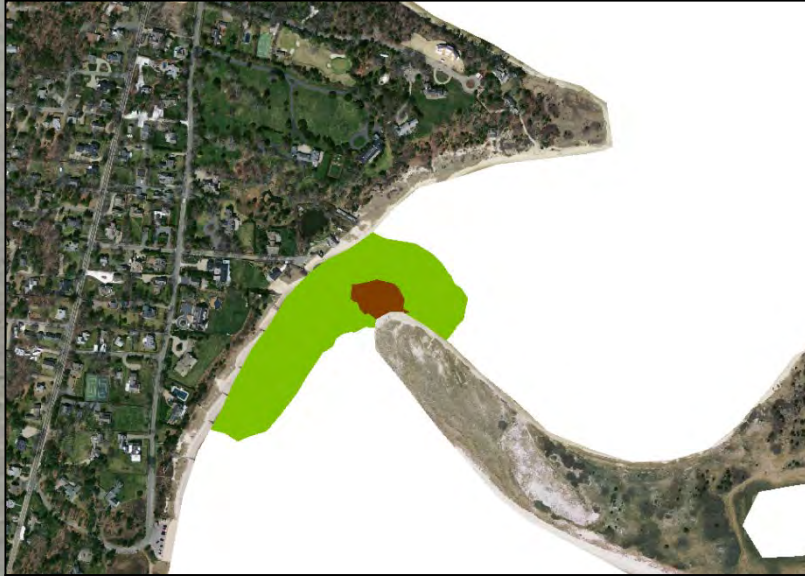
Hydrodynamic Analysis – Existing Conditions

10-year Storm Surge – Similar to Hurricane Bob

Green > 2ft/sec and Red > 3 ft/sec

Existing Conditions
Ebb Tide

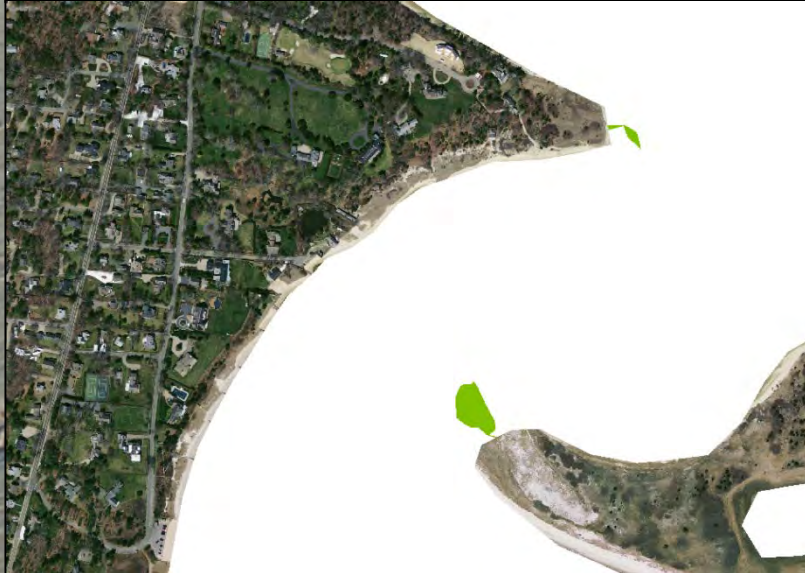
800-ft Spit Removal
Ebb Tide
